Serious incident to Airbus A330
registered **F-GRSQ**
on 26 December 2014
in cruise, over the Mediterranean Sea

Unavailability of the three IRSs⁽³⁾, loss of attitude and navigation data in cruise

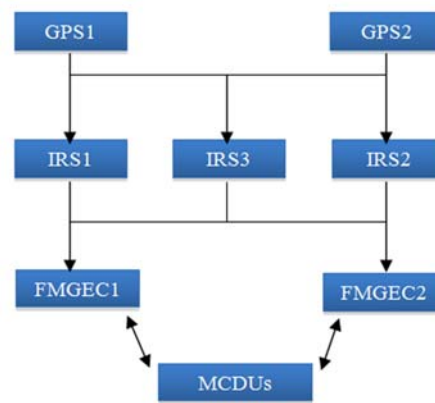
Figure 6: Schematic diagram of transmission of GPS data. The GPS function is provided by the MMRs and the IRS function by the ADIRUs

The FMGEC uses the “*hybrid GPIRS latitude*” parameter as a reference datum to determine the validity of the GPS data (i.e. the pure GPS data and the hybrid GPIRS data).

If this reference data is no longer valid (“*Failure Warning*” status for example), the GPIRS and GPS positions are considered invalid by the FMS part. A parameter must be valid to be used by the FMGEC or displayed on the MCDU.

During the event, at 13:45, the three IRSs in IN FLIGHT ALIGNMENT failure mode positioned the status of the reference datum at “*Failure Warning*” which explains why the crew did not have access to the pure GPS positions on the MCDU GPS MONITOR pages. If one of the IRSs had been set to ATT mode, this would have modified the status of the reference datum and allowed the crew to view the pure GPS positions on the MCDU. This logic was confirmed by the manufacturer in tests on the aeroplane.
