# INVESTIGATION REPORT

**Serious incident** to Airbus A321  
registered **TC-OBZ**  
on 26 September 2013  
during approach to  
Deauville-Normandie aerodrome  
operated by **Onur Air**

**BEA**  
Bureau d'Enquêtes et d'Analyses  
pour la sécurité de l'aviation civile

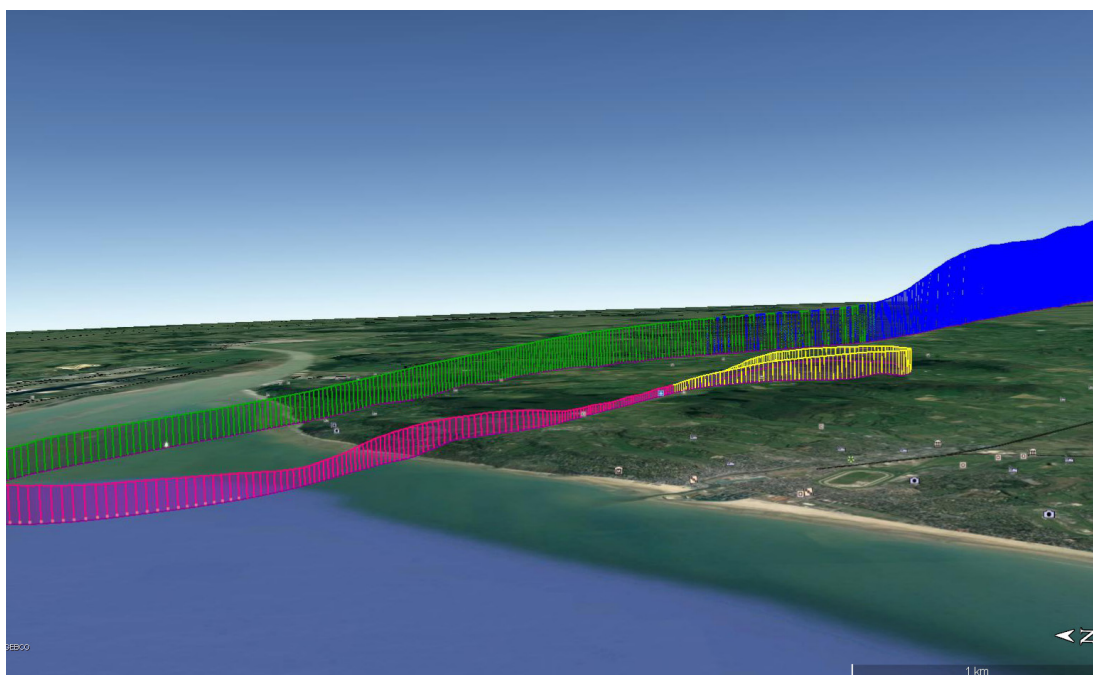
**Appendix 6**  
GEOGRAPHICAL PATH OF FLIGHT BASED ON QAR DATA

From the end of the downwind leg, while the aircraft was 900 ft below the recommended altitude for this type of approach, the crew's actions were similar to those for a visual approach, among others a descent with a rate of the order of 400 ft/min. This resulted in the aircraft passing under the final approach slope and finding itself at a minimum recorded altitude of 528 ft (49 ft above the aerodrome) at a distance of 3 NM from the runway threshold. The flight path followed was such that without the crew's reaction following the occurrence of the TAWS alerts, the aircraft would have probably collided with the coast around twenty seconds later.

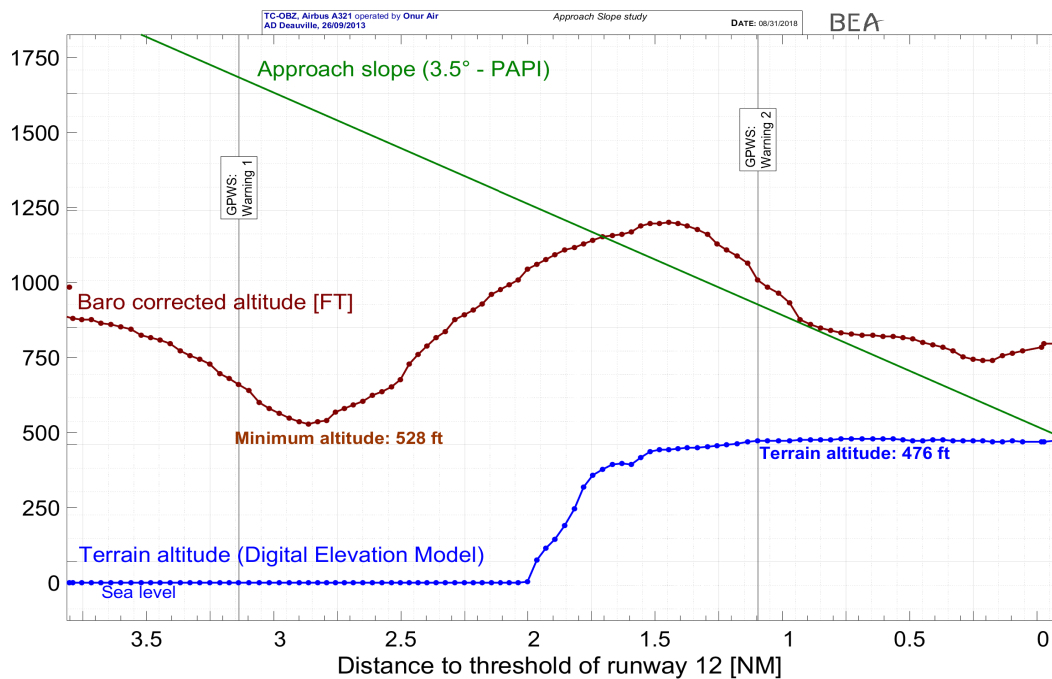
VERTICAL SECTION OF PATH OF LAST PART OF FLIGHT BASED ON QAR DATA

Subsequently, the descent to an altitude of 1,100 ft corresponded to the MDA, the target altitude of an MVL (in a visual approach, the altitude of the downwind leg is 1,500 ft above the ground, i.e. 2,000 ft in the case of Deauville). The airline company trained its crews to descend to the MDA in MVL, which is why the aircraft was so low when in the downwind leg. Although this practice complies with regulations, it causes the aircraft to fly along a flight path close to the ground. It unnecessarily reduces the safety margins when the weather conditions allow flight at a higher altitude.

- the crew descended the aircraft in the last turn, at the end of the downwind leg, thereby passing under the MDA of the MVL, and a fortiori under the recommended altitude for a visual approach;
