Examination of the aircraft Examination of the left and right propellers

Accident to the Fokker - F27-500
operated by **Miniliner SRL**
registered **I-MLVT**
on 25 october 2013
at **AD Paris Charles de Gaulle (95)**

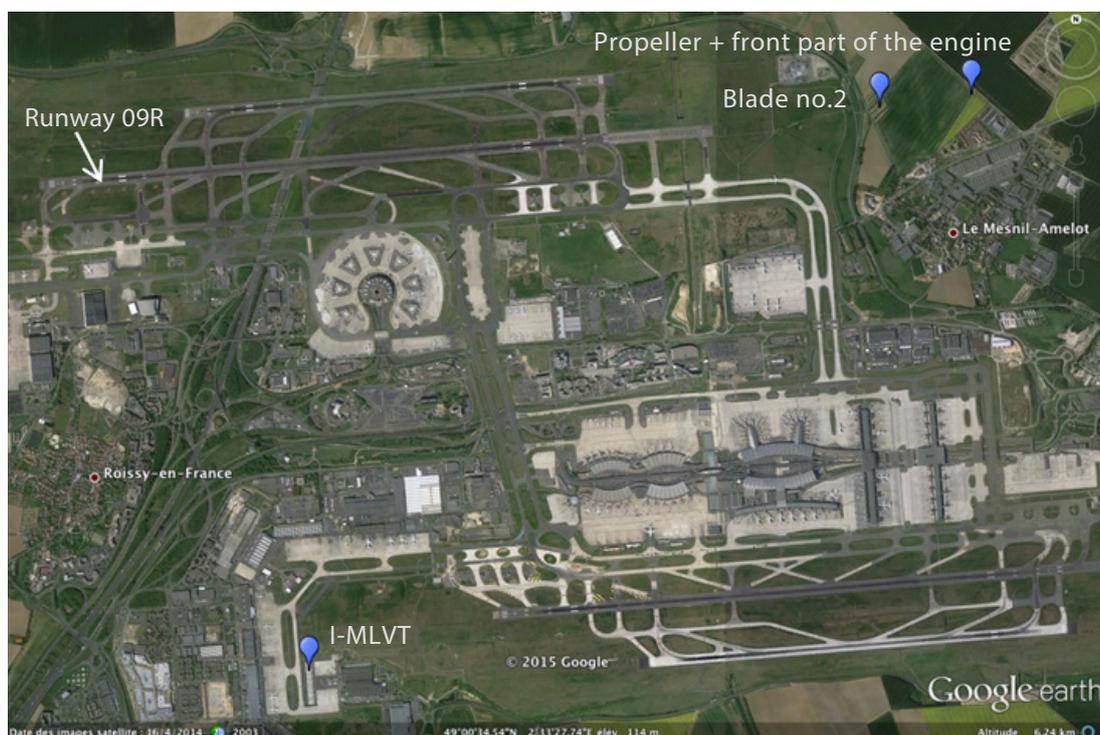
Figure 1: Distribution of debris and location of the aircraft after the event

The left propeller (with the exception of blade no.2) and the forward part of the left engine were found at the end of a field in the town of Mesnil-Amelot (77) approximately 2,400 meters from the end of runway 09R, almost on the extended runway centreline (figure 1).

Blade no.2 of the left propeller was found further out approximately 1,800 meters from the end of runway 09R, aligned with the runway and the left propeller.

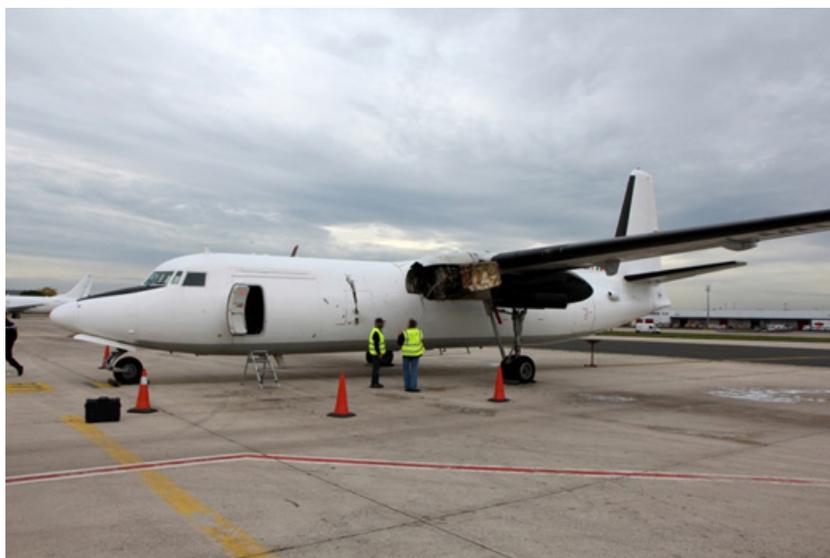
Figure 2: General condition of the aircraft

After the accident, the aeroplane was able to return and land on 09R and park at parking area P71 of the airport. During the examination of the aircraft, it was kept on the same parking area (figure 1 and figure 2). The visual inspection of the outside of the aircraft reported damage to:

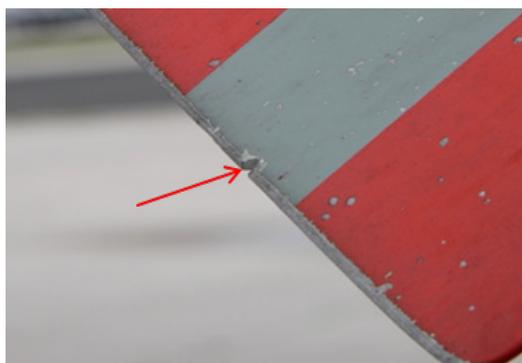
Figure 5: Impact on the leading edge of a blade of the right propeller

- ❑ the left side of the fuselage at the level of the propeller, where an opening of approximately 1.20 m in height was observed, from the outside inwards (figure 3). Other smaller traces of impacts were also identified (see red arrows);
- ❑ the right side of the fuselage, where an opening of approximately 1 m in height was observed, from the inside outwards (figure 4);
- ❑ the right propeller, one of whose blades had an impact on the leading edge, at the end of the blade (figure 5).

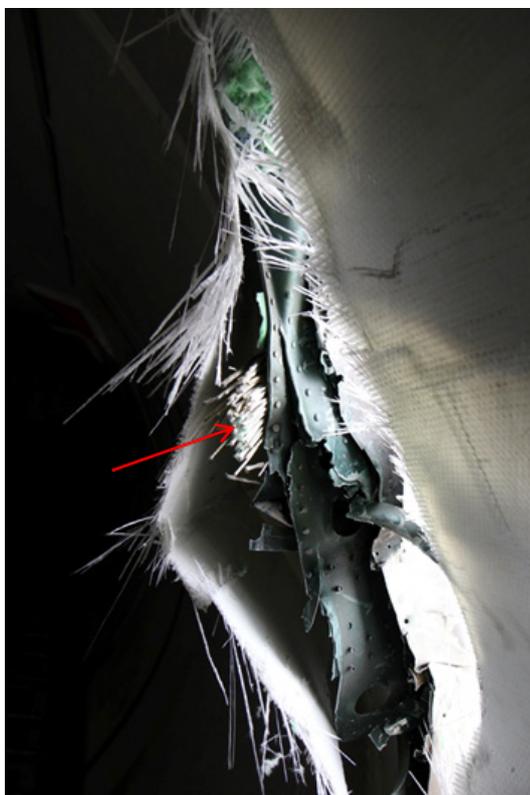
Wiring harnesses located between the metal fuselage and the composite inner skin were found severed at the level of the openings on the left and right sides (figure 6 and figure 7, red arrows).

A piece of blade 100 mm x 70 mm was found inserted in the fuselage, on the left side.

Figure 6: Opening left side seen from the inside, wiring harnesses cut

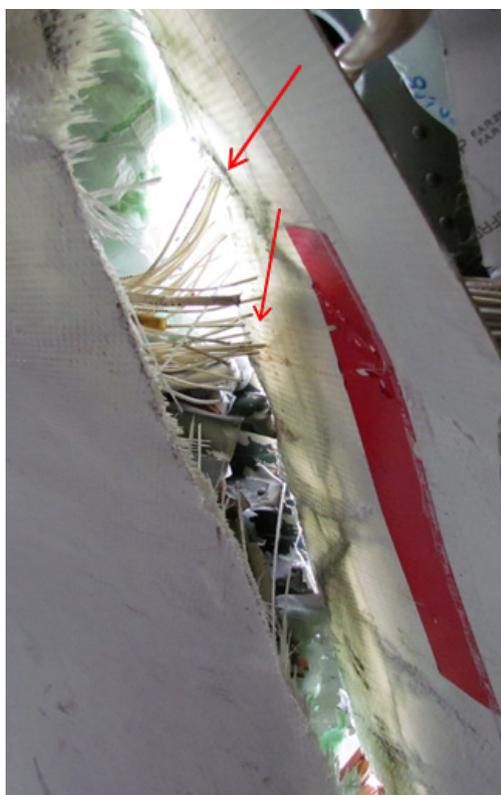
Figure 7: Opening right side seen from the inside, wiring harnesses cut

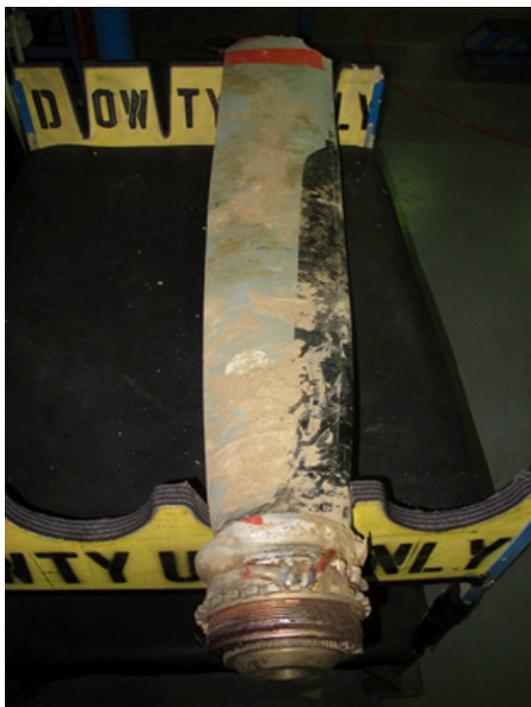
Blade no.1 was found detached from the left propeller. Only the de-icing wire still linked the blade to the hub of the propeller.

The first observations showed that the thread used to attach the blade in the hub was damaged (see §1.3.3.3.1- Bearing of blade no.1 - figure 25 and Figure 26).

Figure 25: no.1 blade alone, after cutting the de-icing wire

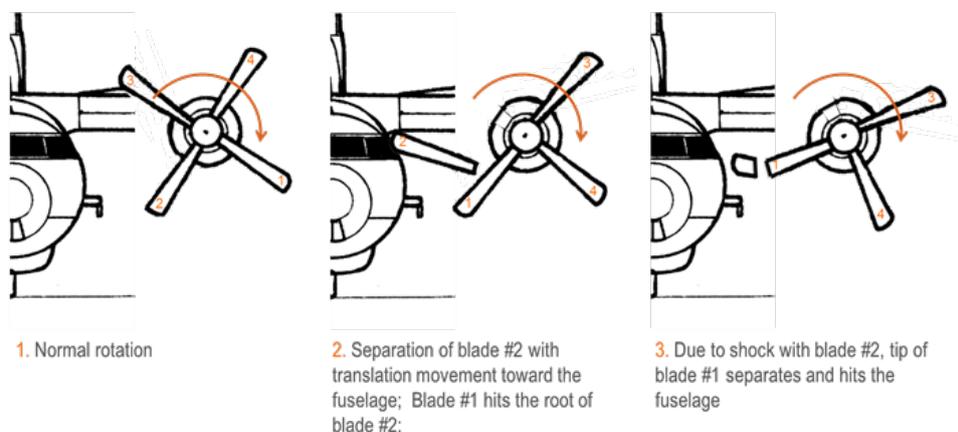
Figure 31: descriptive diagram of the blade loss sequence

The damage observed on blade no.1 is consistent with a tearing of the blade from the hub at the time of the impact with blade no.2, and then with the ground.

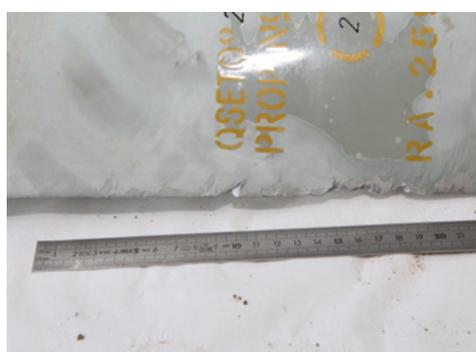
The elastomer of the de-icing system had radial cracks along the leading edge (figure 33). Its base had peeled off from the blade. The upper surface had several curved scratches (figure 34). The trailing edge also showed signs of impacts and scratches (figure 35). The pressure side had scratches, two of which were deeper than the others, one at the tip of the blade (approximately 8 cm in length, Figure 36), and the other near the blade root (3 cm long).

Figure 35: traces of impacts on the trailing edge

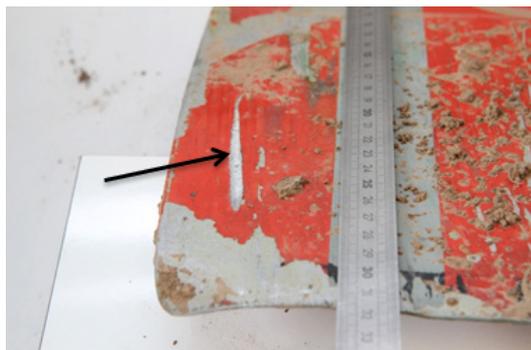
Blade no.2 was found in a field (figure 1). The blade tip was slightly bent towards the pressure side. The leading edge was damaged in several places (figure 32). One part of the damage was particularly pronounced, its shape being curved. It extended from the leading edge to the pressure side and the upper surface. The end of the leading edge was bent towards the rear (figure 36).

Figure 36: deep scratch on the pressure side

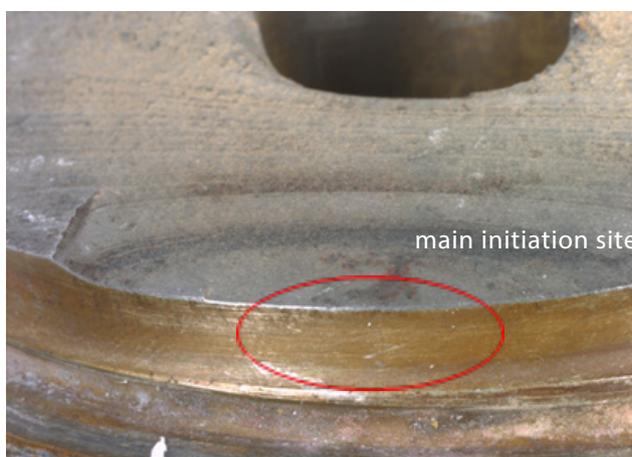
Observation of the (concentric) stop marks made it possible to determine the crack initiation site figure 40). It was located on the leading edge (figure 42). The presence of two radial lines suggested that two secondary cracks were also initiated and propagated.

Figure 40: detail of the fracture surface, at the initiation site

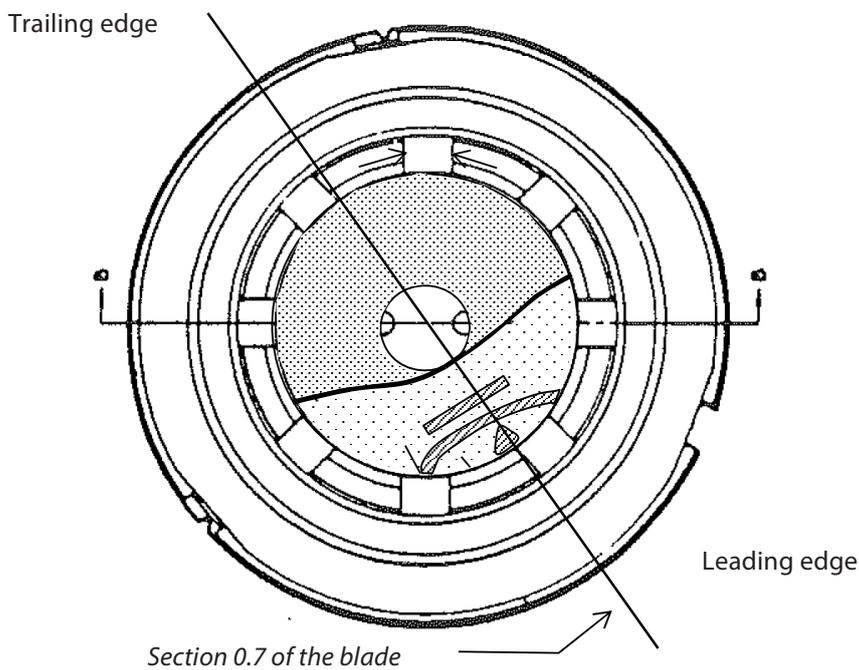
Figure 42 : View of the position of the fracture surface with respect to the blade (bottom view)⁽³⁾

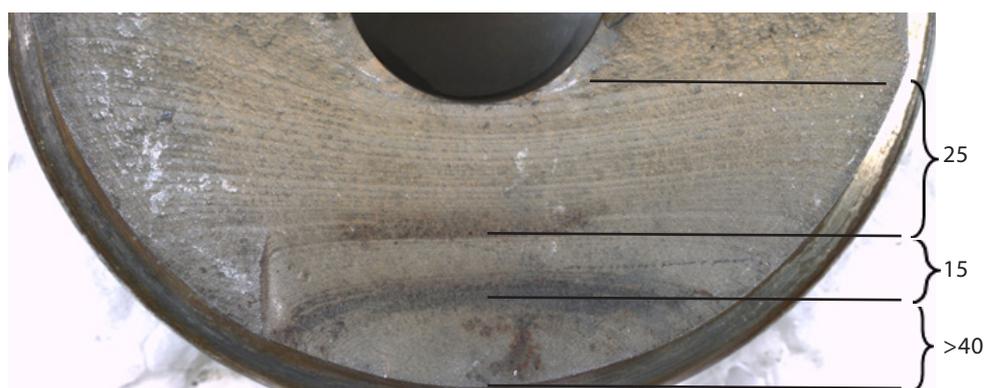
Thus, after counting the beach marks on the whole of the fatigue fracture zone, it was found that (Figure 43):

Figure 43 : Overview of fatigue macro-striations - number of beach marks per area

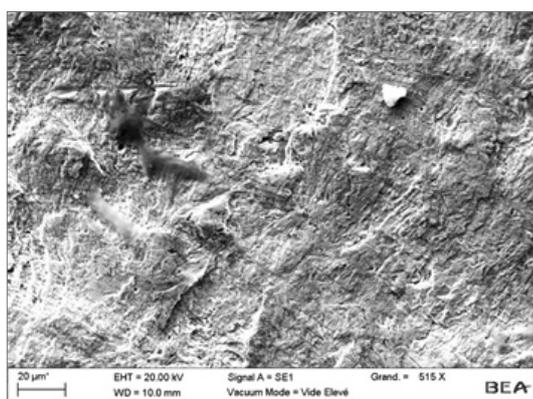
Detailed examinations with a scanning electron microscope (SEM) confirmed the presence of a fatigue crack propagation zone, with the presence of fatigue striations (figure 44). The area with high relief had many dimples, characteristic of a sudden ductile fracture (figure 45).

Figure 44: striations in the fatigue area, SEM views

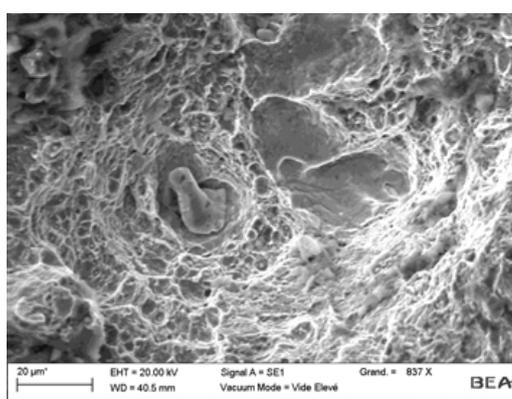
Figure 45: dimples in the final fracture zone, SEM views

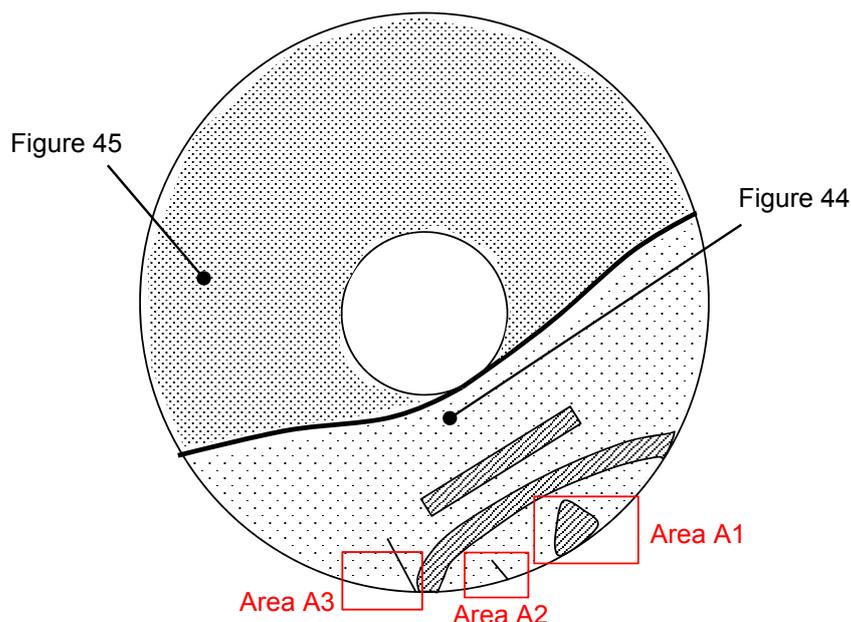
Thanks to the fractographic observations it was possible to identify three characteristic zones. These areas are referenced in Figure 46. Area A1 corresponds to the main initiation site of the fatigue crack. Areas A2 and A3 are located near the two radial lines (or ridges), which are secondary crack initiation areas.

Figure 46 : Areas examined by SEM

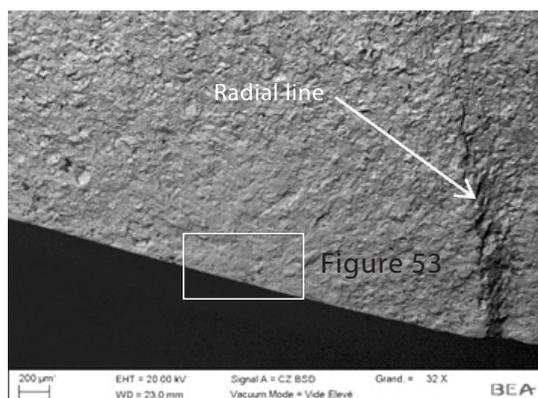
Figure 52: Overview of area A2 by SEM

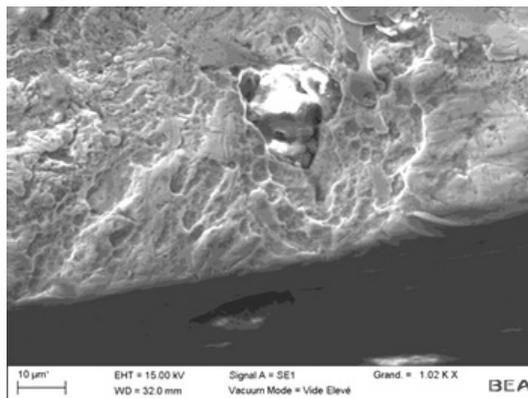
An area on the edge of the part was similar to the initiation area of the main crack, with the presence of inclusions (manganese sulphide), and surface porosities (figure 53). No pre-damage (tool mark, machining defect, etc.), corrosion pitting or geometric defect was visible.

Figure 53 : detail of Figure 52 - porosities on the surface and presence of inclusions

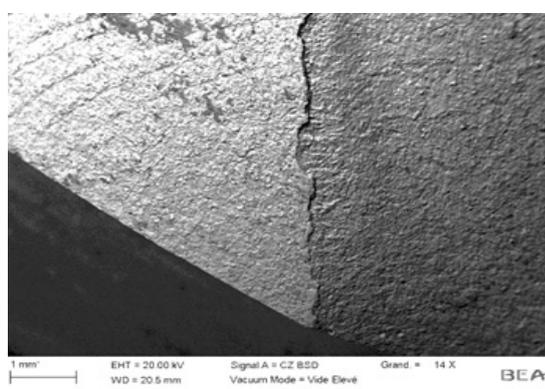
Area A3 also had a fatigue fracture surface, on which the striations were easily visible (Figure 54). The presence of a ridge line again suggested crack propagation in a plane different from the neighbouring plane (plane of the secondary crack). This is clearly illustrated in Figure 55, which shows the fracture surface of the bolt and the crack extending under this surface.

Figure 54: Overview of area A3 by SEM

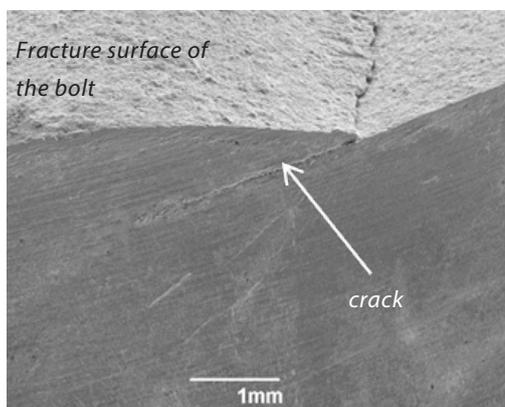
Figure 55: area A3 – matching part of the bolt Figure 54 (Photo DGA-EP)

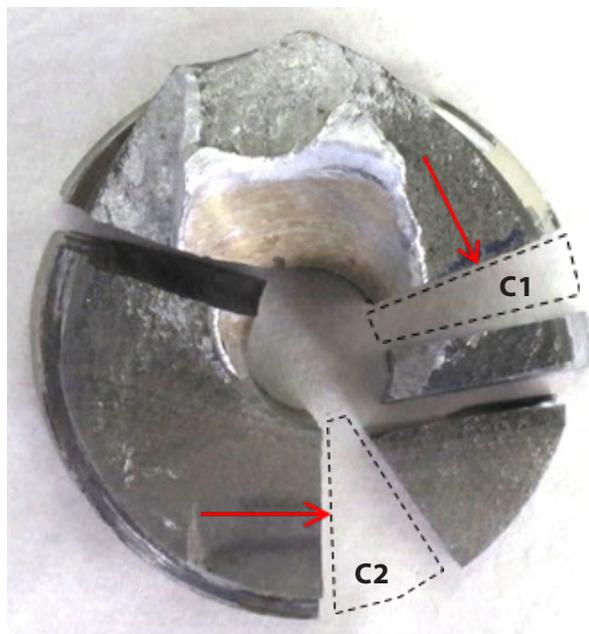
The location of the cross-sections made on bolt no.2 (referenced C1 and C2) is shown in Figure 56.

Figure 56: fracture surface of bolt no.2 after cross-sectioning and sampling—red arrow indicates the direction of observation

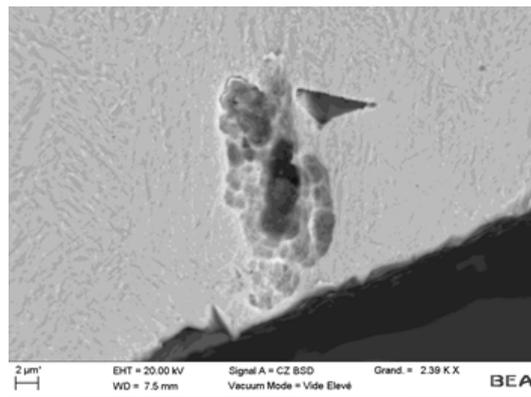
Figure 58: cross-sectional view of a cavity after sulphide shedding

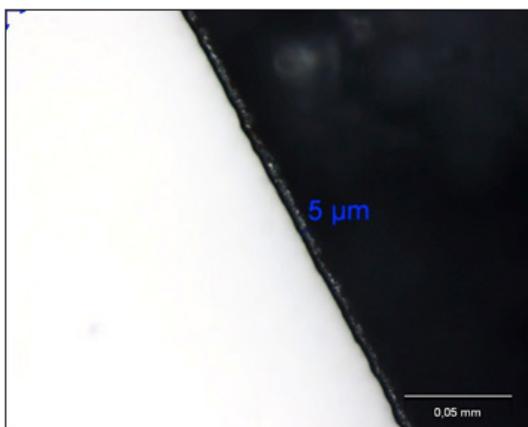
Figure 59: cross-section of the thread root, presence of the layer of cadmium (cross-section C1)

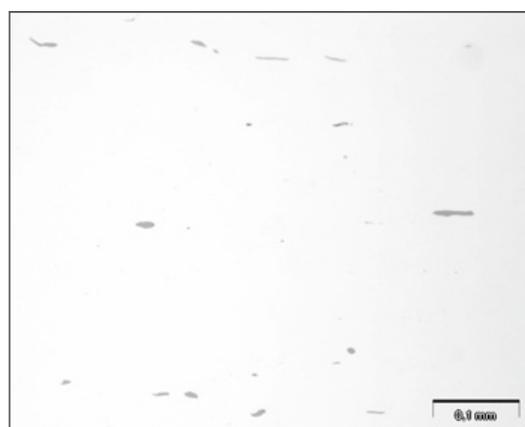
Figure 60: manganese sulphide inclusions in grey (cross-section C1)

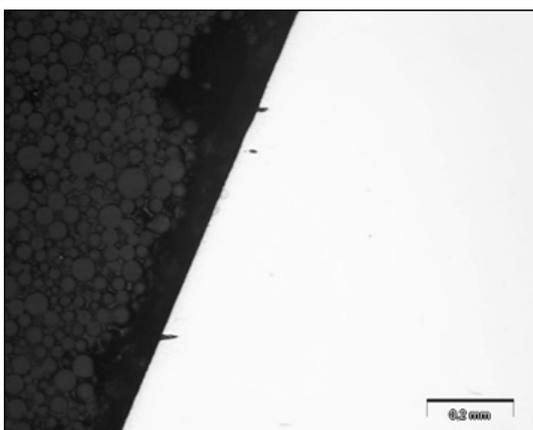
Figure 61: Surface cavities related to manganese sulphide shedding (cross-section C1)

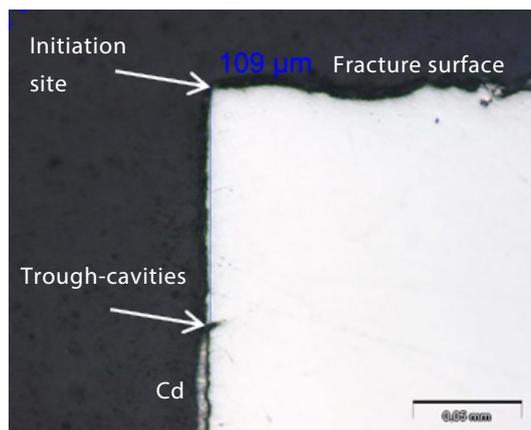
Figure 62: cross-section at the level of the main initiation area (cross-section C2)

Cross-section C2, performed in the main fatigue crack initiation site (Area A1), highlighted the absence of the cadmium layer over a hundred μm at the level of the fracture surface. A cavity opening out onto the surface, approximately ten μm deep, was also visible 109 μm below the incipient crack (Figure 62). However, no singularity was observable at the level of the initiation site.

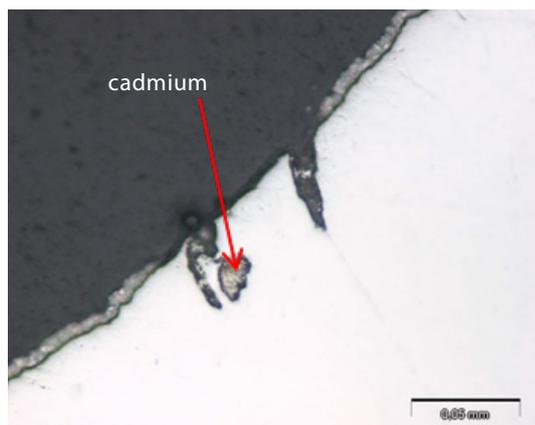
Figure 63: through-cavities with the presence of cadmium at the cavity bottom

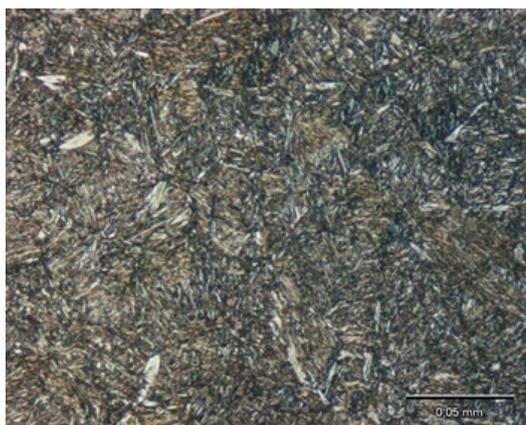
Figure 64: core microstructure: martensite

The etchant then revealed the metallographic structure of the steel, in this case a martensitic structure characteristic of quench-tempered steel (Figure 64).

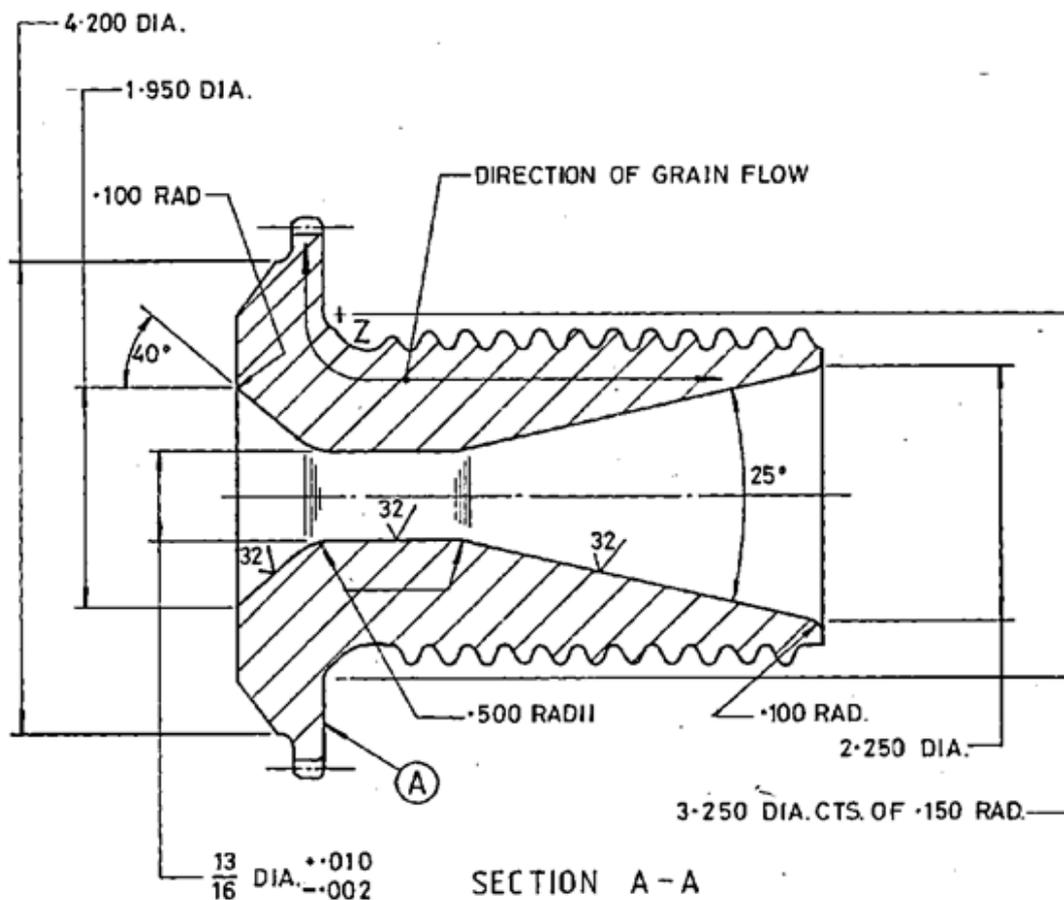
The etchant was used first of all to reveal the grain flow of the steel. The grain flow is caused by the forging of the part. It is specified on the «*direction of grain flow*» drawing in Figure 65. An optimal compromise must be found between the loading of the part and the manufacturing process, so that the grain flow is oriented as much as possible in the direction of stress.

Figure 65: drawing of the preload bolt, longitudinal cross-sectional view

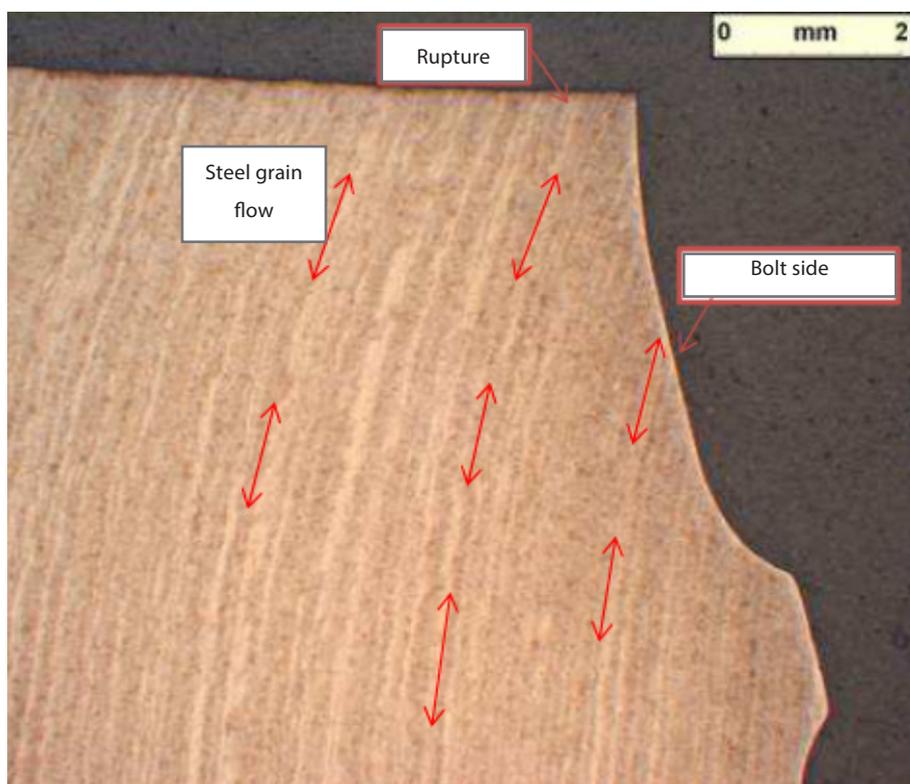
Figure 66: View of grain flow of steel in bolt no.2 in the fracture zone. 90° clockwise rotation of box in Figure 65 (photo DGA-EP)

The grain flow of the steel was consistent with the specification in the drawing. It was noted that the grain flow opened out onto the surface in the fracture zone, at an angle of approximately 30°. This phenomenon was a consequence of the forging and machining operations of the part.

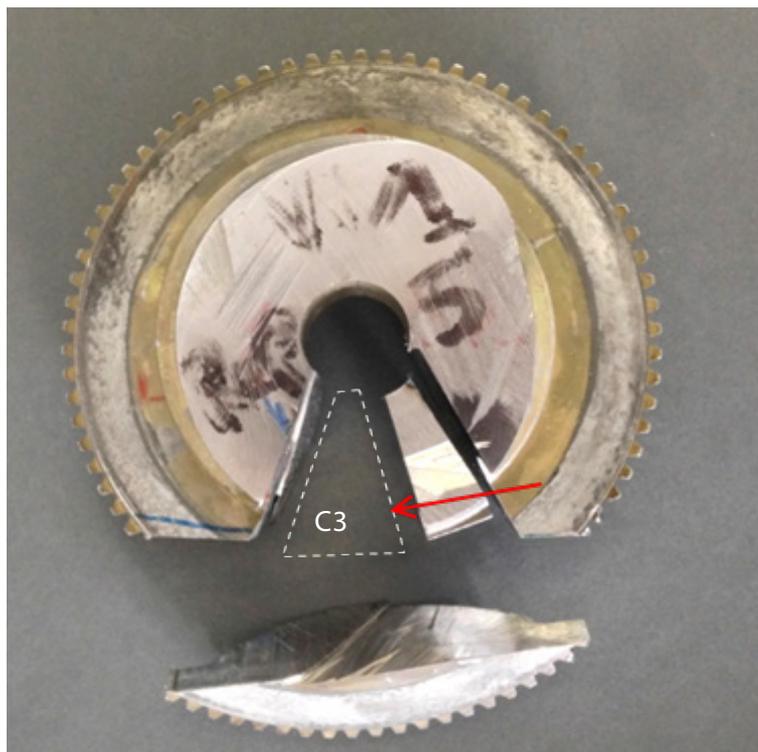
Figure 67: cross-sections of bolt no.1 - red arrow indicates observed face

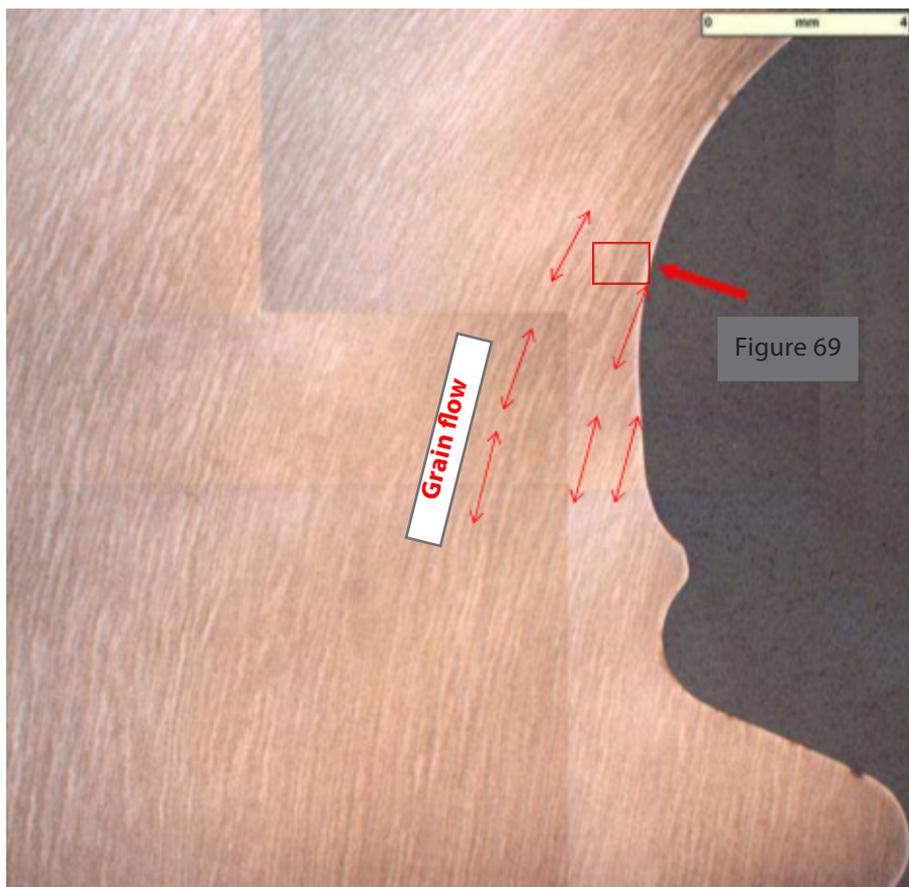
The grain flow is similar to that of bolt no.2. In Figure 68 it is easier to see the “through” character of the grain flow in the radius of the fracture area of bolt no. 2.

Figure 68: View of grain flow in bolt no.1 in the radius area (fracture zone of bolt no.2)
90° clockwise rotation of box in Figure 65 (photo DGA-EP)

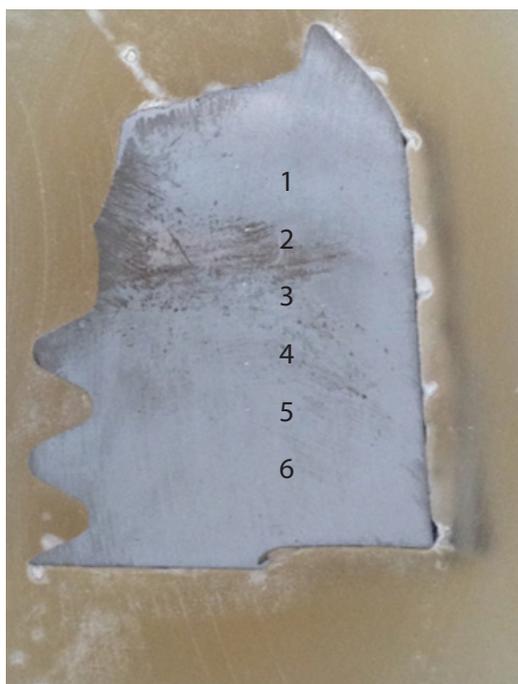
Vickers core hardness measurements, under a load of 30 kgf according to NF EN ISO 6507-1 were performed on cross-section C1 (Figure 70). The results, shown in Table 4, complied with the specifications for Aircraft Grade S99 Steel.

Figure 70: references for hardness measurements

References	Hardness HV
Reference 1	420
Reference 2	417
Reference 3	416
Reference 4	410
Reference 5	412
Reference 6	418
Average	416
S99 specification	380-435

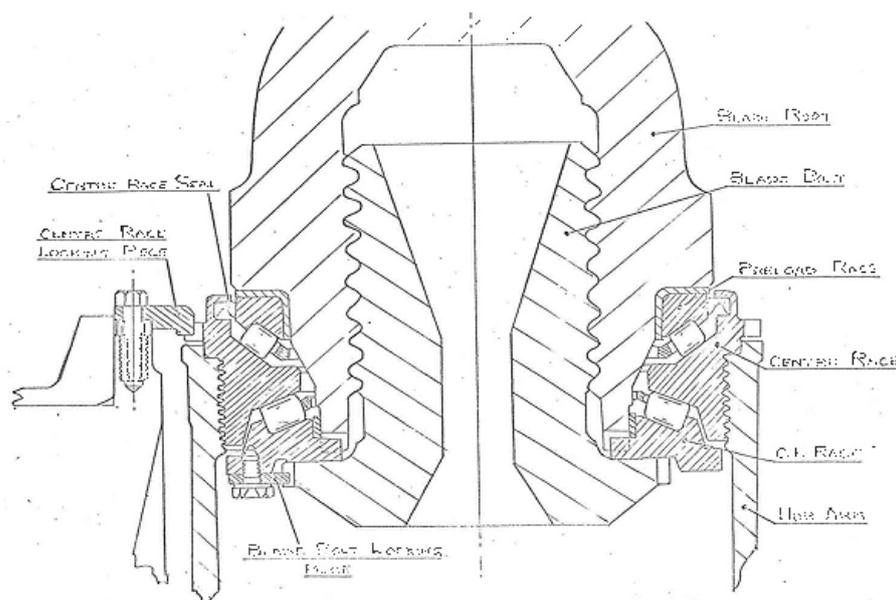
According to the Dowty Rotol Ltd. investigation report, the loss of blade no.1 could be attributed to incorrect installation of the centre race seal on the blade root bearing (Figure 76).

The seal was found twisted, allowing moisture to penetrate the bearing, and grease to escape. This resulted in the emergence of severe corrosion pits on the bearing raceways, resulting in a significant loss of the bearing pre-load. Stress in service on the preload bolts was thus significantly increased, causing the fatigue failure of the bolt in the fillet radius under the bolt head.

Figure 76 : drawing of the blade root of propeller R130/4-20-4/12E.

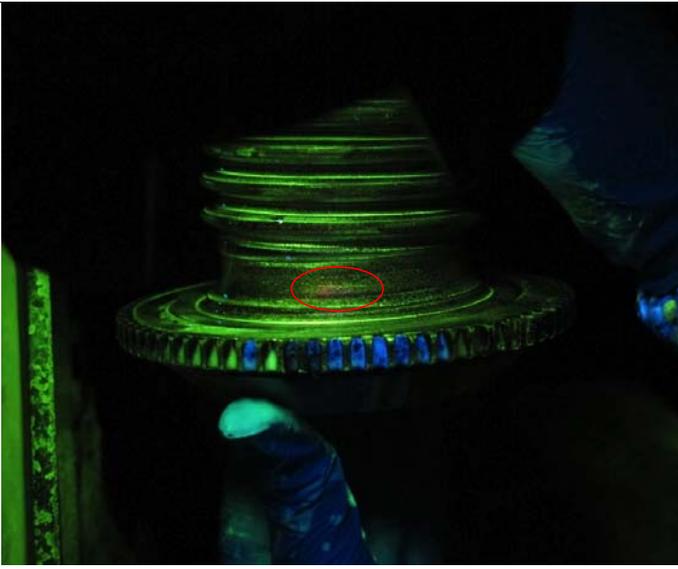
A fluorescence image of a propeller blade. The blade is illuminated with a blue light, causing it to glow. A single, horizontal red line is visible on the blade's surface, circled in red. The background is dark.	ligne

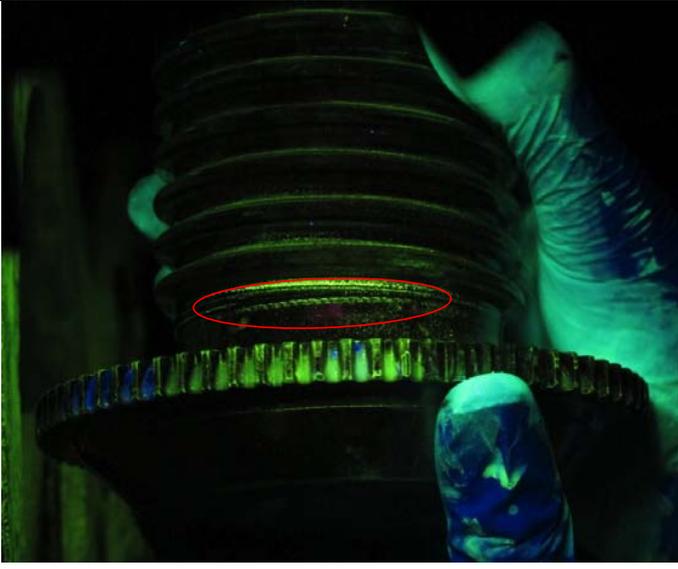
A fluorescence image of a propeller blade, similar to the one above. Three parallel, horizontal red lines are visible on the blade's surface, circled in red. The background is dark.	3 lignes discontinues parallèles

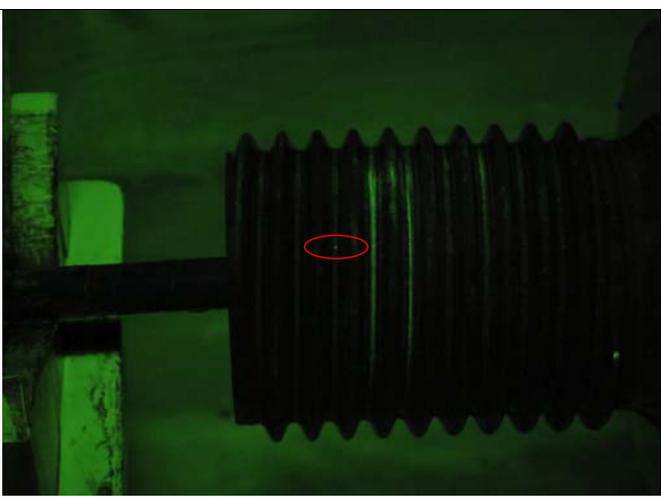
Point en fond de filet

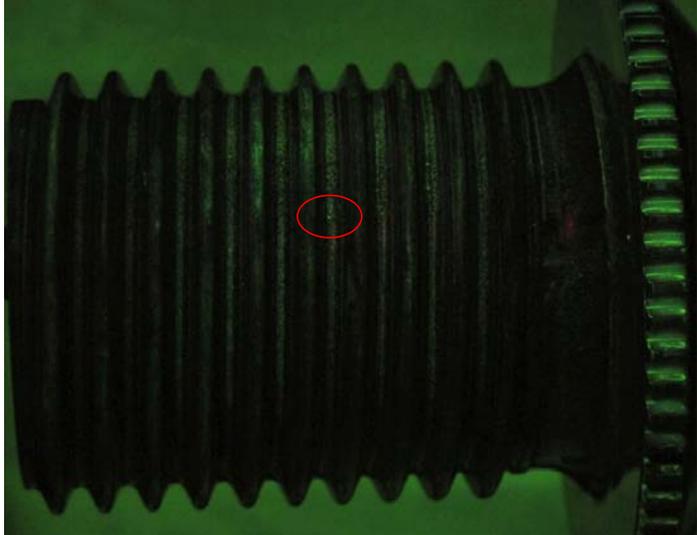
Point en fond de filet
-----------------------------------------------------------------------------------	------------------------

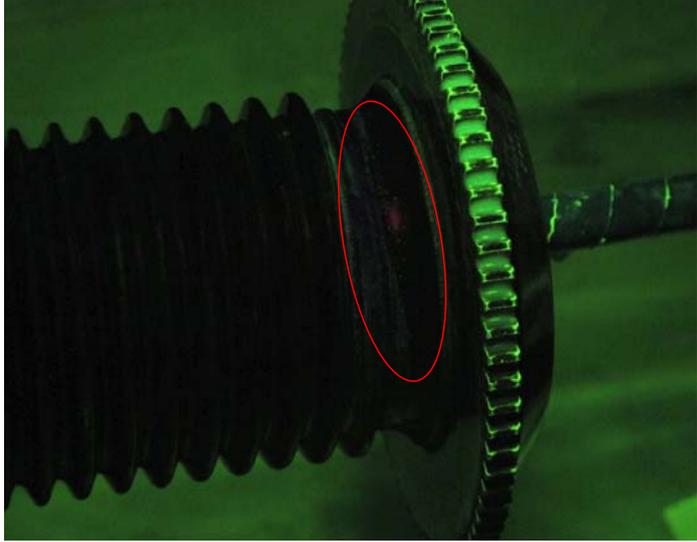
Multiple points

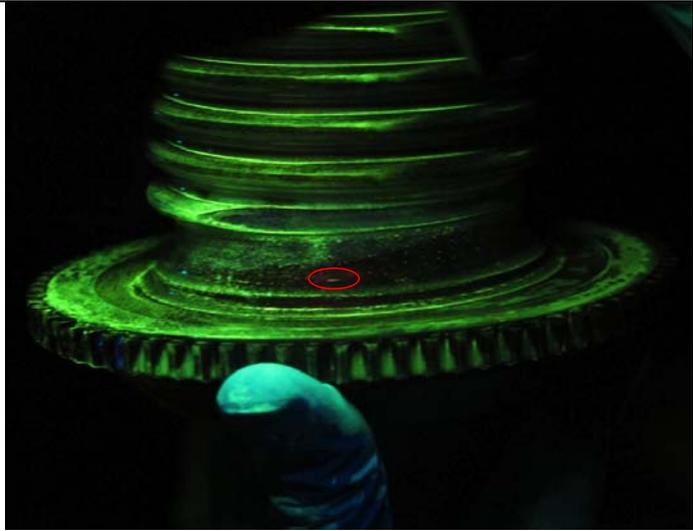
ligne

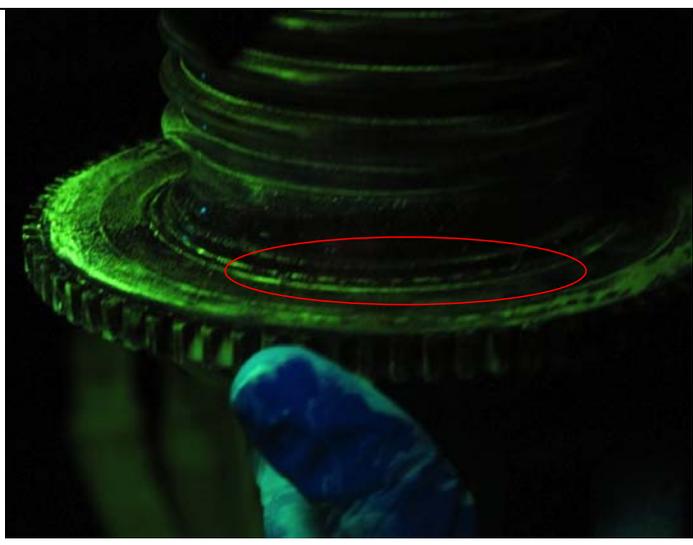
Ligne discontinue

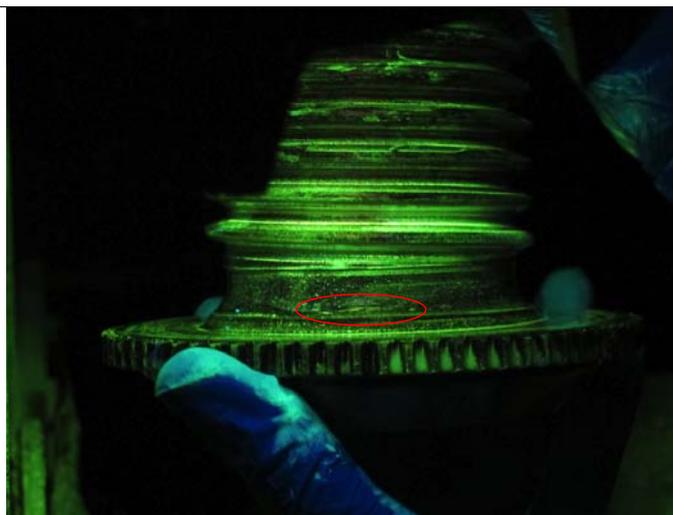
Multiples points +
quelques lignes

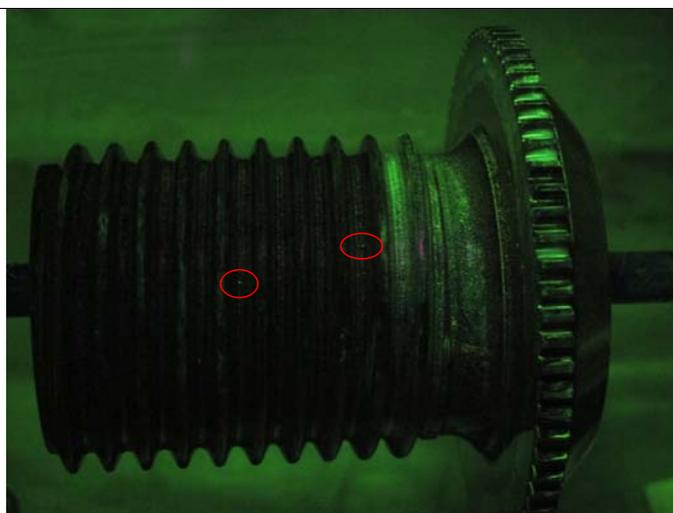
Points en fond de filet

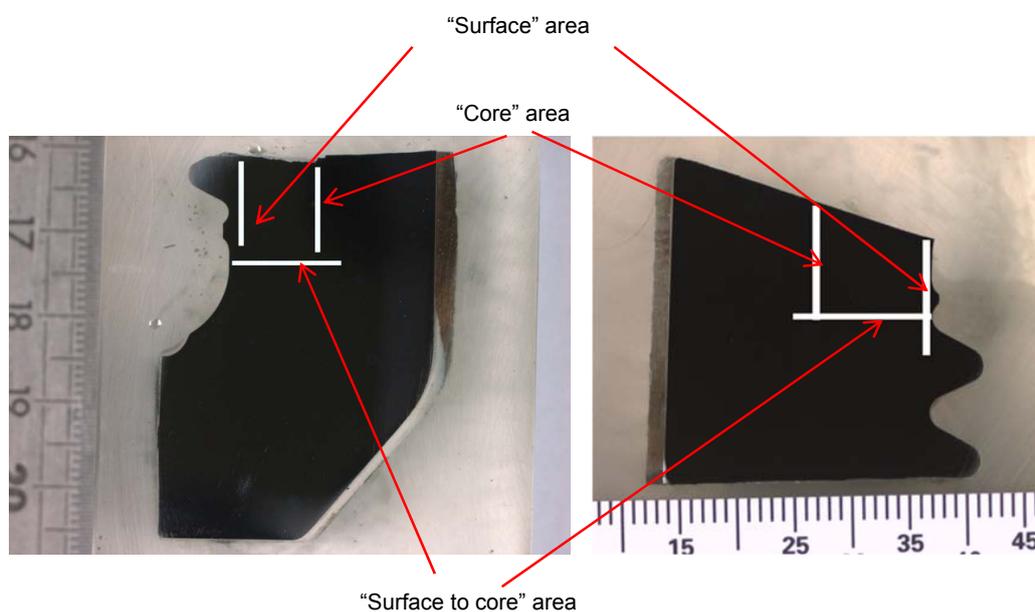
Figure 79: Cross-sections of bolt no.1 (left) and bolt no.2 (right) - the white areas were used to calculate the rate per unit area of inclusions on the surface

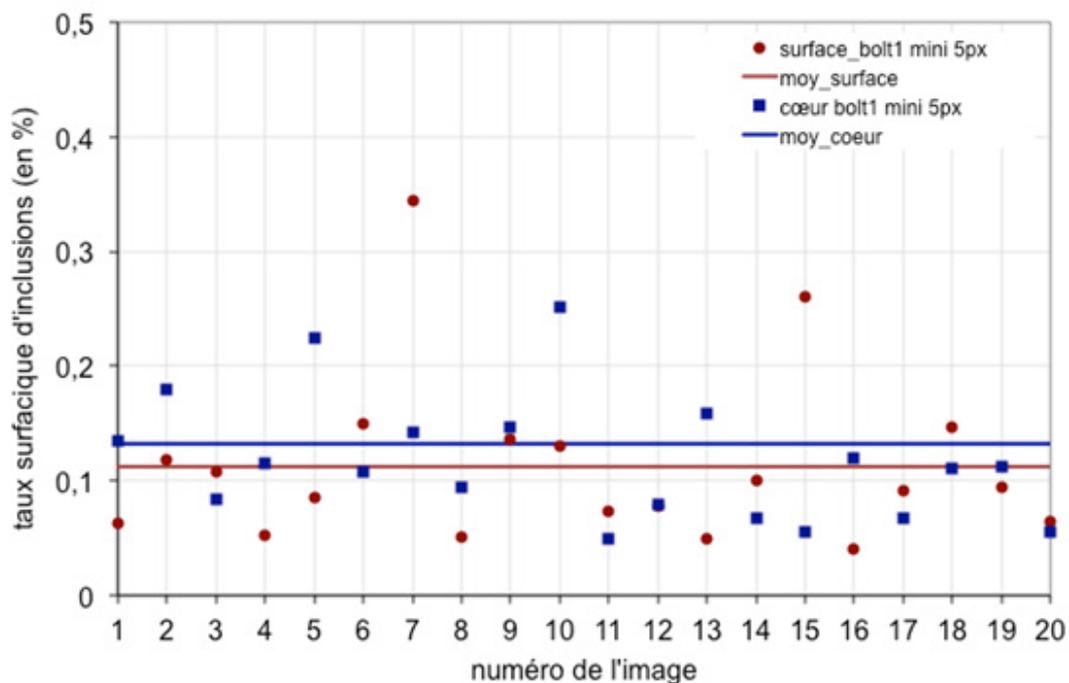
For bolt no.1, the surface rate could be compared with the core rate (Figure 84). It could be seen that the cloud of points corresponding to each core and surface image merged, with an average value for the inclusion rate slightly lower on the surface (0.11% against 0.13% for the core). Locally, however, inclusions on the surface were found to be larger or more concentrated, the maximum rate being obtained on an image taken on the surface (0.34%).

Figure 84: inclusion rate on the surface and core, bolt no.1.

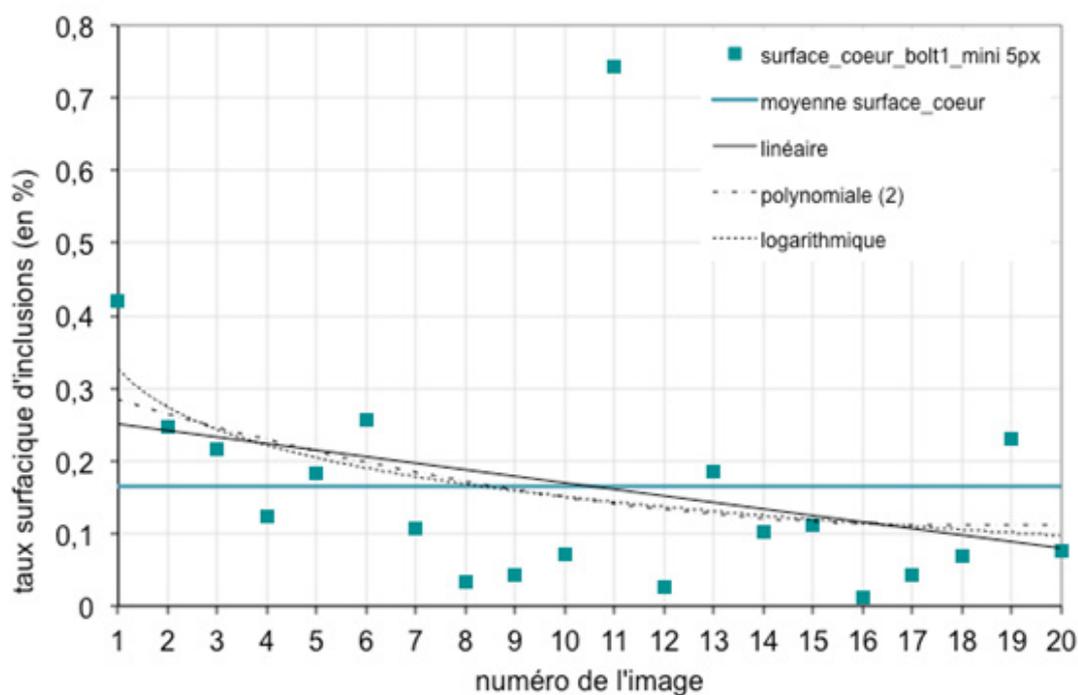
When observing the evolution of the rate of inclusions from the surface to the core, obtained by analysis in the «surface-to-core» area, we found that whatever trend line chosen, it decreased, with a higher rate on the surface than at the core. This information remained local, valid only in the area under study (corresponding to imaging) of 0.49 mm wide and approximately 12 mm long, i.e. approximately 6 mm².

Figure 85: inclusion rate from the surface to the core (image 1: surface, image 20: core)

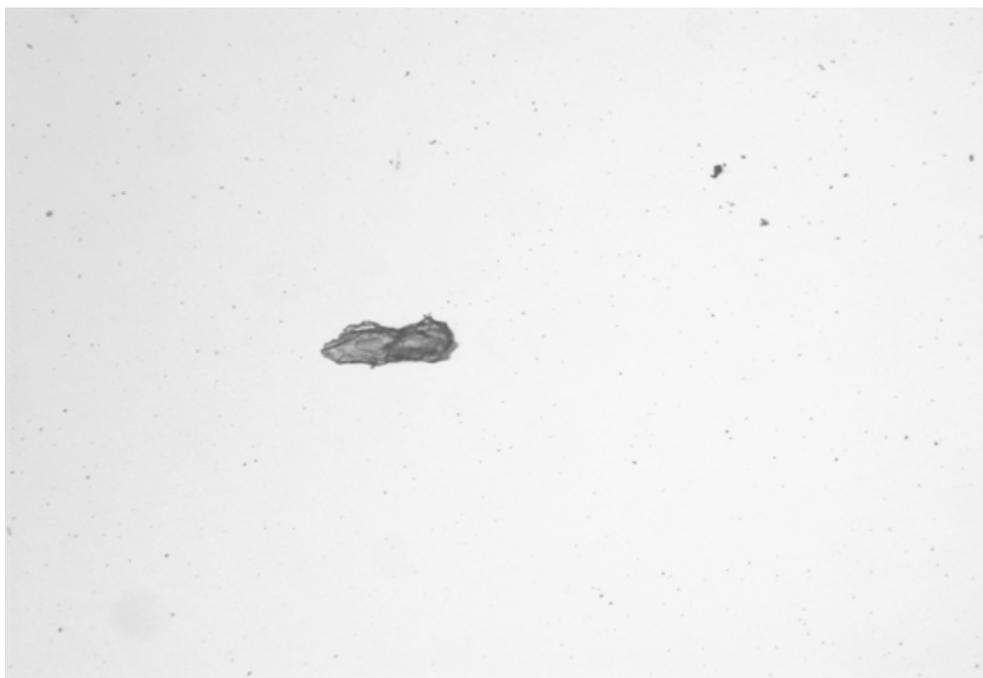
Finally, the maximum inclusion rate for this area is 0.74%. The corresponding image was shown in Figure 86 and had a particularly large inclusion, which explained the high area rate relative to other images.

Figure 86: image 11, surface-to-core zone of bolt no.1
(image dimensions: 490 μm x 614 μm i.e. 0.3mm²)

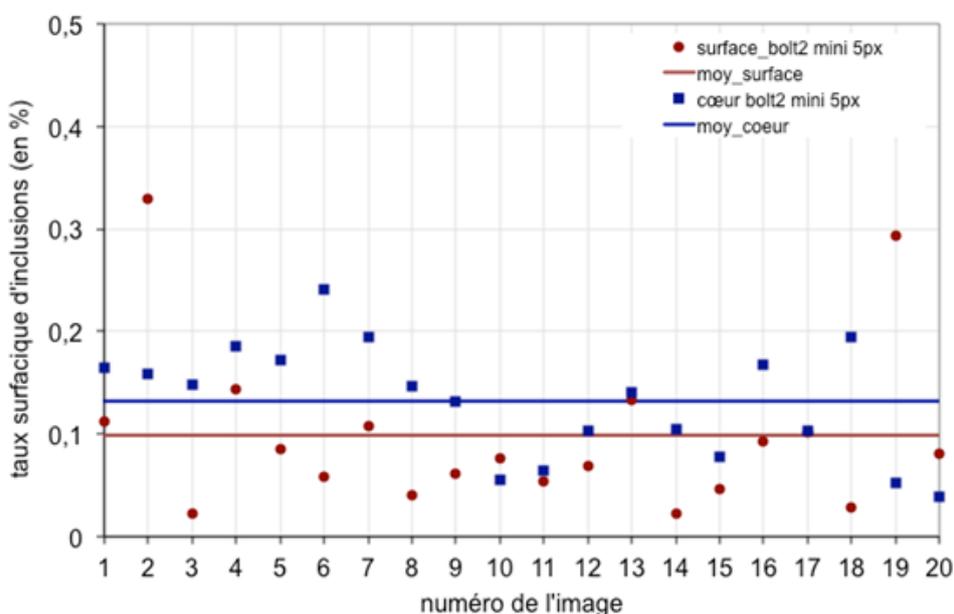
Figure 87: inclusion rate on the surface and core, bolt no.2.

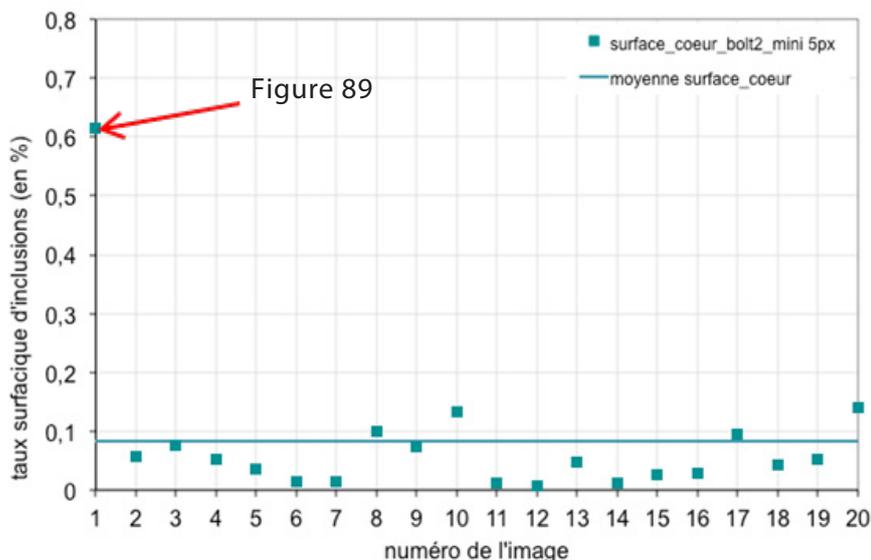
If we look at the evolution of the rate from the surface to the core («surface-to-core» zone, Figure 88), it can be seen that the average is less than 0.10%, that all of the values are below 0.20% and that the maximum value obtained is 0.61%. This value was obtained on Figure 89. It was easier to understand that the rate was high in this image, which was not representative of most of the images taken.

If this image was not taken into account, no change in the rate of inclusions was observed from the surface to the core.

Figure 88: inclusion rate from the surface to the core
(image 1: surface, image 20: core)
