Examination of the aircraft Examination of the left and right propellers

Accident to the Fokker - F27-500
operated by **Miniliner SRL**
registered **I-MLVT**
on 25 october 2013
at **AD Paris Charles de Gaulle (95)**

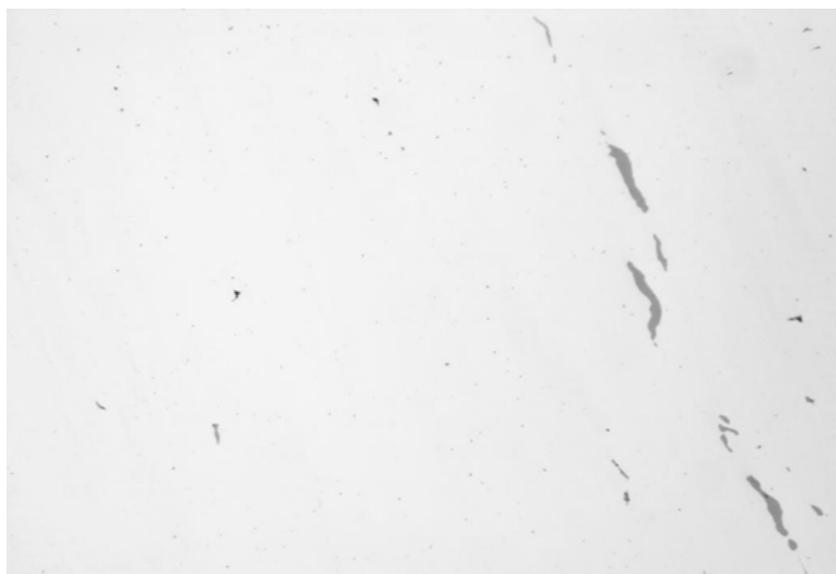
If we look at the evolution of the rate from the surface to the core («surface-to-core» zone, Figure 88), it can be seen that the average is less than 0.10%, that all of the values are below 0.20% and that the maximum value obtained is 0.61%. This value was obtained on Figure 89. It was easier to understand that the rate was high in this image, which was not representative of most of the images taken.

Figure 89: age 1, surface-to-core zone of bolt no.2
(image dimensions: 490 μm x 614 μm i.e. 0.3mm²)
