Accident to the TECNAM - P92 S ECHO
identified **01VA**
on 30 September 2021
at Saint-Rambert-d'Albon

Time	Around 18:25 ¹
Operator	Private
Type of flight	Local
Persons on board	Pilot and passenger
Consequences and damage	Pilot and passenger fatally injured, microlight destroyed
This is a courtesy translation by the BEA of the Final Report on the Safety Investigation published in October 2022. As accurate as the translation may be, the original text in French is the work of reference.

Reduction in engine power in initial climb, right turn, stall

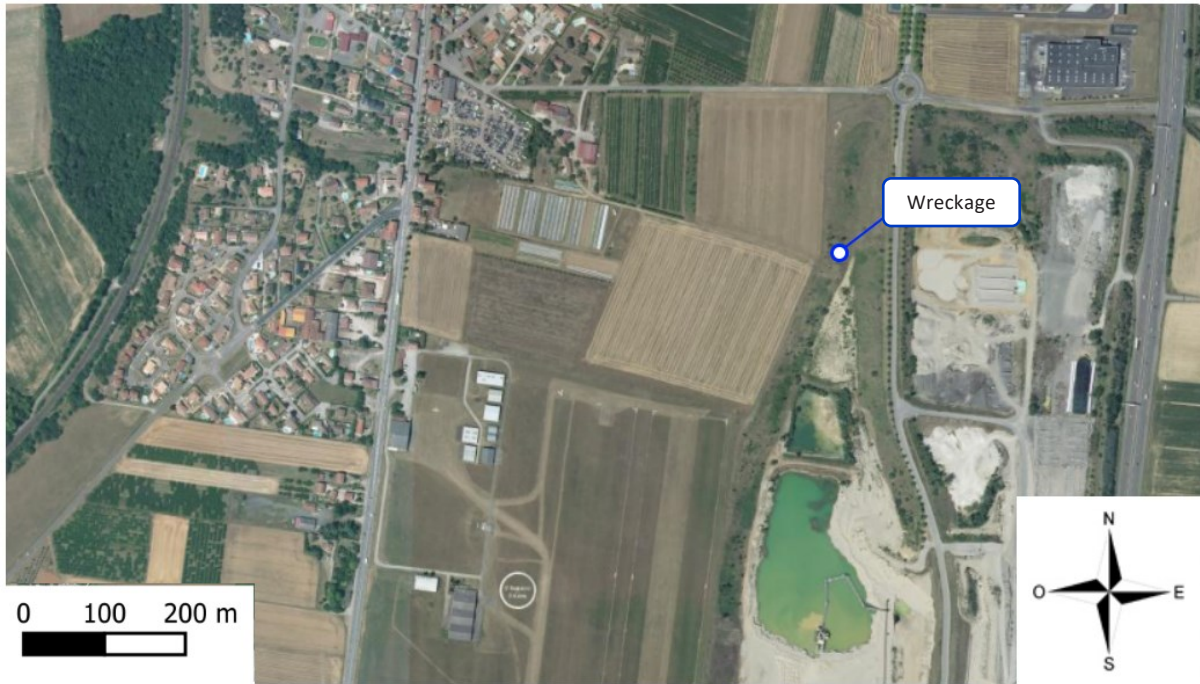
The wreckage was located at the bottom of a basin, in a quarry located on the eastern edge of Saint-Rambert-d'Albon aerodrome (see Figure 1 below). It was complete and not dispersed.

Figure 1: general view of accident site (source: Google Earth, annotated by the BEA)
