Accident to the Aerospool WT9 Dynamic
identified **04FO**
on Sunday 11 August 2024
at Eschbach (Bas-Rhin)

Loss of control, collision with ground, in instruction

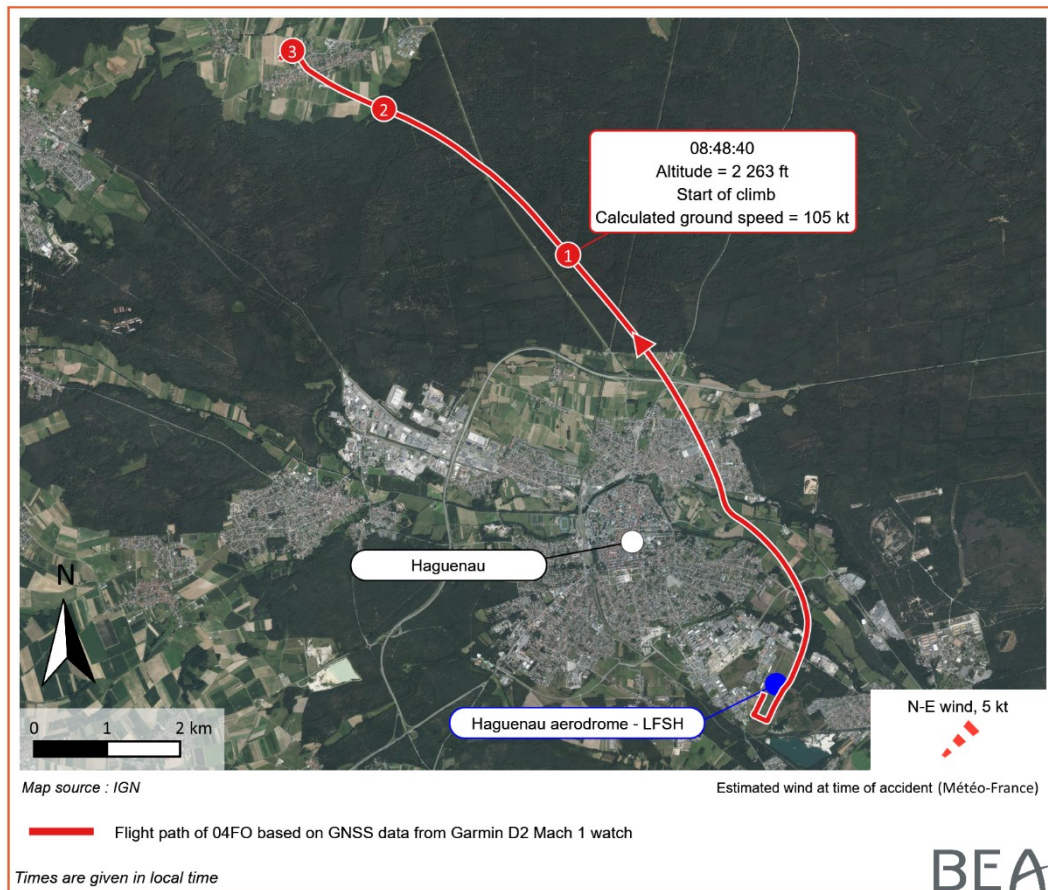
He headed north, bypassing the Haguenau urban area. He then headed towards the commune of Eschbach at a stable altitude of approximately 2,300 ft² and a ground speed estimated to be 105 kt.

Figure 1: flight path of 04FO

He then climbed to 3,100 ft before returning gradually to 2,800 ft; during this descent, the ground speed fell sharply below 50 kt³.
