Accident to the G1 Aviation G1 SPYL-XL-R ULS (P)
identified **04IF**
on Saturday 4 February 2023
at Salignac (Alpes-de-Haute-Provence)

**Distortion of both wings in flight in rough air, loss of control,
activation of the airframe parachute, in instruction**

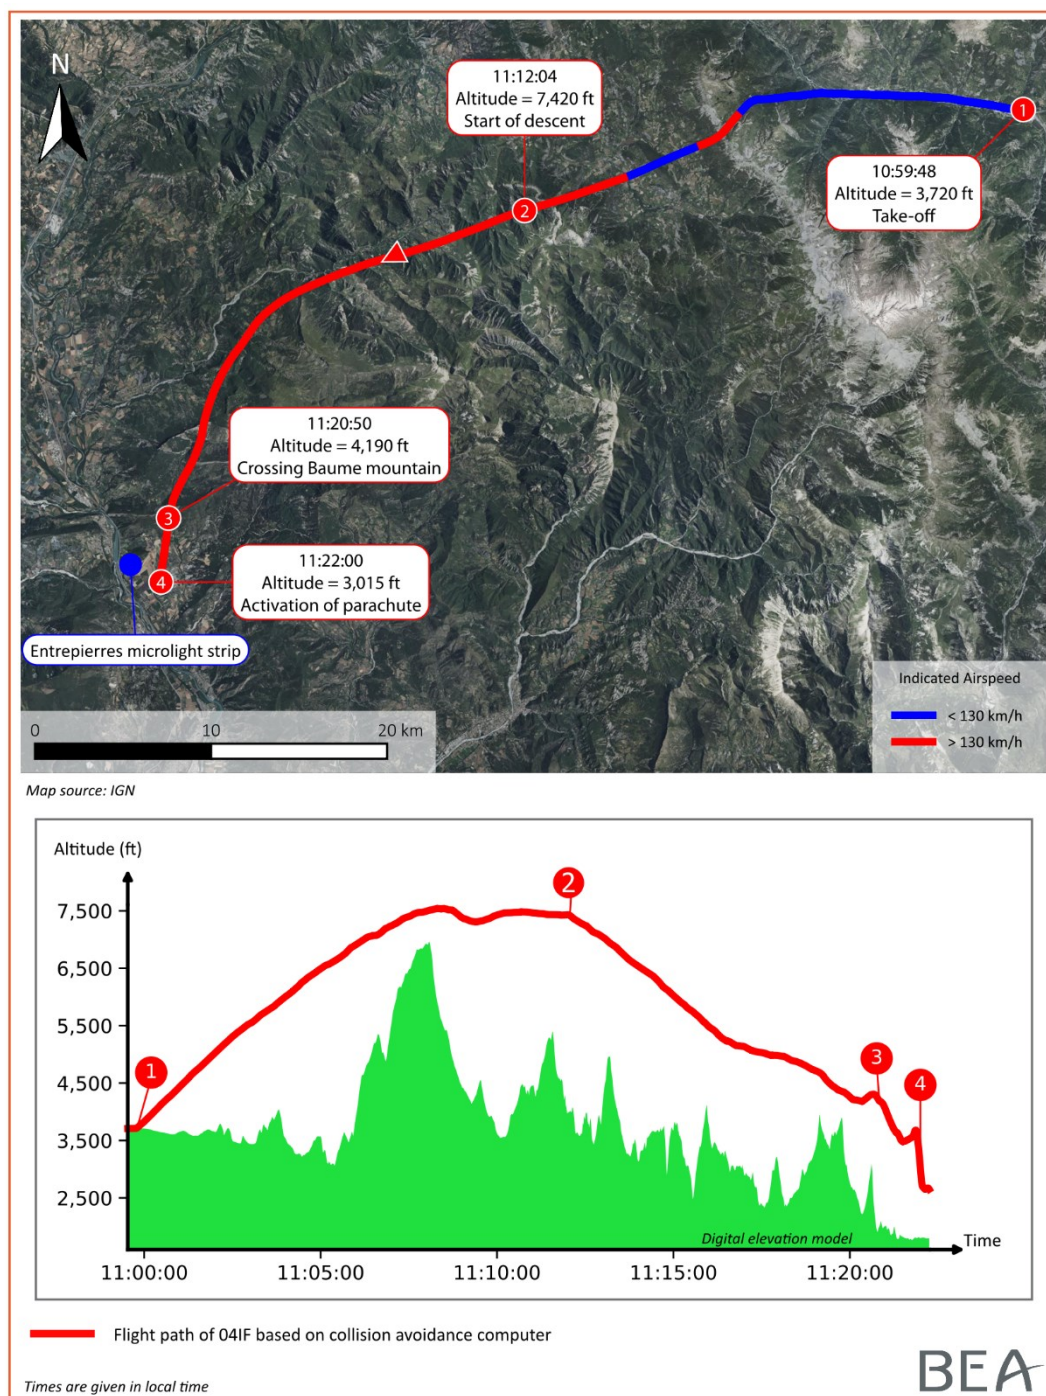
Figure 1: flight path

A few seconds later, while the microlight was at an altitude of approximately 4,200 ft, on the downwind side of the mountain, the two pilots heard a noise. Part of the canopy tore off, then the microlight suddenly adopted a right bank angle and entered a spin. The instructor took over the controls and tried to regain control. After three full spins, as he was unable to regain control of the microlight, he released the airframe parachute at a height of approximately 1,200 ft (Point **④**).

After the latter deployed, the microlight descended to the ground, pushed by the wind, and ended its descent in a field, hitting an olive tree. The two occupants evacuated the microlight and alerted the emergency services.

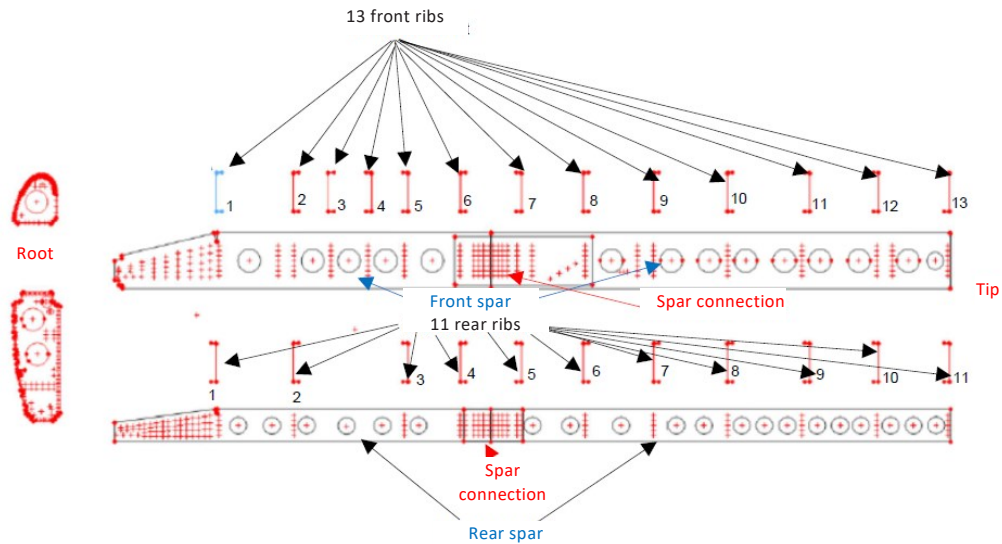
Figure 3: wing structure (Source: G1 Aviation and BEA annotations)

The wing spars and ribs are made from 0.5 mm to 1 mm thick aluminium-plated sheets with lightening holes⁹. This metal structure is covered with riveted aluminium sheets.
