Accident to the SUPER GUÉPARD 912 ULS
identified **12HP**
on Saturday 30 September 2023
at Dragey-Ronthon

Time	Around 20:50 ¹
Operator	Private
Type of flight	Cross country
Persons on board	Pilot
Consequences and damage	Pilot fatally injured, microlight destroyed

**Get-home-itis, fuel exhaustion, activation of airframe
parachute at low height, collision with ground, at night**

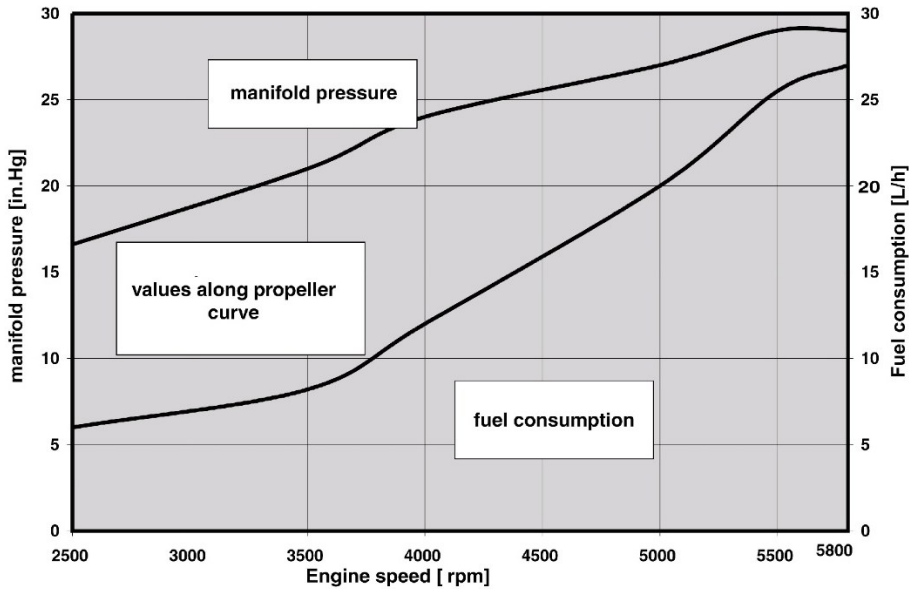
Figure 4: performance curves for ROTAX 912 ULS engine (Source: ROTAX Operators Manual)

This estimate is consistent with the performance described in the flight manual for the microlight fitted with a ROTAX 912 ULS engine (see **Figure 3**) and in the engine operator’s manual (see **Figure 4**).
