**Accident** to the HUMBERT AVIATION - Tétrás  
identified **21AJD**  
on 21 August 2021  
at Courcelles (Doubs)

<b>Time</b>	Around 11:15 <sup>1</sup>
<b>Operator</b>	Private
<b>Type of flight</b>	Cross country
<b>Persons on board</b>	Pilot
<b>Consequences and damage</b>	Pilot fatally injured, fixed-wing microlight destroyed

## **Collision with a power line and then ground during low-height flight**

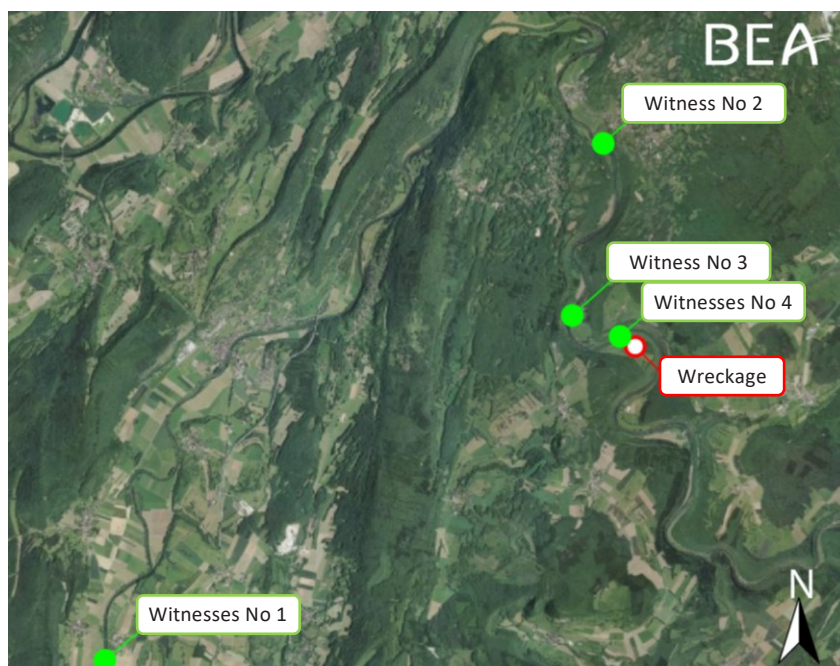
Figure 3: location of various witnesses

The first witnesses (witnesses No 1, Figure 3) were paddle boarding. They reported seeing aircraft coming towards them "one after the other", all at approximately the same height. They were flying up the river (south to north direction) and were closely following each other. These witnesses counted seven aircraft. They thought all the aircraft looked the same; they thought it was an airshow. They saw them intermittently as the aircraft were flying sufficiently low to be hidden by the trees.

The witnesses to the accident (witnesses 4 on Figure 3) were a group of six people split between five kayaks. They were approaching a dam at around 11:15 when the three aircraft appeared, flying towards them at a very low height. The witnesses stated that they were following each other with a short distance between each aircraft, flying no higher than the ridge. A first aircraft flew by at a low height, a little before the others, at around the height of the ridge. They added that the second microlight arrived a lot lower and then descended even more, apparently to say hello to them. The witnesses very clearly saw the pilot's gestures, he was leaning forwards and waving to them. One of them observed that the pilot was a man of a "certain age". The kayaker who was in the last kayak saw the aircraft's landing gear strike the power line, the microlight tip, abruptly take a nose-down attitude and strike the ground on the axis of its flight path. The other kayakers heard the noise of the impact with the power line. They did not see the aircraft because of the trees. They turned around and then heard the noise of the impact with the ground.
