Accident to the Shark
identified **22LE**
on Sunday 23 June 2024
at Saint-Pol-de-Léon

Loss of control during cruise without external visual references, collision with ground, during a revenue flight

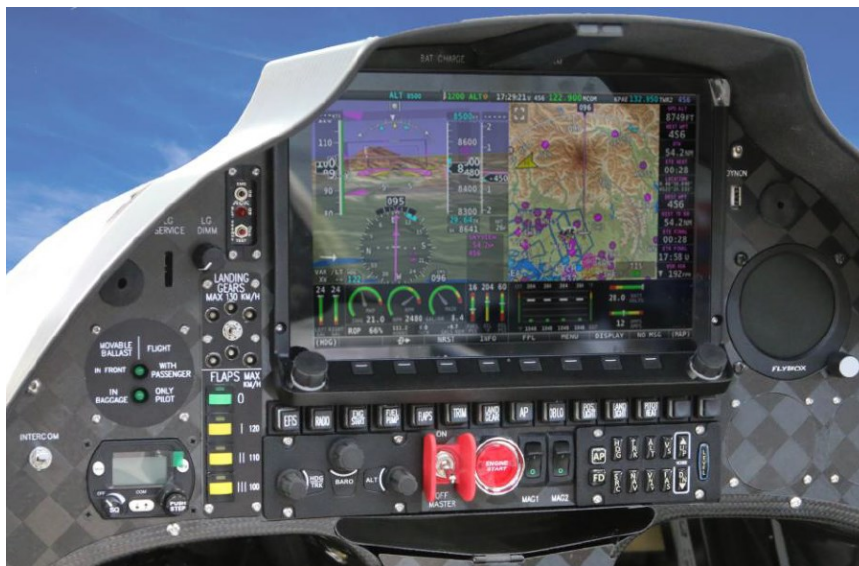
Figure 4: front instrument panel of a Shark 600F (source: Flight manual, Shark Aero)

22LE was equipped with two Dynon EFIS units. The front EFIS⁴ took up the central panel of the instrument panel (see **Figure 4**). This is a standard screen for the pilot, with integrated flight data, engine data and navigation data (map/GPS).

The 22LE was also equipped with a dual-axis autopilot, controlling the ailerons and elevator. It incorporated a "LEVEL" function, usable in "emergency situations", which immediately searches for a vertical speed and zero bank, even if the autopilot is not engaged. Below the EFIS screen were circuit breakers, including the autopilot circuit breaker. Below the circuit breakers were the autopilot, starter, magnetos and Master switch. The autopilot activation and de-activation buttons were located on the two side sticks.
