Accident to the Aéroservices Guépy 582
 identified **25AAG**
 on Tuesday 28 May 2024
 at Thise

Time	Around 16:15 ¹
Operator	Private
Type of flight	Local
Persons on board	Pilot
Consequences and damage	Pilot fatally injured, microlight destroyed

**Reduction in engine power in initial climb, loss of control
 in turn, collision with ground**

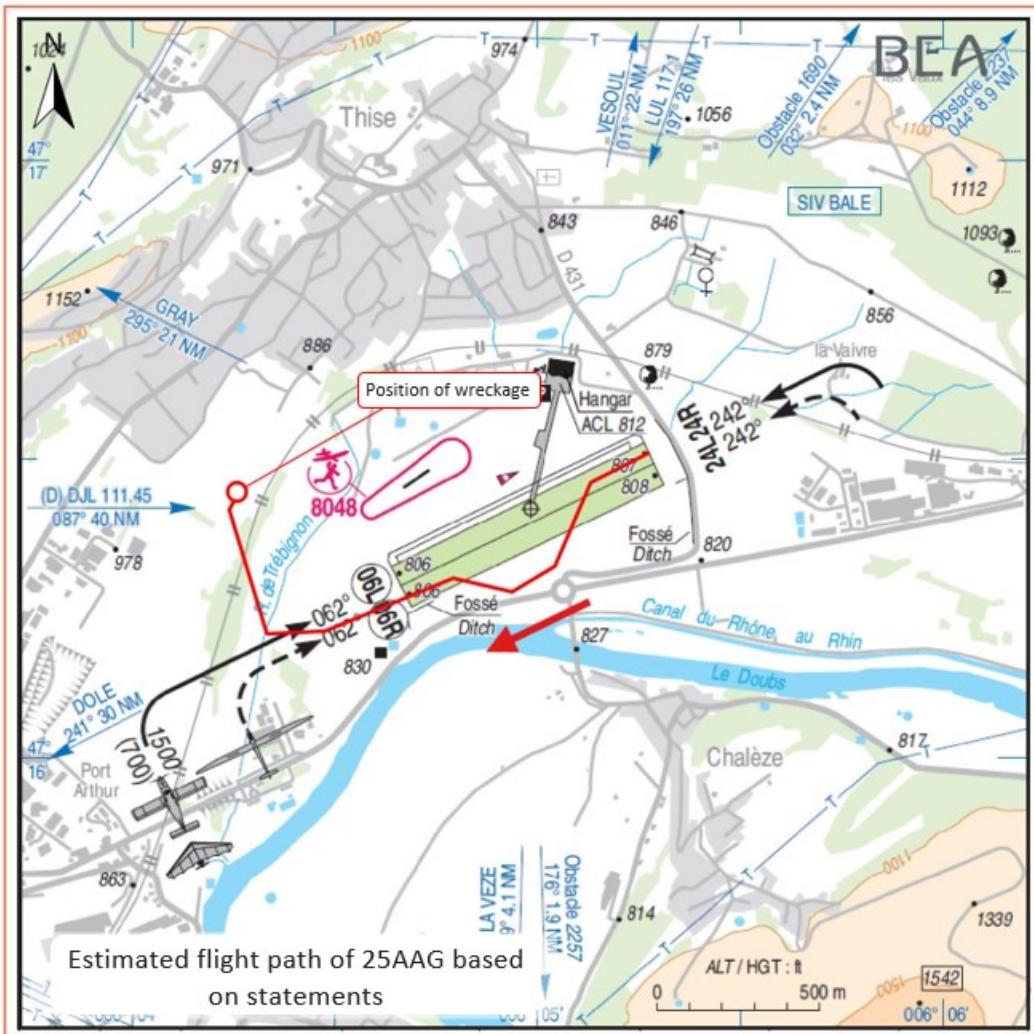
The pilot then turned right, in a northerly direction. The eyewitnesses once again heard variations in the engine speed. They would indicate that they thought the microlight was flying slowly. The microlight flew over a field bordered by a row of trees. According to the eyewitnesses, the microlight had a steep nose-up attitude and was flying at a low height. They then saw the pilot start a right-hand turn, the microlight tip onto its right-hand side and then plunge until it collided with the ground.

Figure 1: flight path described by the eyewitnesses and position of the wreckage of 25AAG
(Source: SIA, annotations BEA)
