Accident to the class 3 JMB AIRCRAFT VL-3-A
identified **59DUJ**
on 19 June 2020
at Mortemer

SAFETY INVESTIGATIONS

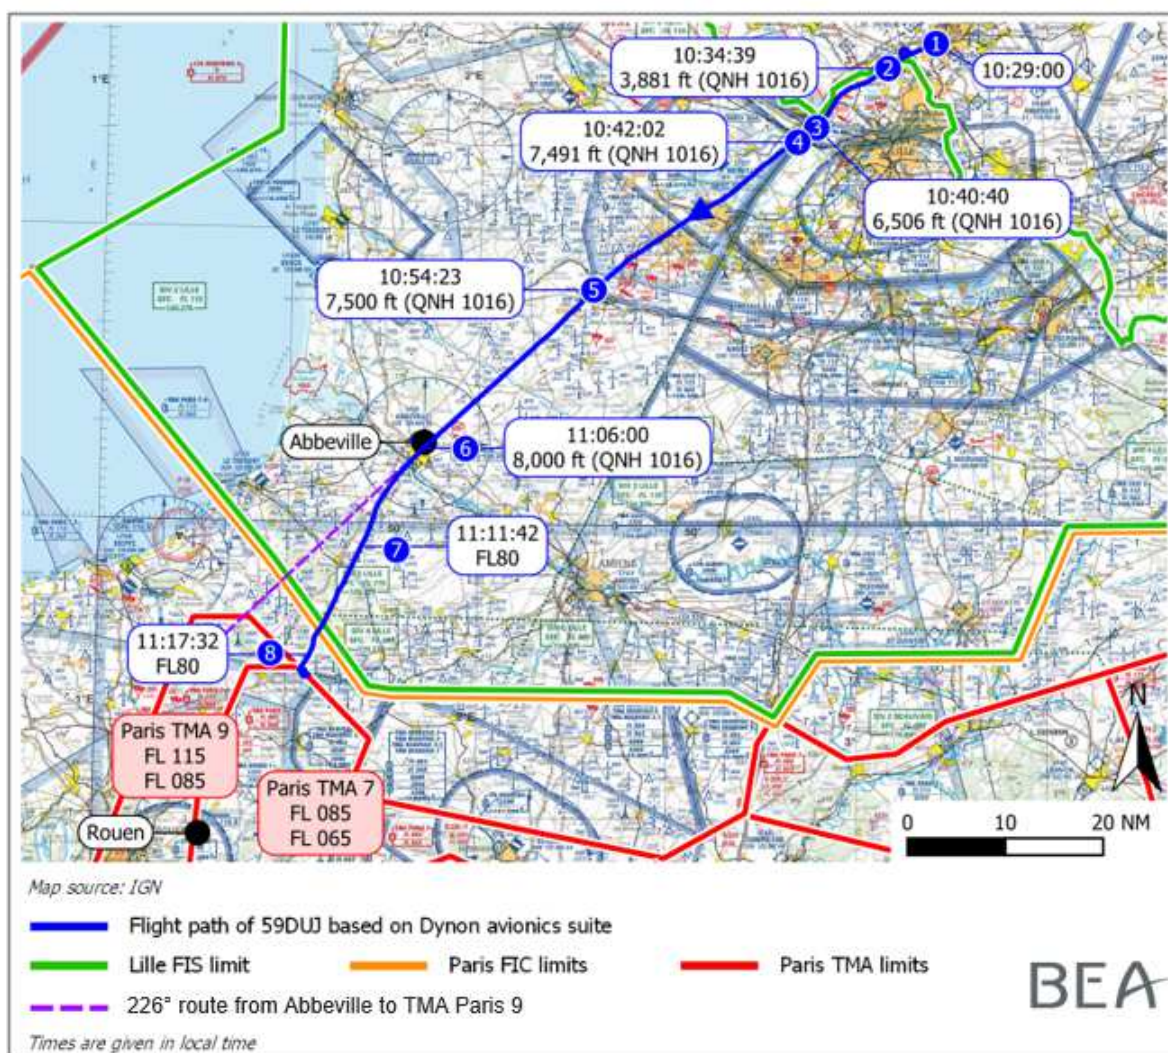
Figure 1: overall flight path of 59DUJ

At 10:29, the pilot in the left seat, accompanied by a passenger in the right seat, took off from Kortrijk-Wevelgem airport (Belgium) bound for Blois-Le Breuil aerodrome (Loir-et-Cher) on a VFR flight plan with the radio call sign F-JDMB (see **Figure 1**, point ①). The crew planned to stop at Blois-Le Breuil before continuing to their destination, Figeac-Livernon aerodrome, where the family of the passenger was waiting for them.

- class G from the time it crossed the border (see **Figure 1**, point ②) until it entered the Lille TMA (point ③);
- class D from when it entered the Lille TMA at 6,500 ft (point ③) then at 8,000 ft until it exited it at point ⑤;
- class G from when it exited the Lille TMA at 8,000 ft (point ⑤) up to the accident.

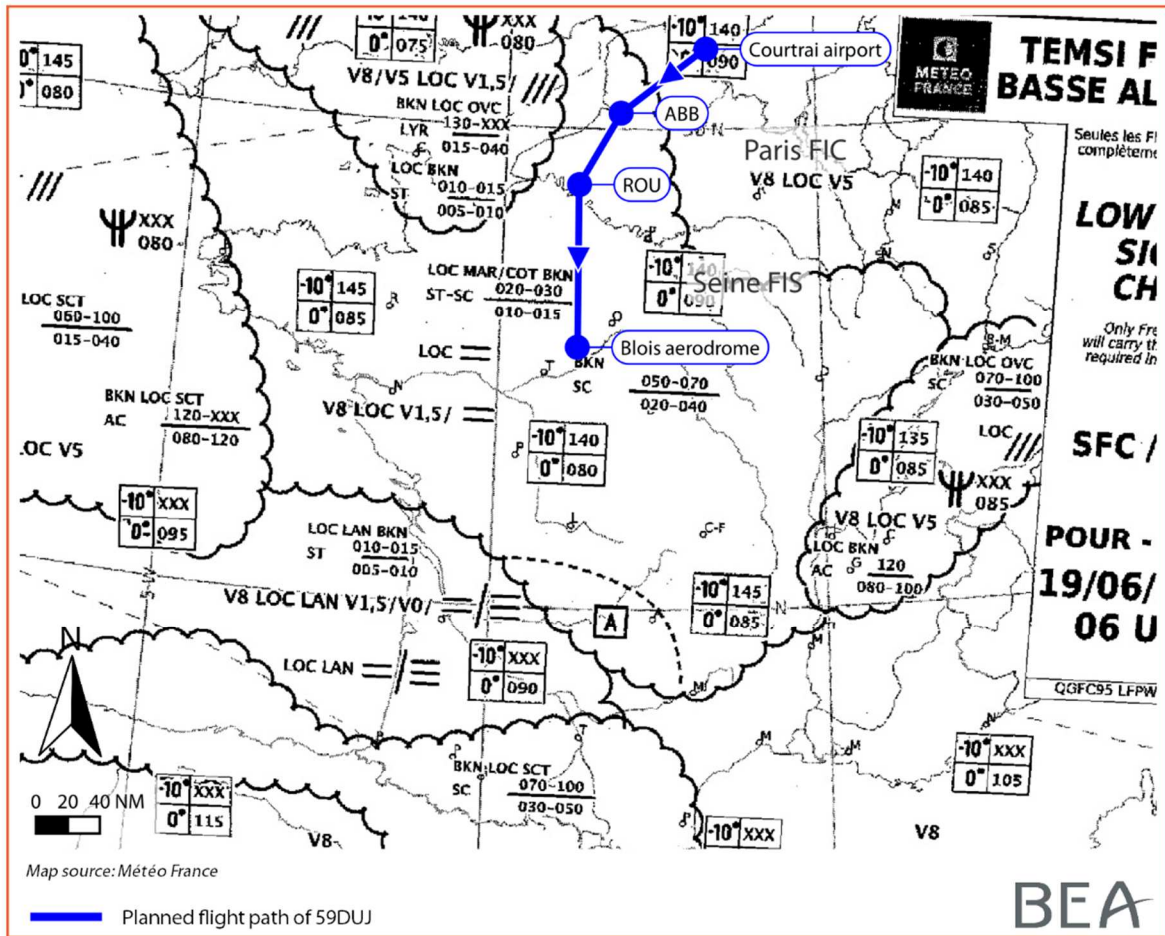
Figure 7: excerpt from 06:00 UTC SIGWX chart of 19 June 2020 (source: Météo-France)

On the planned route, the 06:00 UTC SIGWX chart indicated visibility greater than 8 km for the first part of the flight, and locally, visibility between 5 and 8 km, followed by the presence of broken clouds (5 to 7 octas) up to an altitude of 7,000 ft, based at between 2,000 and 4,000 ft, overall visibility greater than 8 km, locally, visibility between 1.5 and 5 km, and the presence of local fog. To the west of the route, the 06:00 UTC chart showed a very overcast area unsuitable for VFR flight.

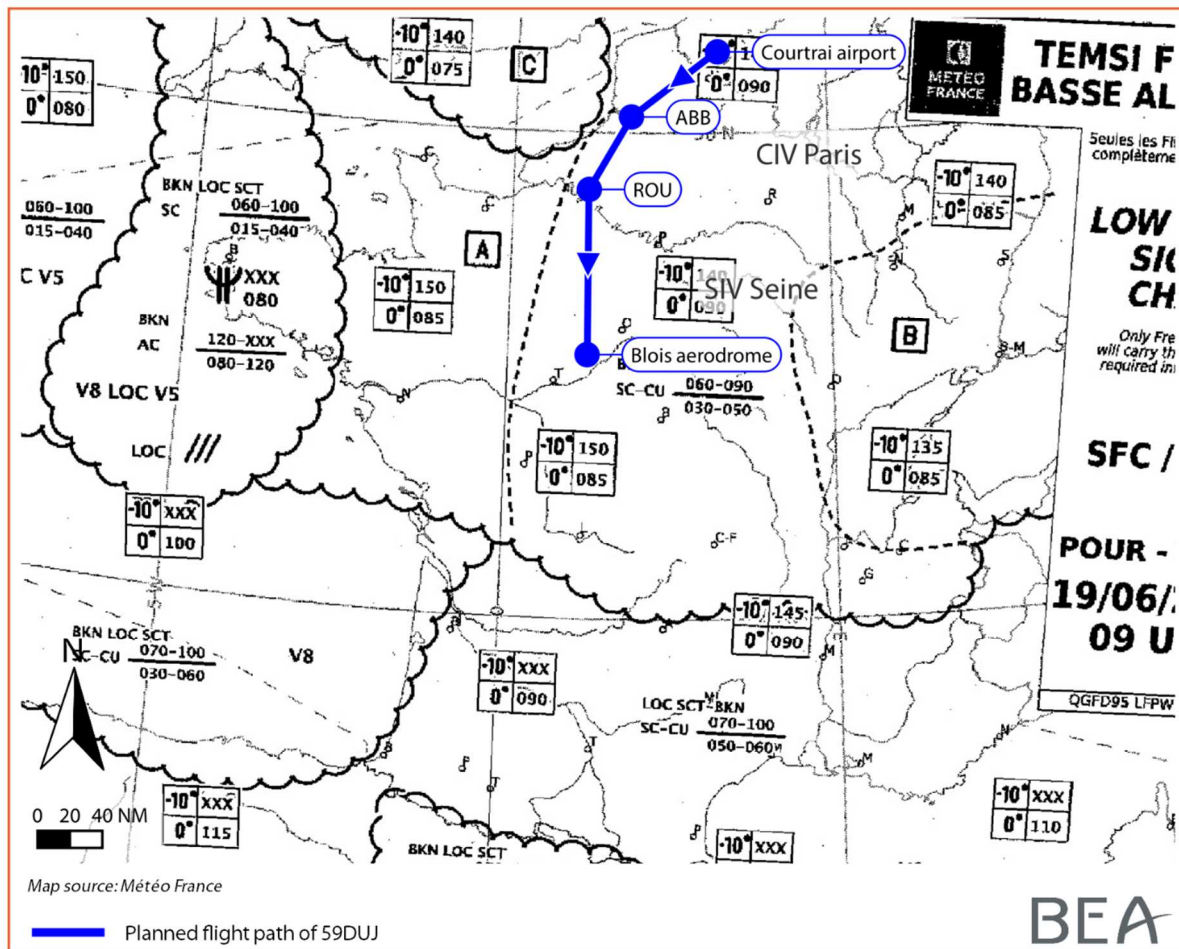
Figure 8: excerpt from 09:00 UTC SIGWX chart of 19 June 2020 (source: Météo-France)

The 09:00 UTC chart forecast a higher cloud base, between 3,000 and 5,000 ft on the first part of the route, between 5,000 and 6,000 ft on the last part, and better visibility conditions. Between the 06:00 UTC SIGWX chart and the 09:00 UTC chart, the area of bad weather can be seen to retreat towards the north-east while not affecting inland areas.

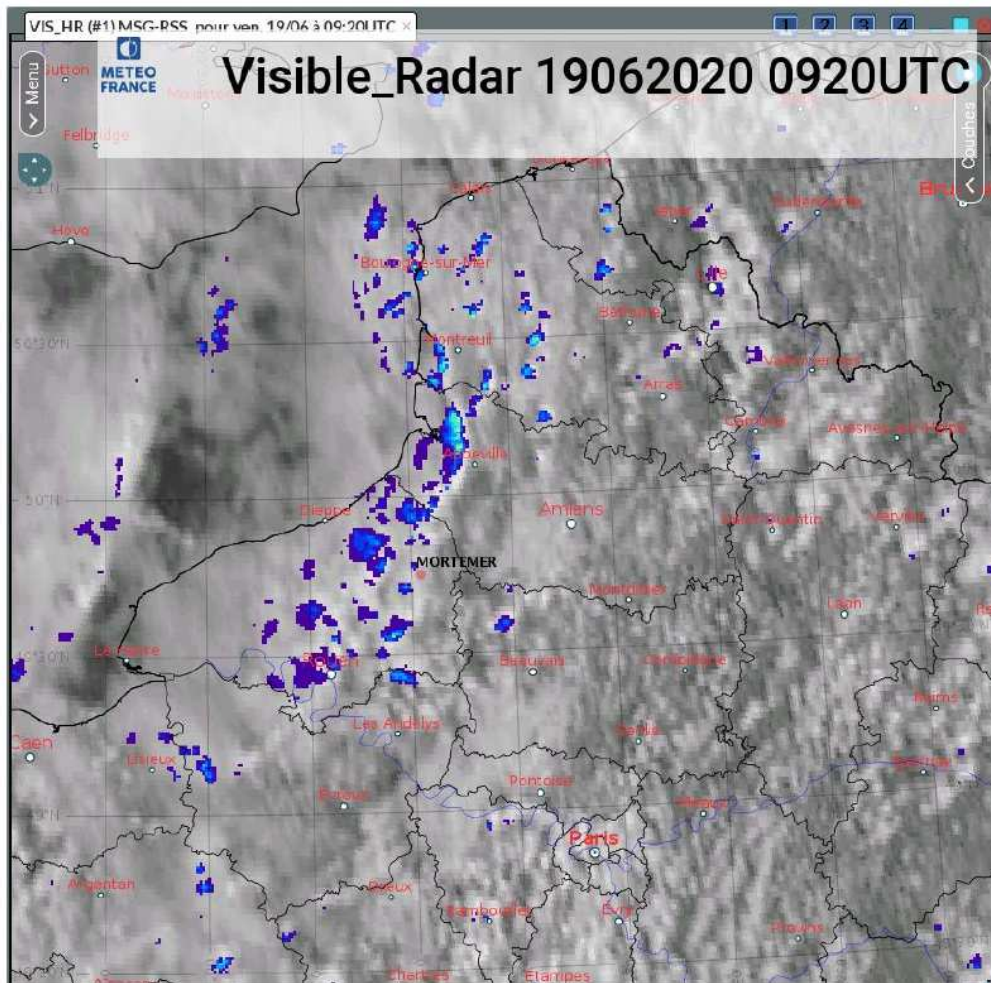
Figure 9: mixed visible satellite and weather radar image at the time of the accident (source: Météo-France)

The occluded front coming from the British Isles moved further inland than expected. At 11:20, a line of precipitation associated with the cloud front was located roughly on a line from Abbeville to Rouen, possibly interfering with the planned flight path of 59DUJ level with Abbeville (see Figure 9).

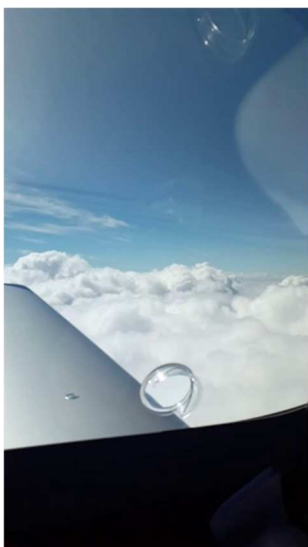
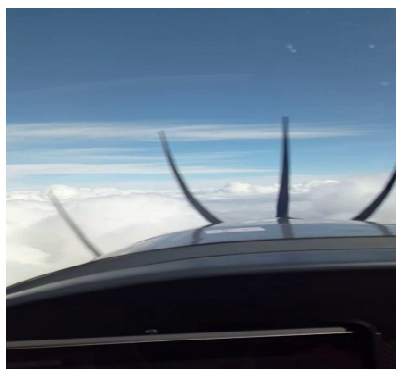
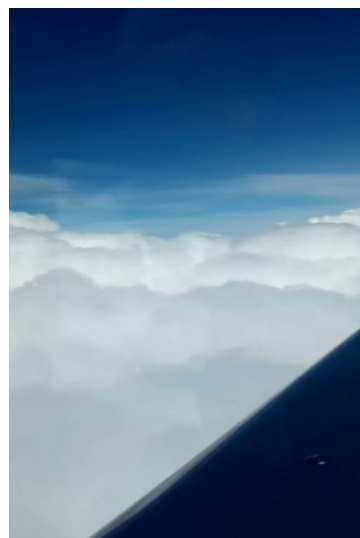
Figure 11: photos from a video taken by the passenger at 10:57 at 7,800 ft

Figure 11 shows the occluded front, which contained clouds higher than the flight altitude of 59DUJ and appeared to the pilot as a “wall” of cloud to the right of his flight path (as seen in the distance in the photo of what was ahead of the aircraft).

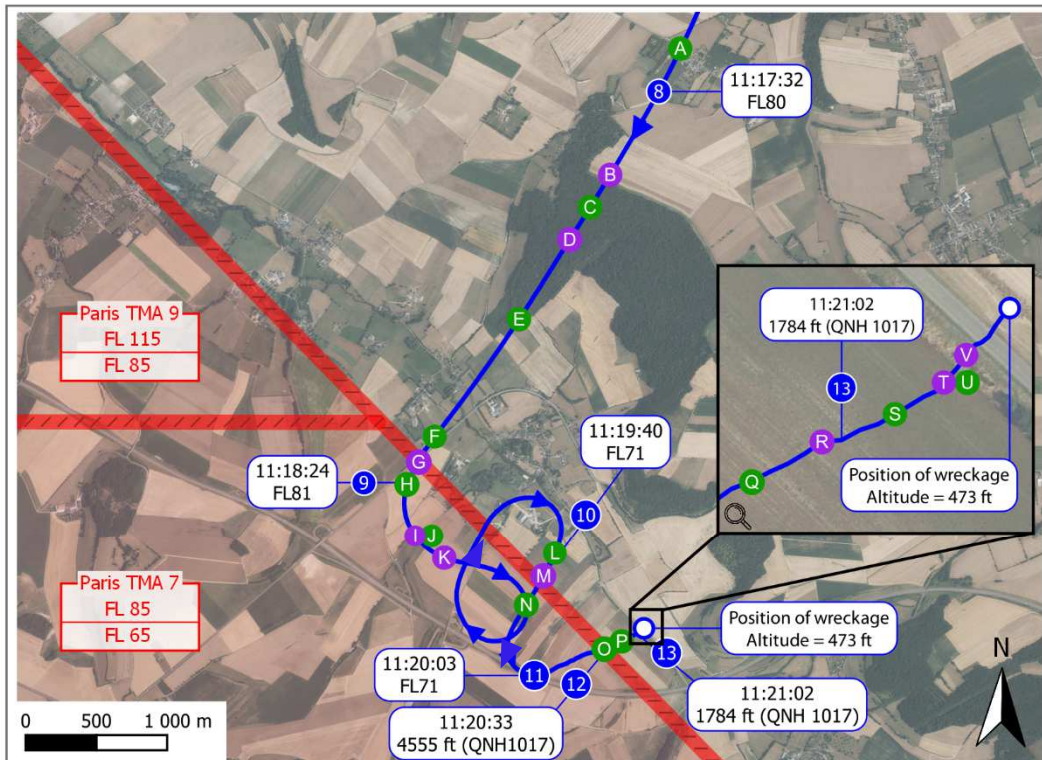
Figure 12: last exchanges between 59DUJ and FIC agent

— End of flight path of 59DUJ based on Dynon avionics suite data.
The altitude has been corrected with QNH 1017 (actual altitude) although the altimeter was at the standard setting.

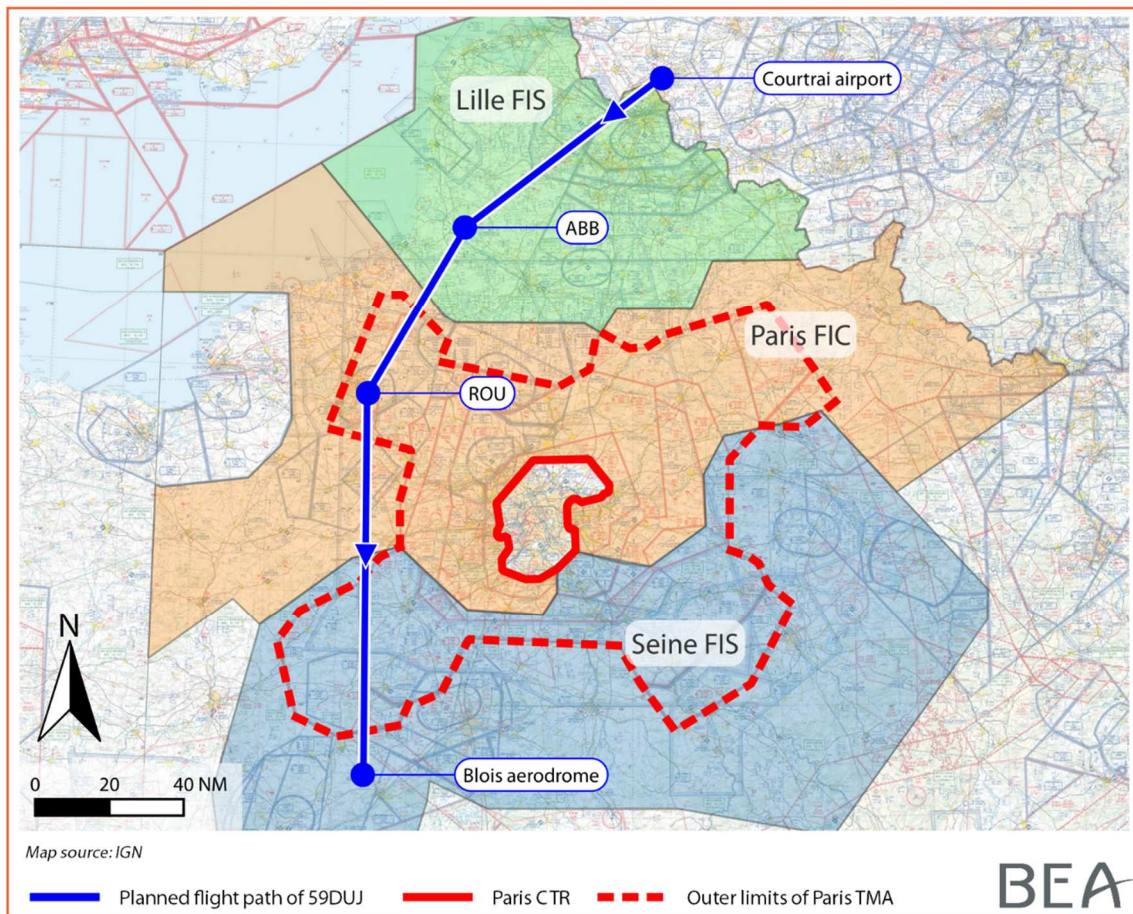
Figure 15: flight information sectors in north France (source: DSNA, annotations BEA)

The route filed on the flight plan of 59DUJ concerned the Lille and Melun (Seine Info) FIS and the Paris FIC (see **Figure 15**).

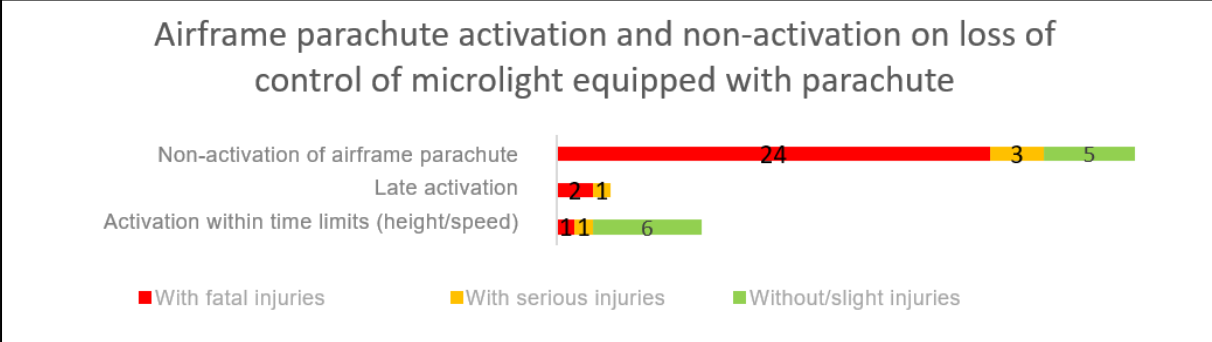
Figure 17: nature of injuries according to whether or not the parachute was opened during loss of control of a microlight fitted with a parachute (source: BEA)

In 32 of the 43 cases, i.e. nearly 3 out of 4 occurrences, the parachute was not activated. There were fatal injuries in 75% of the cases (24 out of the 32 cases) when the parachute was not activated and 27% of the cases (3 out of the 11 cases) when it was activated.

When the parachute was activated in the timeframe which would have permitted its deployment (third line of **Figure 17**), the case with fatal injuries is linked to the technical malfunction of the ballistic system.
