Accident to the Aerospool WT9 Dynamic Club microlight identified **67BVN** on Friday 12 April 2024 at Peynier

Loss of control during a stall exercise, activation of the airframe parachute, in instruction

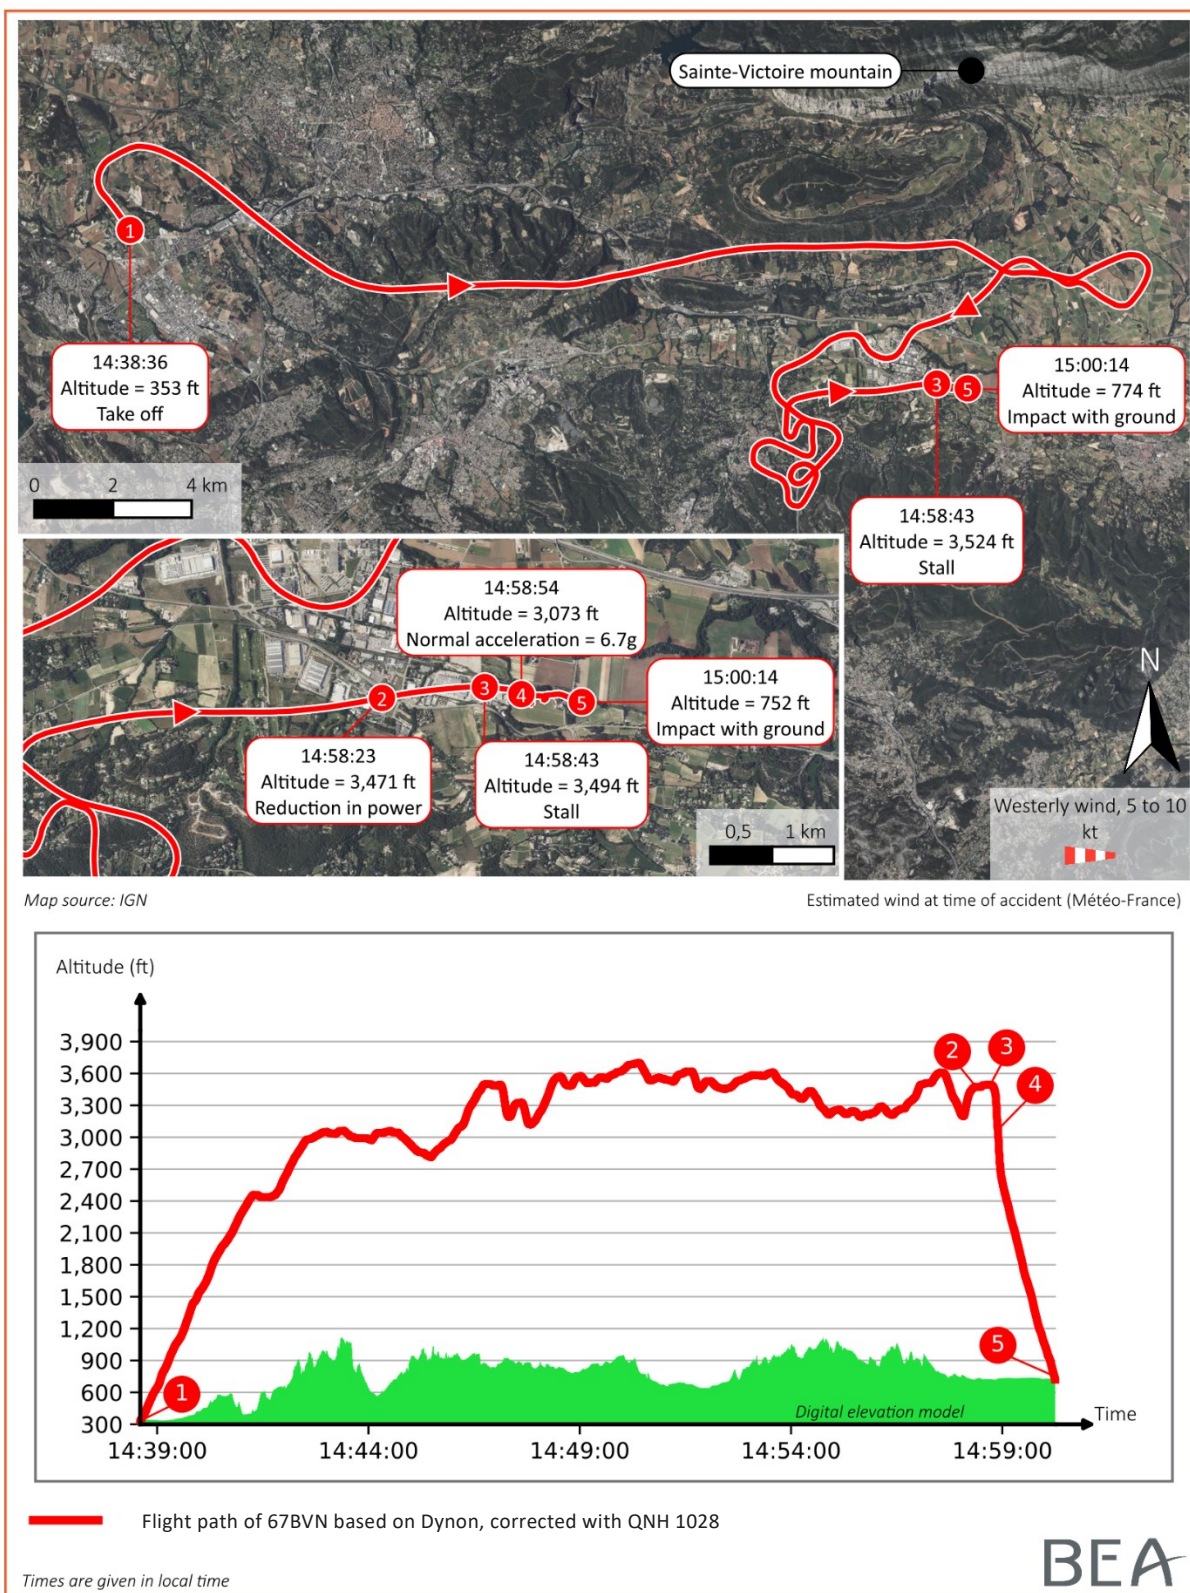
Figure 1: microlight flight path

After a briefing on the ground, the instructor and the student-pilot took off at 14:38 (see **Figure 1**, point **①**) from Aix-Les-Milles aerodrome (Bouches-du-Rhône) to perform handling exercises (steep bank turns, stall) and then runway circuits. They headed towards the south of Sainte-Victoire mountains, where the instructor took control to show the student-pilot a stall exercise.

At 14:58, at an altitude of 3,500 ft² (i.e. a height of approximately 2,750 ft), the instructor gradually reduced the power to idle and fairly maintained level flight while gradually increasing the attitude. The indicated airspeed decreased from 92 kt to 47 kt.
