Accident to the ZT 610
identified **77AUM**
on Friday 6 September 2024
at Frestoy-Vaux

Time	Around 18:20 ¹
Operator	Private
Type of flight	Practical exam
Persons on board	Pilot in training and instructor
Consequences and damage	Pilot in training and instructor fatally injured, microlight destroyed
This is a courtesy translation by the BEA of the Final Report on the Safety Investigation. As accurate as the translation may be, the original text in French is the work of reference.

**In-flight opening of canopy, collision with ground,
fire, check flight**

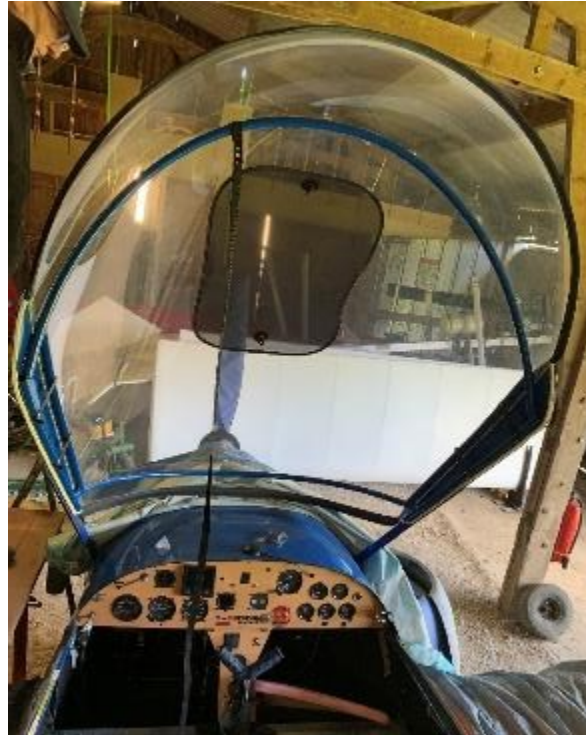
The canopy of this microlight is a single piece of Plexiglas fixed onto a metal frame. It opens by tipping forward.

Figure 4: photo of open canopy of another ZT610 (source: BEA)
