**Accident** to the AIR CREATION - IFUN16 SKYPPER  
identified **974OW**  
on Friday 15 September 2023  
on Cambaie microlight strip

**Loss of control on final approach,  
collision with a hangar, fire**

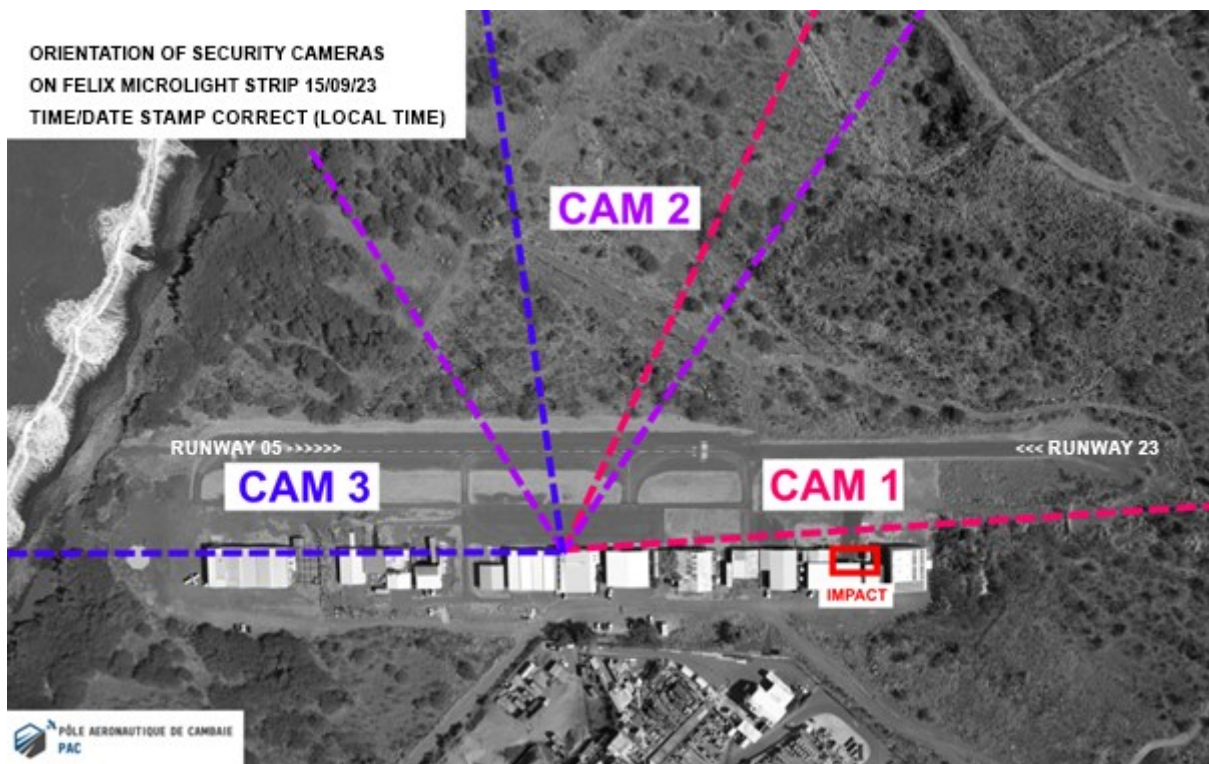
Three security cameras on the microlight strip were operating at the time of the accident. Only cameras 1 and 3, each oriented towards an end of the runway, partially recorded the accident flight. These cameras did not have an audio recording.

Figure 3: location and orientation of security cameras (source: Pôle Aéronautique de Cambaie)

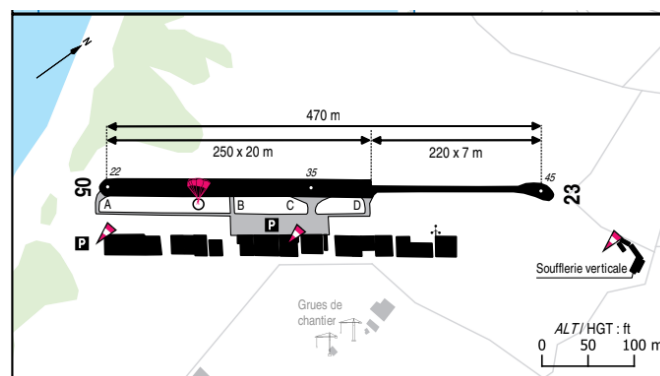
Figure 5: position of windsocks (source: Pôle Aéronautique de Cambaie)
