Accident to the Embraer– EMB-500
registered **9H-FAM**
on 8 February 2021
at Paris-Le Bourget

**Stall on short final in icing conditions, hard landing,
rupture of main landing gear and nose gear,
fire, runway veer-off**

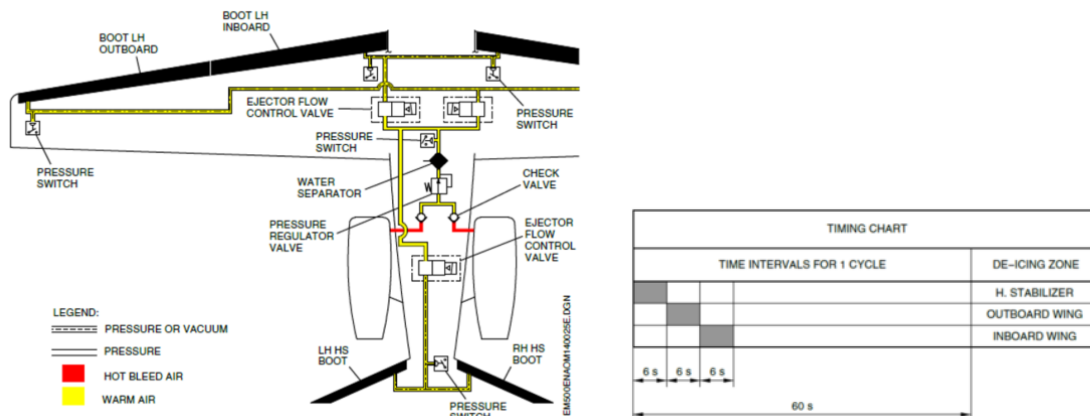
Figure 5: diagram of wing and horizontal stabilizer de-ice system (on left) and system's operating cycle (on right) (source: Embraer)

The readout of the flight data recorded in the FDR, and in particular the pressure sensor data and data concerning the open/closed state of the various valves of the de-ice systems indicates that the de-ice system was operating nominally.

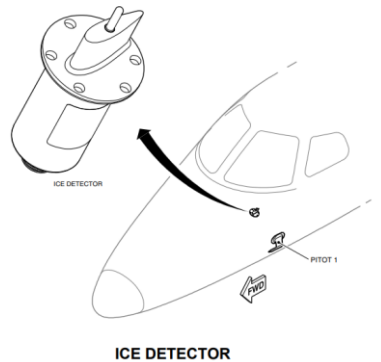
Figure 6: diagram of ice detector (source: Embraer)

On 16 November 2021, EMBRAER indicated to the BEA that 373 EMB-500 Phenom 100s were in service and that 39 of these had been equipped with this detector. 9H-FAM was not equipped with one.

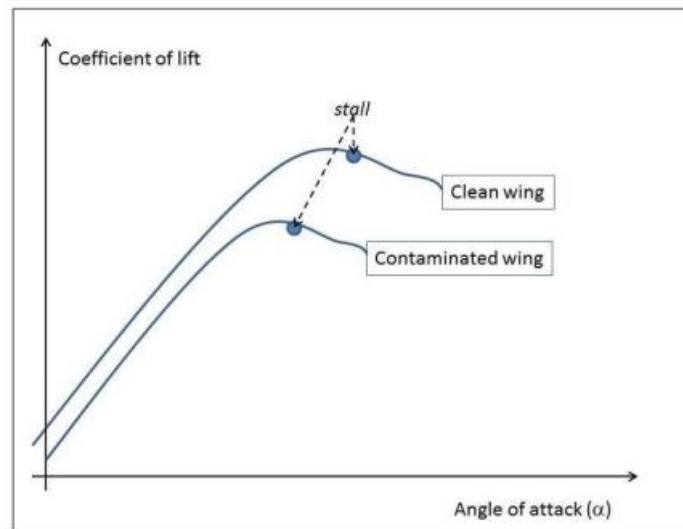
Ice contamination of the wing, even in small quantities, locally modifies the airflow and can cause the airflow to separate from the surface. The wing's aerodynamic characteristics can then be significantly degraded. In particular, there is a reduction in:

- lift for a given angle of attack;
- the maximum lift;
- the angle of attack at which a stall will occur.

In these conditions, the actual stall angle-of-attack may be much lower than the thresholds for the stall alarm calibrated for a "clean" wing.

Figure 9: effects of contamination on lift (source: BEA)
