# INVESTIGATION REPORT

**Incident** to the ATR 72-212A  
operated by Caribbean Airlines  
registered **9Y-TTC**  
on 4 May 2014  
at top of descent to **Piarco airport**  
(Republic of Trinidad and Tobago)

**BEA**

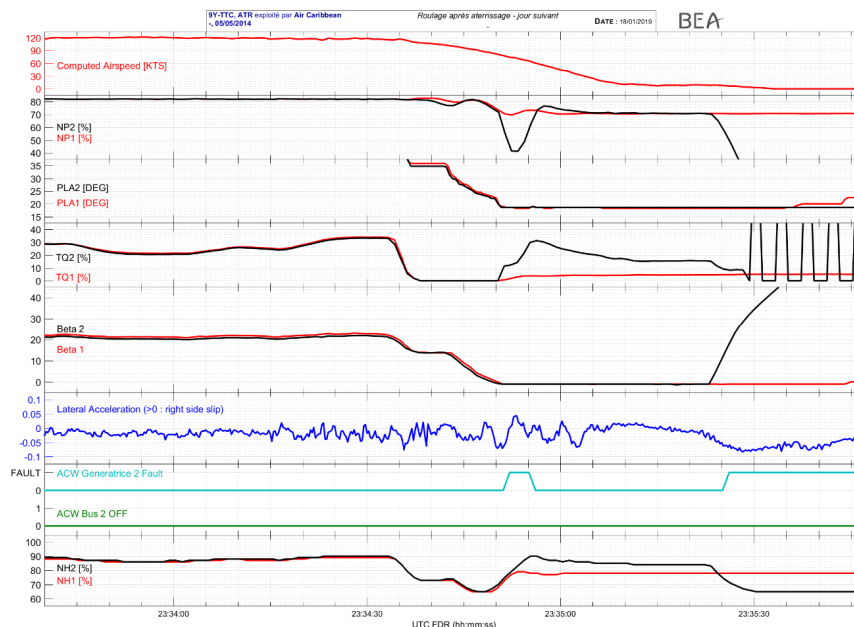
Figure 2: QAR parameters recorded during landing run on 5 May 2014

The next day, the aeroplane took off from Piarco international airport bound for Arthur Napoléon Raymond Robinson international airport . The flight proceeded normally. The recorded parameters were normal with no difference in values between the left engine and the right engine. During the landing run, the crew reported a loud vibration noise when they moved the power levers from the flight idle to ground idle position. The recordings showed a reduction in torque of both engines, to around zero whereas the angle of the propeller blades was at  $1^\circ$  and the propeller rotation speed was at 71% Np. The rotation speed of the right propeller decreased with respect to that of the left propeller and the torque provided by the right engine increased again, up to 27 % more than the left (31 % compared to 4 % ). Thereafter, the right engine provided around 10 % more torque than the left engine up to its shutdown (Figure 2). The crew reported that the vibrations and noise disappeared when the right propeller was feathered. No warning appeared in the cockpit. The crew taxied to the apron with the left engine.

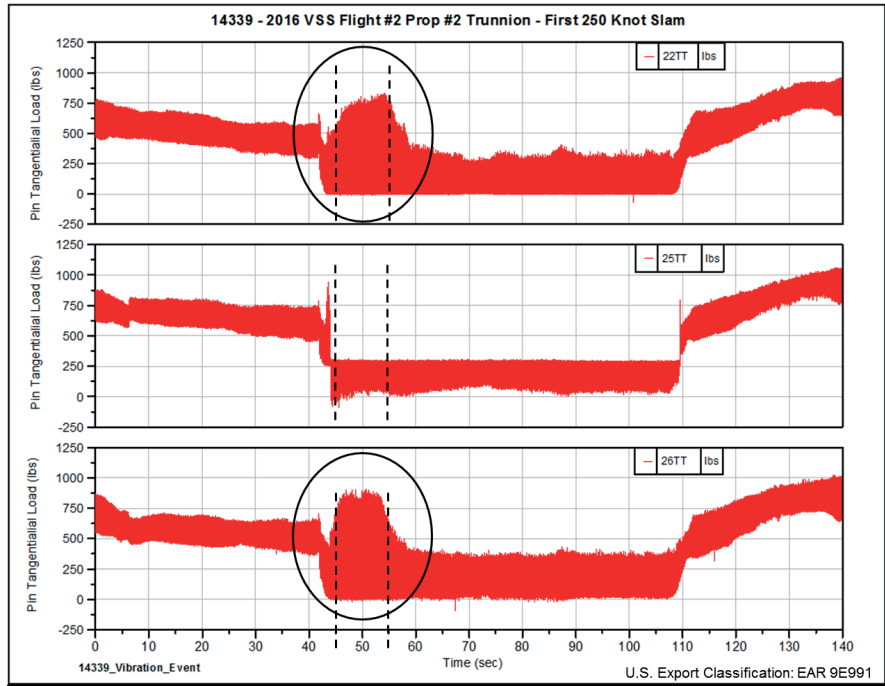
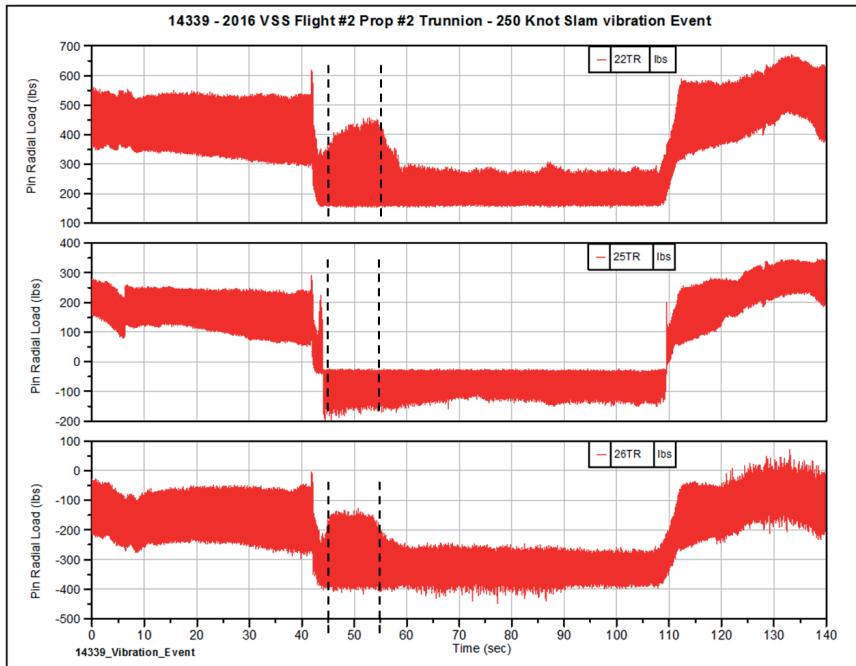
During 2016 VSS flight, trunnion cyclic load increase event was noted on two 250 knot descent maneuvers. This trunnion load “vibration event” occurred immediately after the first 250 knot slam on flight 2.

The two following figures show the complete prop 2 tangential and radial 2000 Hz strain gage recordings. The ‘vibration event’ is the load amplitude increase on gages 22TT, 26TT, 22TR and 26TR that occurs immediately after the PLA reduction.

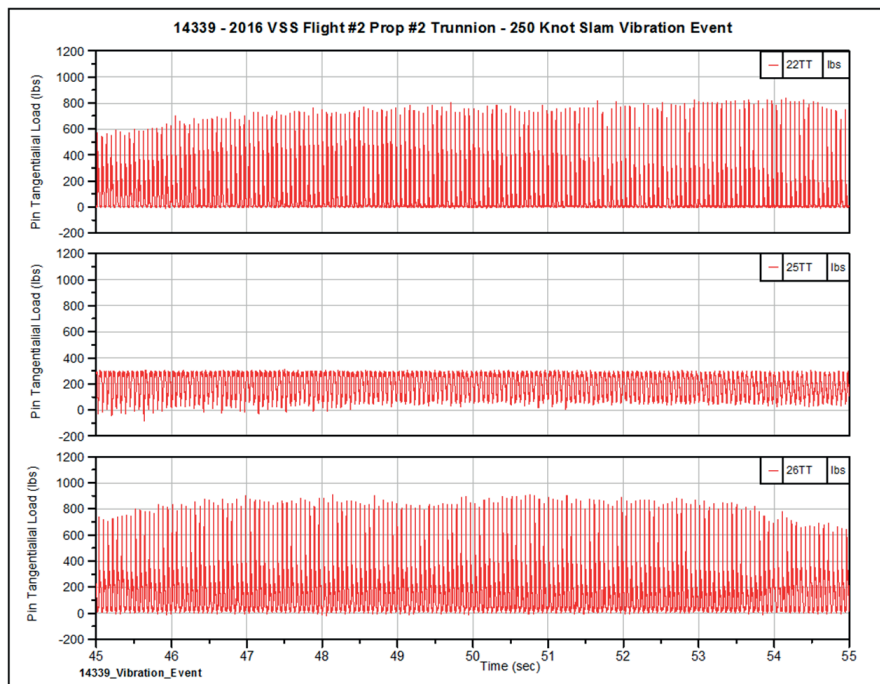
The following figure shows a blown-up view of the tangential signals for 5 seconds duration window:

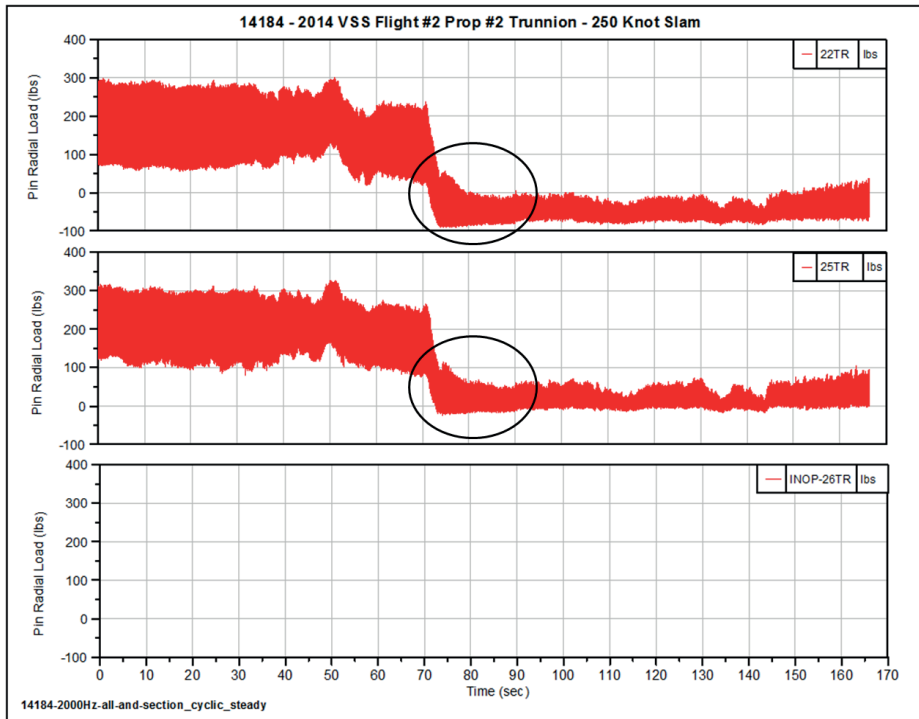
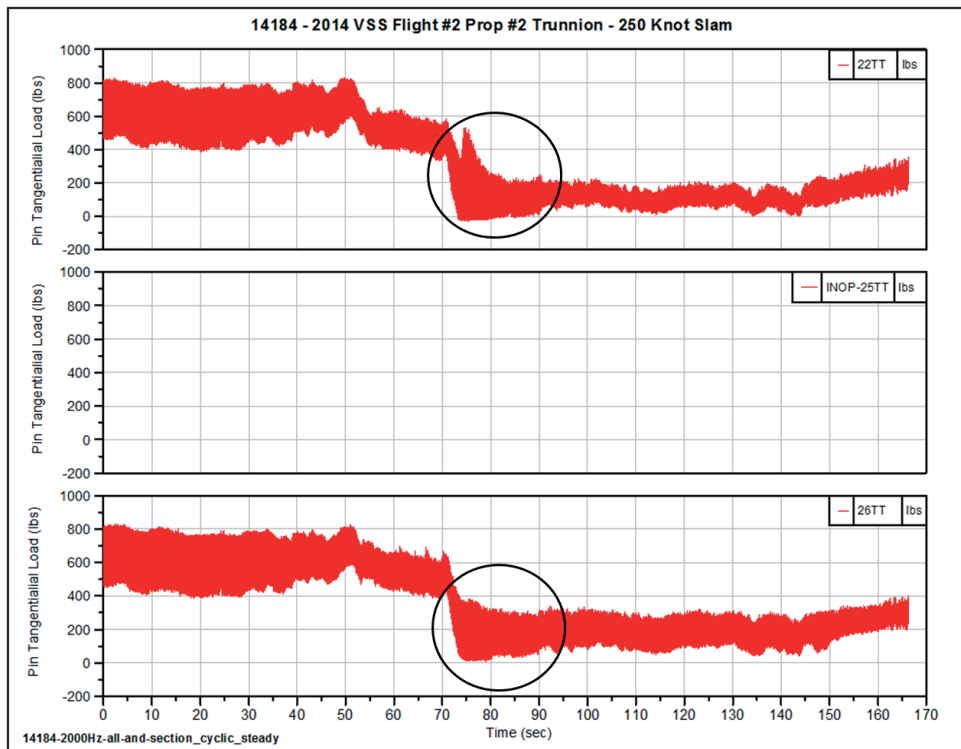
For comparison, 2014 VSS 250 knot slam data was analyzed. Prop 2 trunnion gages show a small dip in the cyclic load after PLA reduction occurring during 6 seconds. Trunnion data shows that it is unloading the aft plate to a near zero load between impacts.

The two following figures show the tangential and radial trunnion pin signals, respectively:

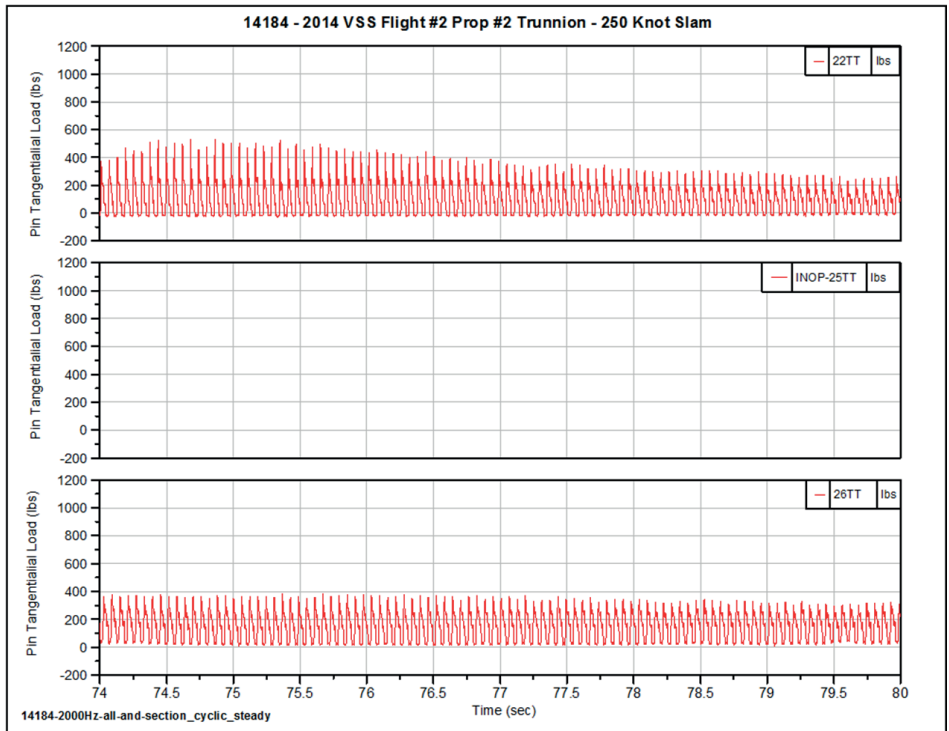
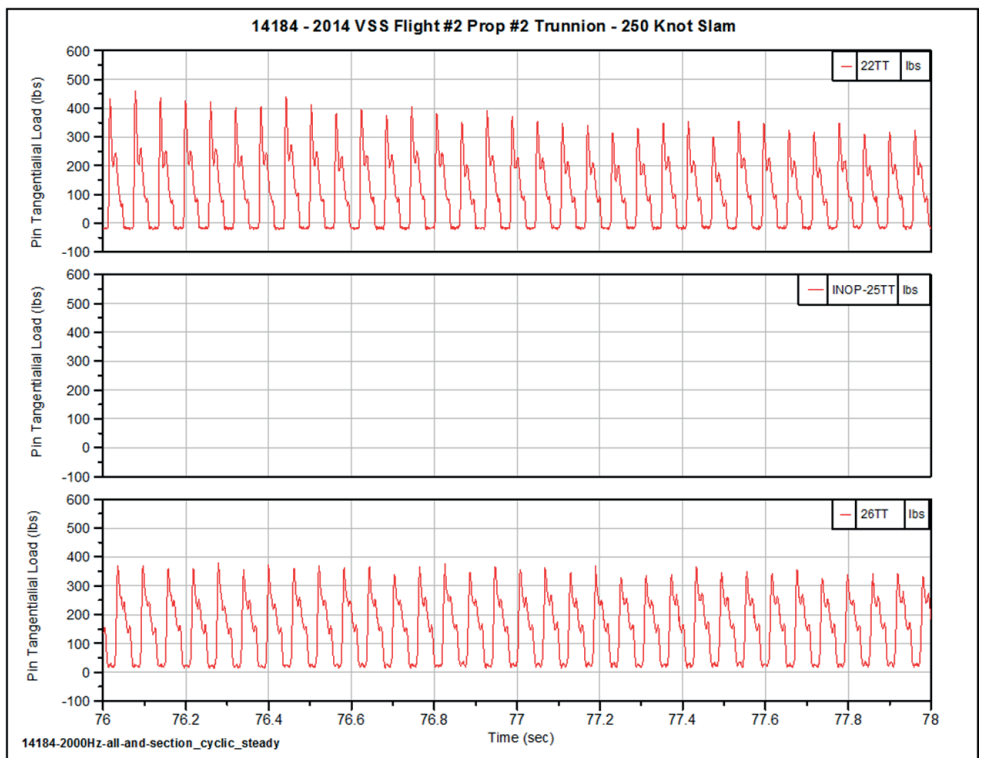
The following figure shows 22TT and 26TT during the 6 seconds:

The following figure focuses on a time sample during 2 seconds:

The 26TT sensor does not dip below zero because of a positive offset in the gage. Similarly, although both 22TR and 25TR 2000 Hz signals show a dip after slam, both are below zero due to gage offset.
