INVESTIGATION REPORT

**Serious incident to the Boeing 737- 800
registered CN-ROJ**

operated by Royal Air Maroc

on 30 December 2016

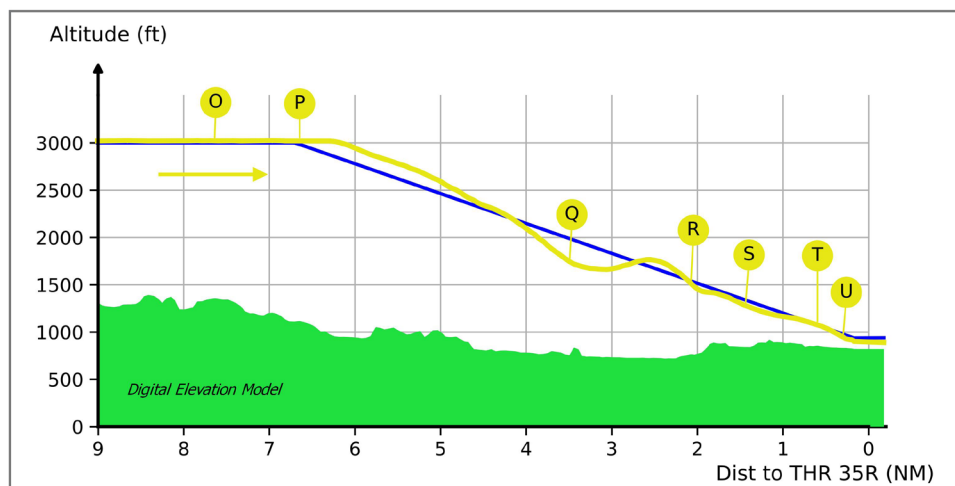
⁽¹²⁾ The QAR data shows that in reality the aeroplane was 1.6 NM east of the path.

- CN-ROJ's path during first approach based on GNSS data recorded in QAR.
- CN-ROJ's path during second approach based on GNSS data recorded in QAR.
- ILS 35R approach slope (3°).
- Direction of path.
