Incidents to the Boeing 737 - 800 registered F-GZHO operated by Transavia France

on 7 February 2018 at Norwich (United Kingdom) and 8 February 2018 at Paris-Orly

Dysfunction of AOA sensor, alerts during take-off (7 February 2018)

Dysfunction of AOA sensor, alerts during take-off, turn around (8 February 2018)

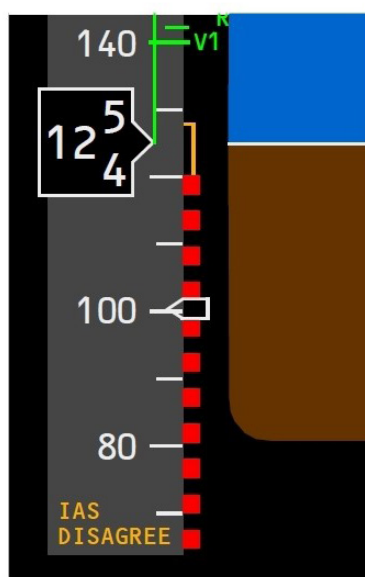
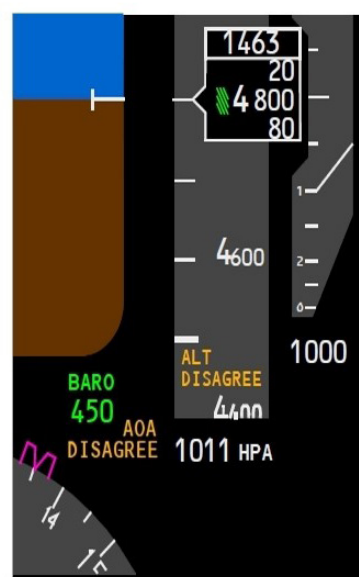
Figure 1: Display of IAS DISAGREE, AOA DISAGREE and ALT DISAGREE alerts on the PFD

An IAS DISAGREE alert message appeared between 90 and 95 kt according to the instructor⁽¹⁰⁾. The latter took the controls, terminated the instruction situation, continued the take-off run and carried out the rotation. He set a pitch of 15° and thrust was at the *assumed temperature*⁽¹¹⁾. Shortly after, the AOA DISAGREE and ALT DISAGREE alerts appeared in succession. The instructor then observed that his PFD displayed values which were 20 kt and 400 ft below the left PFD and the standby instrument values. He told the pilot in training that the indications were erroneous on his side and asked him to continue the flight. The latter, PF again, engaged the AP.

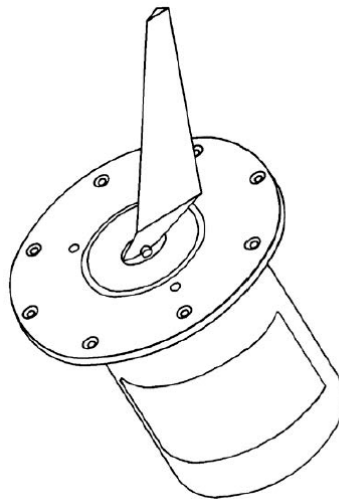
Figure 2: AOA sensor on Boeing 737

The maintenance team which inspected the aeroplane after this flight observed that the AOA sensor on the right side was abnormally resistant to being turned and there were unusual clicking noises.

The faulty sensor was removed from the aircraft and sent to KLM EM⁽¹⁶⁾ in Amsterdam for tests and disassembly in the presence of the BEA. The examination found damage to several internal components. The gears between the two resolvers were damaged and at ambient temperature, the shaft of resolver 2 was blocked in rotation and was slightly deformed. At operating temperature, reached after the vane heater test, the two resolvers gave indications which differed from each other by around 100°.

Resolver 2 was sent to the manufacturer of the AOA sensor, Collins Aerospace, who coordinated an examination with its subcontractor, MOOG, the resolver supplier. The examination of the resolver blocked in rotation found the presence of a viscous and tacky substance, between its stator and rotor, which prevented the relative movement of these two parts.

Examinations carried out by Collins Aerospace and MOOG found that this substance was composed primarily of epoxy resin, used in the manufacture of resolvers (winding) but contaminated with one or more other substances.
