## Incident to the CESSNA - 182 - P registered N609PC

on 28 February 2018  
at Yonval (Somme)

### Vibrations and smell of smoke en route, commanded engine shut-down, off-field forced landing

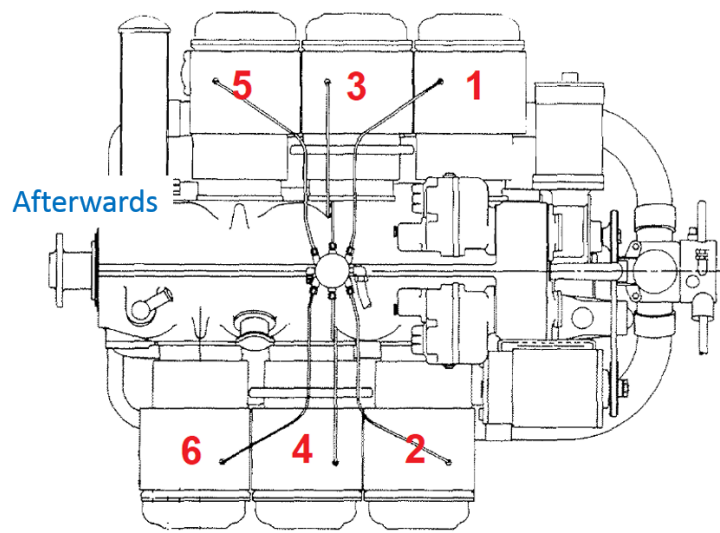
Figure 2: Top view of engine, identification of cylinders

The propulsion system is an air-cooled, flat six-cylinder engine. The cylinders are numbered 1 to 6 as shown in the diagram below.

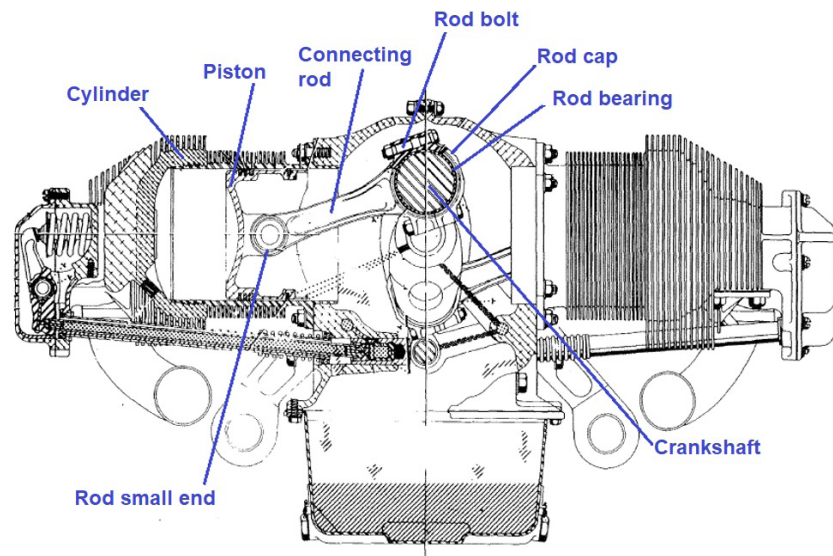
Figure 3: Cross-section view of engine

Each cylinder is equipped with a rod attached to the crankshaft by the rod cap and to the piston pin by the rod small end. Two rod bearings are positioned between the rod and the crankpin (see Figures 3 and 4). A lubrication system lubricates this zone with oil.
