## INVESTIGATION REPORT

### Serious incident to the ATR 42-500

Registered F-GPYF

On 25 March 2018

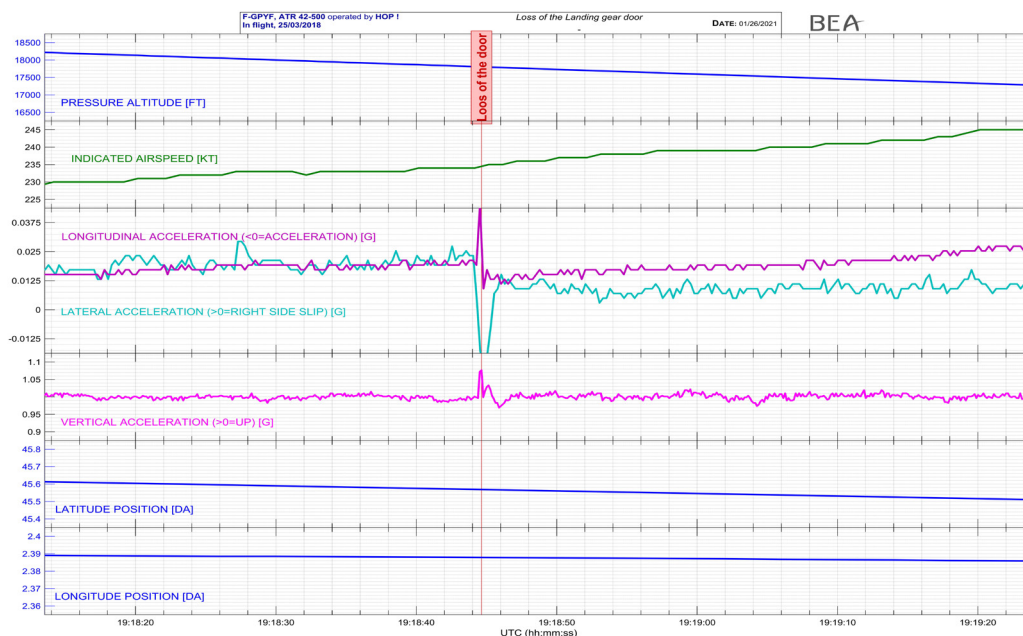
Figure 12: Locating the door loss using the flight parameters

During the aircraft's descent, the recorded values of the three accelerations (longitudinal, vertical, and lateral) were consistent. Shortly afterwards, at 19:18:44, these three acceleration values showed an extremum (see Figure 12).

The plane was on its descent and was powered. The coordinates of the position thus located were as follows:

- ❑ 45.568371° N - 2.387853 E;
- ❑ altitude of 17,800 ft (5,425 m).

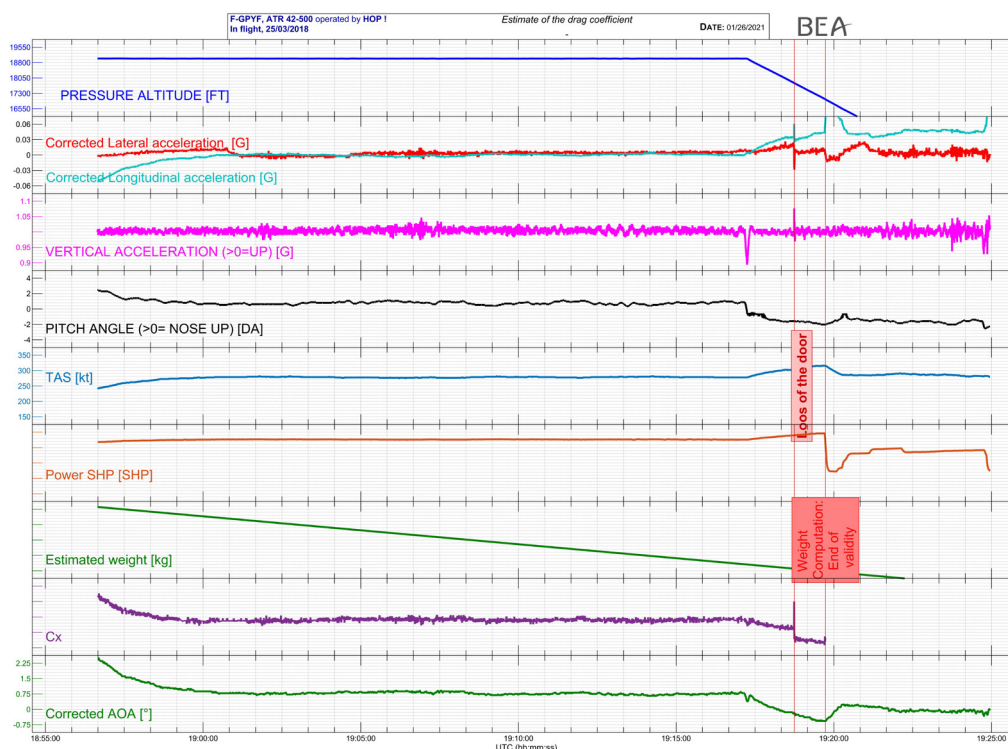
Figure 14: Drag study

The drag coefficient ( $C_x$ ) of the aircraft<sup>(16)</sup> is a function of the angle of attack (AOA). During cruising (see Figure 14), the angle of attack stabilised at an average value of  $0.8^\circ$ . During the 15 minutes of cruise, the CRUISE SPEED LOW alert was active and the aircraft's drag coefficient did not vary significantly (values close to the mean  $\pm 5\%$ , with a standard deviation of  $1\%$ ).

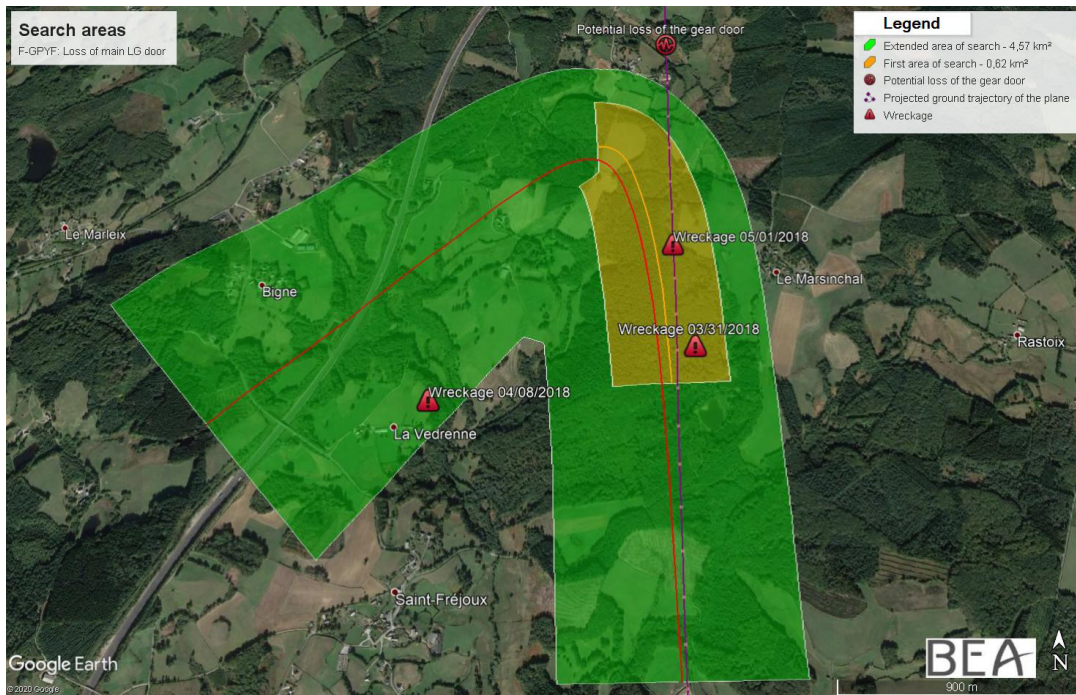
Figure 15: Location of debris found and search area

Three components of the L MLG door were found respectively on 31 March 2018, 8 April 2018 and 1 May 2018, within a radius of approximately 2 km around the estimated point of loss of the door (see [Figure 15](#)).

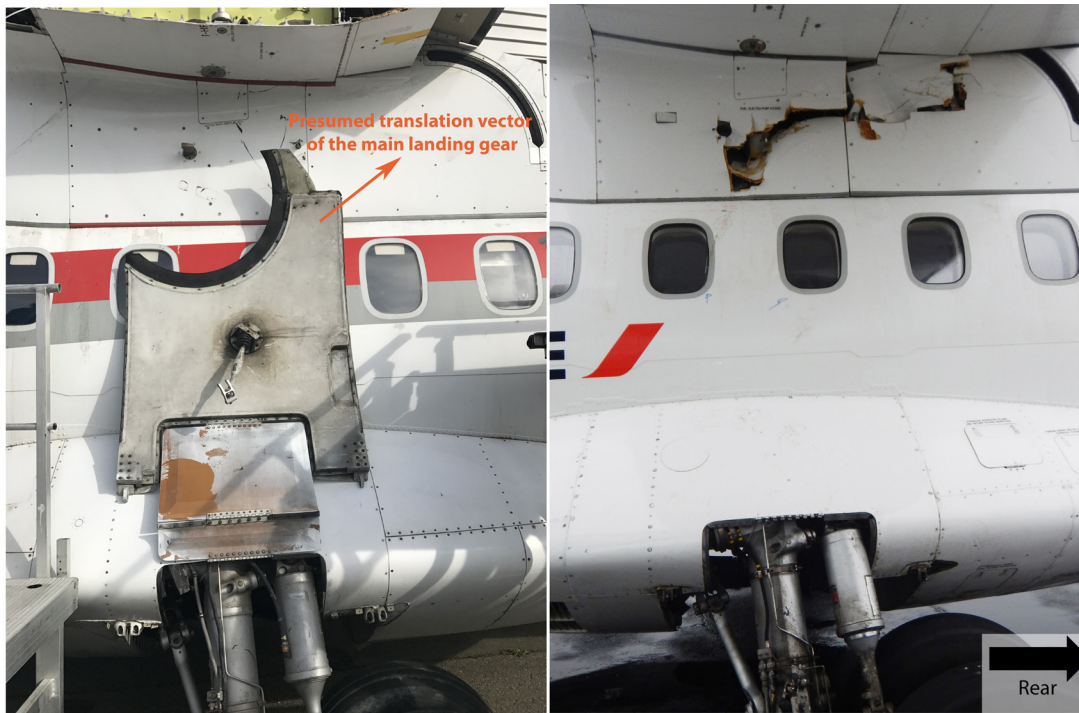
Figure 22: ATR test on MSN002

The door became detached from its hinge assemblies and its link. It was projected against the aircraft fuselage. The door was at that juncture retained only by hinge 1.

The damage observed on F-GPYF after the incident, particularly on the cabin window and under the wing root, was consistent with a landing gear door position as per Figure 22 followed by a backward and slightly upward movement.

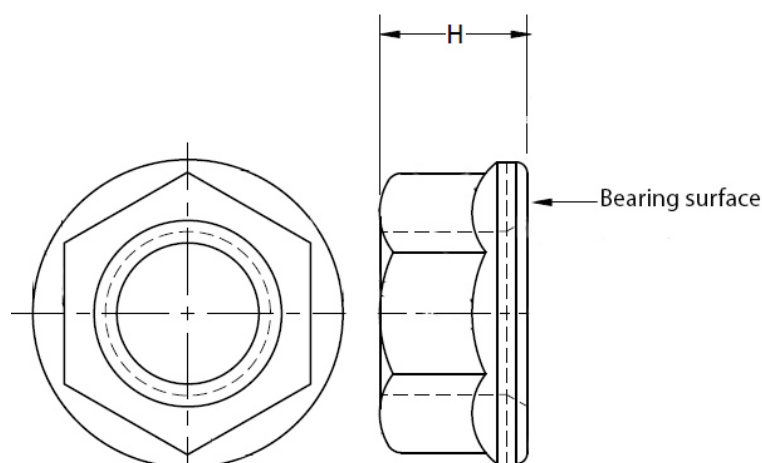
Figure 23: Definition of the bearing surface and the height H of a nut

The 9 nuts are made from a different material (steel) and protection (cadmium) compared to the IPC P/N (stainless steel and silver protection).

In an attempt to determine the P/N of the magnetic nuts that were recovered, the bearing surface was observed and the height H measured (see Figure 23). All 9 nuts have a circular bearing surface and a reduced height<sup>(23)</sup> (like the IPC P/N).

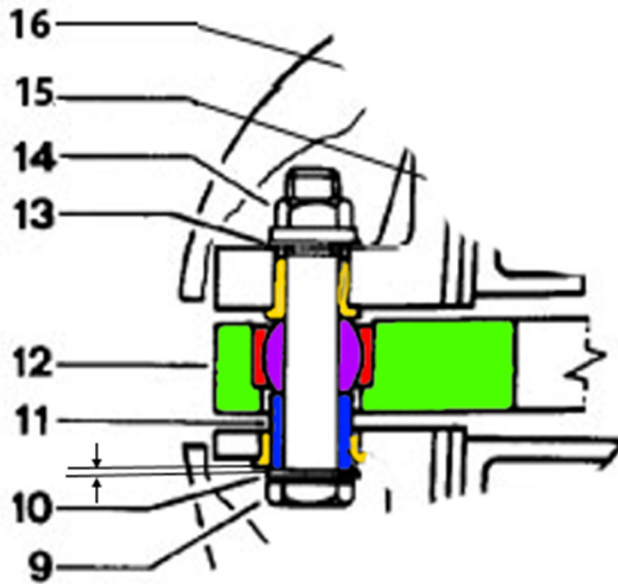
Figure 24: Rotation of the assembly

During initial certification of the ATR 42, it was considered that the fastener was not subject to rotation because it is the ball joint (in red in Figure 24) mounted in the bore of the male hinge that rotates around the part in purple in Figure 24 encircling the screw. Thus, with proper lubrication, there is no torque force transmitted to the screw when opening and closing the landing gear door.
