Accident to the CESSNA 525A "CitationJet CJ2+" registered D-IULI

on 06 June 2018

at La Môle (Var)

Runway overrun during landing run on wet runway, collision with an obstacle

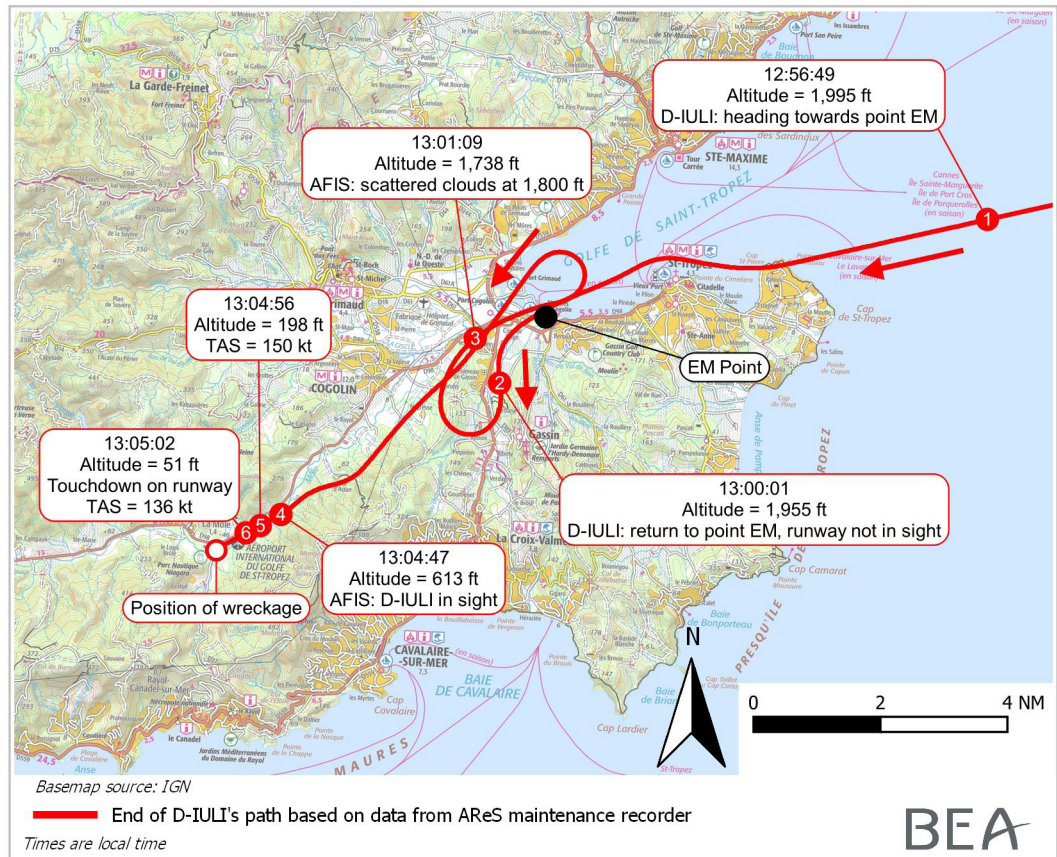
Figure 1: Approach path

Three minutes later, although he had not received information about weather developments, the pilot asked to turn towards point EM. In the minutes that followed, the pilot asked to change heading several times in order to avoid clouds.

A few minutes later, the pilot indicated that he had point EM in sight. The controller authorized him to carry out a visual approach for runway 24 and then asked him to contact the La Môle AFIS officer.

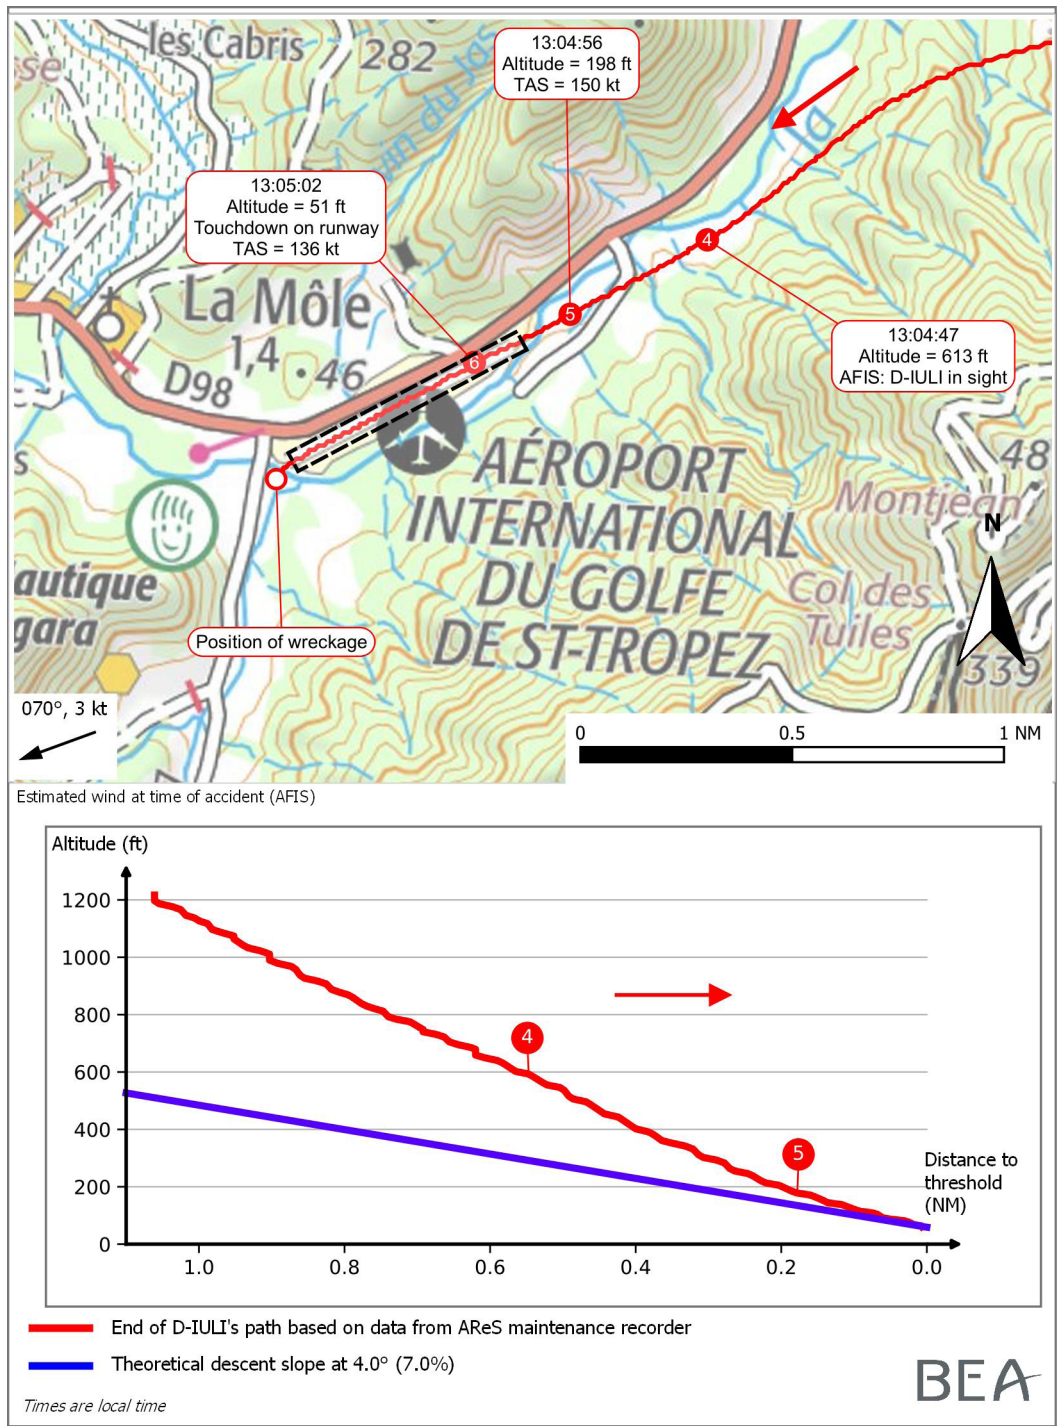
Figure 2: Final approach path

Two minutes later, the pilot asked for the visibility on the final path. The AFIS officer told him that visibility was 4 to 5 km, before informing him that he had him in sight⁽⁴⁾ and giving him the latest wind conditions (070°, 3 kt). Between points⁽⁴⁾ and⁽⁵⁾, the aeroplane's TAS⁽³⁾ varied between 145 kt and 150 kt⁽⁴⁾.

The aeroplane touched down on the runway 200 m after the runway threshold ⑥, at a true airspeed of 136 kt. The pilot set the flaps to the “full ground” position and the spoilers were deployed. The aeroplane reached the taxiway B intersection⁽⁵⁾ 13 s later at a true airspeed of 77 kt. It continued its run over the paved strip situated after the end of runway 24 and deviated left. It left the paved surface at a true airspeed of 41 kt and descended into the river situated at the bottom of a small bank. The aeroplane’s nose violently struck the opposite bank.
