Serious incident between the Bombardier CRJ700 registered F-GRZG and the Boeing 717-200 registered EI-EXB on 12 April 2019 at Strasbourg Entzheim airport (Bas-Rhin)

Immediate departure, low-level missed approach, near collision

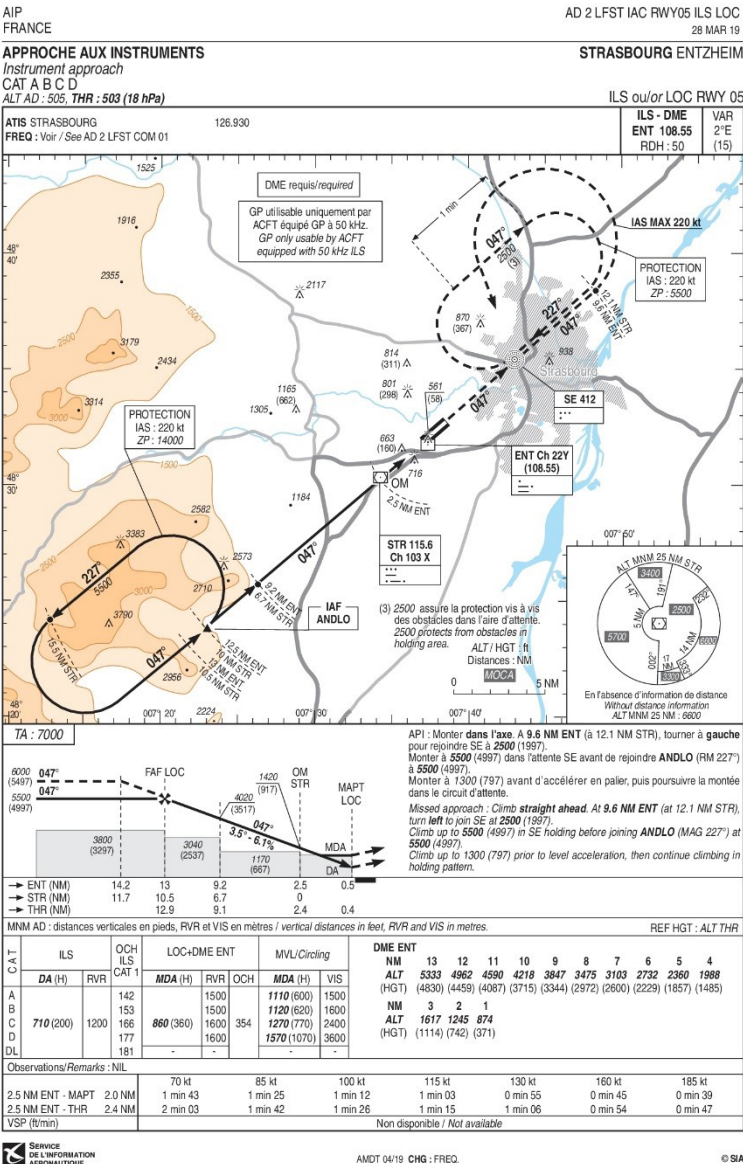
Figure 4: excerpt of ILS approach chart for runway 05

The initial approach fix (IAF) of the ILS procedure for runway 05 is situated on the runway centreline at 12.5 NM from the DME of the ILS ENT (DME situated at 079° and 303 m from the threshold of runway 05). From the final approach point (FAP), the approach slope has a gradient of 3.5° (i.e. 6.1%). The DH is 200 ft (altitude of 710 ft), at around 0.5 NM from threshold 05.

The missed approach procedure requires the crew to first climb straight ahead, to turn left at 9.6 NM from the DME of the ILS ENT to join the NDB SE at an altitude of 2,500 ft and to then climb in the established holding pattern at NDB SE before joining the IAF of the procedure at 5,500 ft. Volotea uses the information provided by LIDO whose approach chart regarding the ILS procedure for runway 05 has no differences with that of the AIP.
