Accident to the Pilatus – PC-12 - 47E registered LX-JFD

on 30 March 2020

on approach to Nice-Côte-d'Azur airport (Alpes-Maritimes)

In-flight lightning strike, structural damage observed on ground

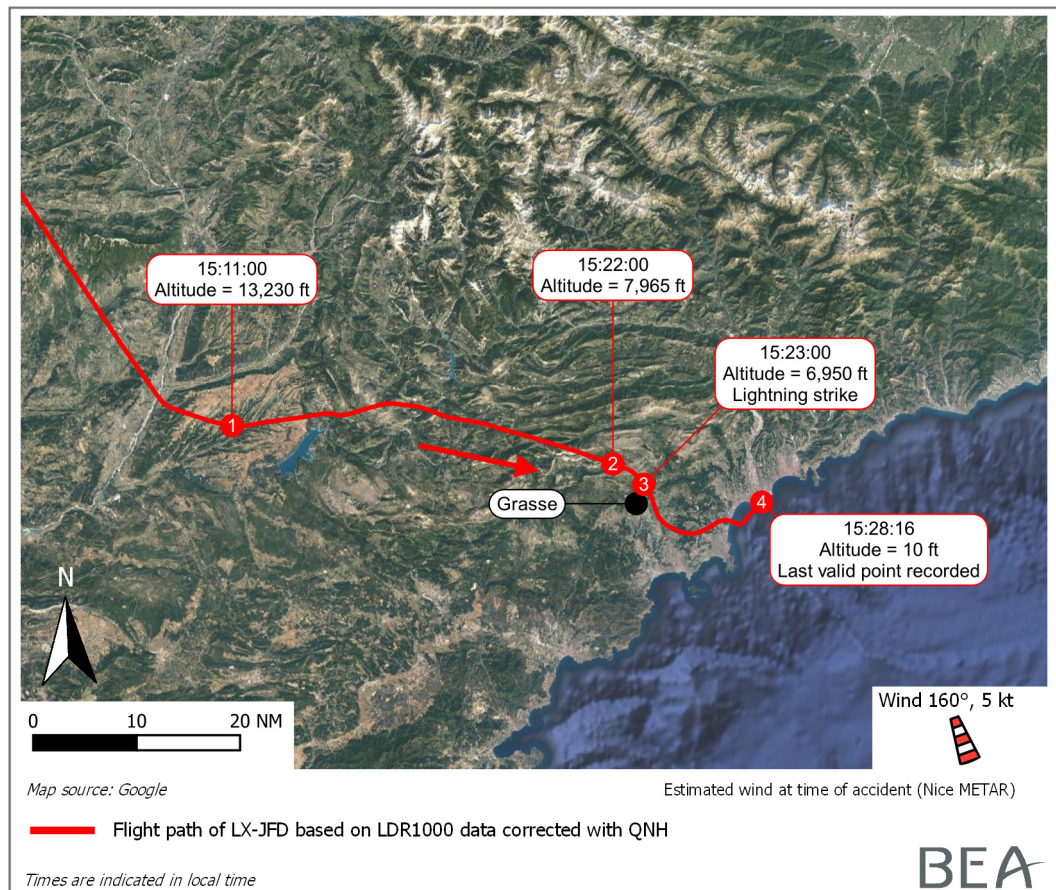
Figure 1: LX-JFD's flight path

At 15:11 (see [Figure 1](#), point ❶), the crew asked the Nice controller if they could change heading as required for avoidance purposes⁽³⁾. The controller replied that they could change heading at their discretion.

At 15:22 (see Figure 1, point ②), the crew descended to FL 060 and changed their heading by 30° to the right for a heading of 160° for avoidance purposes.

At 15:23 (see Figure 1, point ③), the crew told the controller that they were in good conditions. When descending through FL 60 and at this point in calmer conditions, there being no turbulence, they saw a brief flash of lightning and heard a loud bang. The crew reported that a few seconds later they were outside the clouds. The propeller and engine parameters remained normal and there was no evidence to suggest that the aircraft's operation was impaired. Nevertheless, the crew decided to land at Nice as quickly as possible.

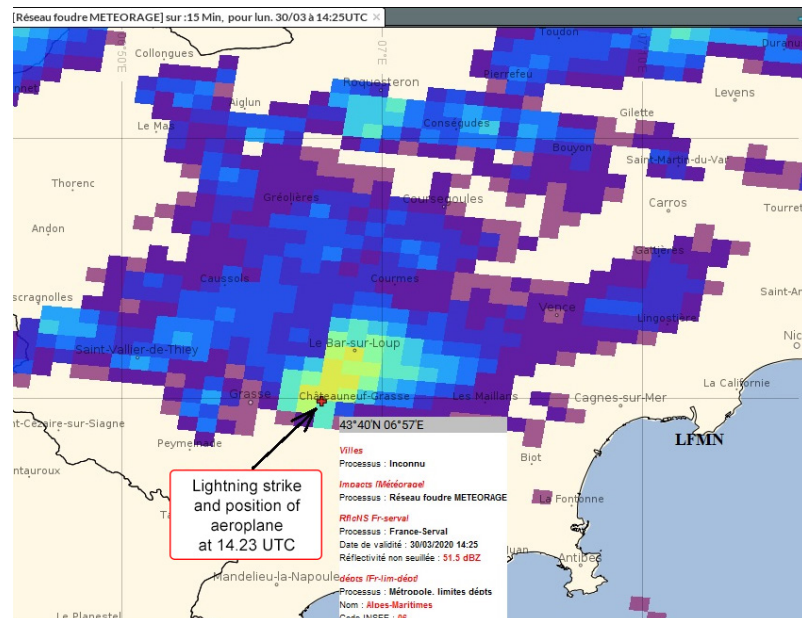
Figure 4: Radar image of precipitations at 15:25

The image shows a calculated reflectivity in the area of the heaviest precipitations (yellow pixels) which suggests hail. Generally speaking, turbulence is strong under, in and around such Cumulonimbus. However, the accuracy of the (Météo-France) weather radar means that it is not possible to have more information about the strength of small-scale turbulence.

At 15:23, the position of the lightning strike (red cross on Figure 4) was consistent with that of the plane.
