Accident to the MAGNI M24 PLUS identified 49ABZ

on 31 August 2020

at Saumur - Saint-Florent (Maine-et-Loire)

Loss of control in initial climb, collision with the ground, fire

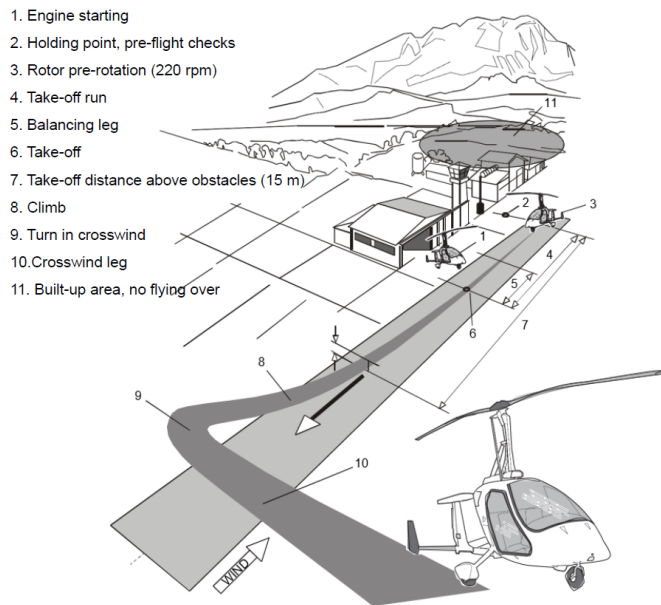
Figure 3: Take-off of a Magni M24 Plus

The Magni M24 Plus Flight Manual breaks the take-off down into 11 phases (see [Figure 3](#)).
