Accident to the ROBIN - DR400 - 140B registered F-GSBS

on 12 September 2020

at Col du Pas de la Coche, Belledonne Massif (Isère)

Transition to the backside of the power curve, collision with the terrain, post-impact fire, during a mountain BIA flight

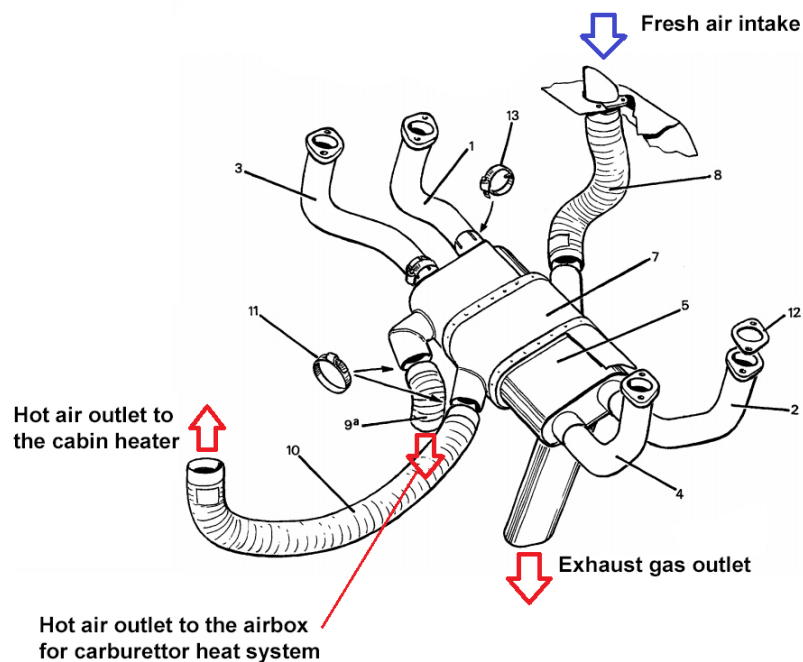
Figure 3: View of the crack

A detailed examination of the aeroplane's exhaust system revealed a crack in the exhaust outlet pipe, in line with its connection with the exhaust muffler (see Figures 2 and 3).

The metallographic examinations and chemical analysis of the area around the crack showed the initiation of a corrosion phenomenon which had then progressively developed during use of the exhaust pipe. This phenomenon most likely led to an incipient crack which then grew. It was not possible to determine when this crack appeared or its dimensions prior to the impact.

The opening resulting from this crack may have caused exhaust gases to leak into the aeroplane's engine compartment during the flight, possibly leading to a higher-than-normal carbon monoxide (CO) level.
