Accident to the ROBIN - DR400 – 160 registered F-GKQG and the ROBIN – DR400 – 120 registered F-GXJR on 05 June 2021 at Loudun (Vienne)

Loss of control during take-off, collision with an aeroplane parked in the parking area

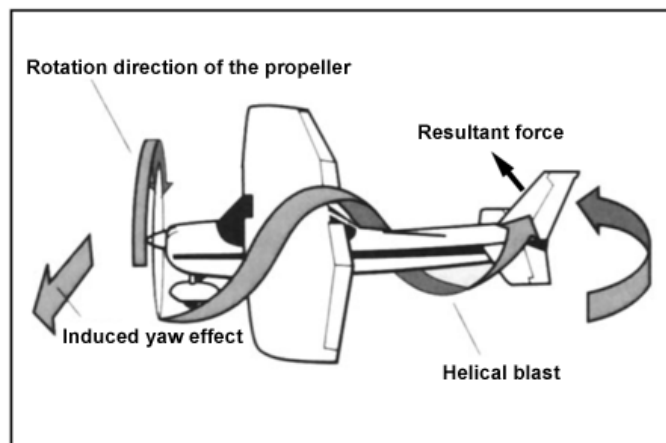
Figure 5: Representation of the helical blast

At take-off, the helical blast (airflow created by the propeller), which wraps around the structure, creates an asymmetric airflow on the tail fin. Changing the tail fin's angle of incidence causes a lateral resultant force. Since the DR400-160 propeller turns clockwise⁽³⁾, this force causes a left rotation around the yaw axis.

This phenomenon is heightened when the flaps are in the fully extended position during take-off, as the lift increase leads to a decrease in rotation speed at take-off. At low speed and high engine speed, the airflow is more lateral on the tail fin, and the yaw effect is stronger.
