## Accident to the LA MOUETTE - ORYX (P) identified 31RS

on 29 July 2021

at Fousseret (Haute-Garonne)

### Loss of control after take-off, collision with the ground

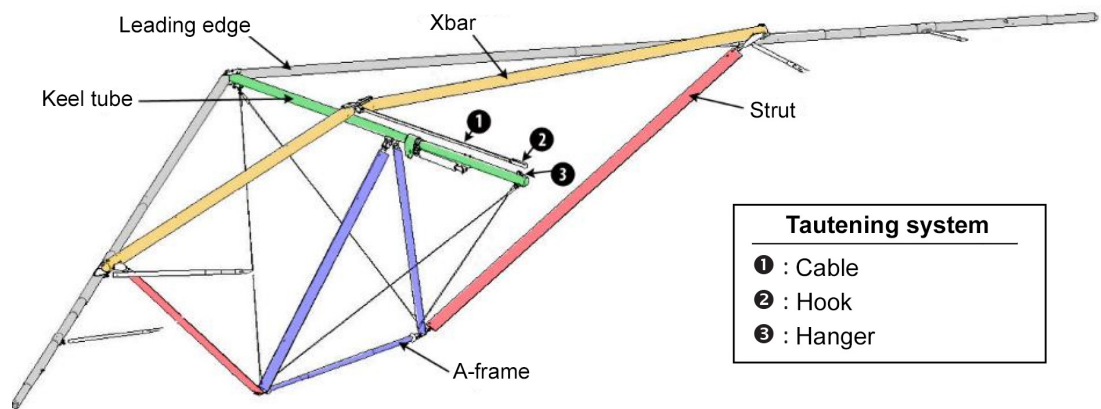
Figure 1: Diagram of the wing structure

The Xbar is held in the “open wing” position using a tautening system (see Figure 1). When this tautening system is not in position, the wing can fold freely. The manufacturer’s documentation shows how to unfold and make the wing taut before installing it on the trike.

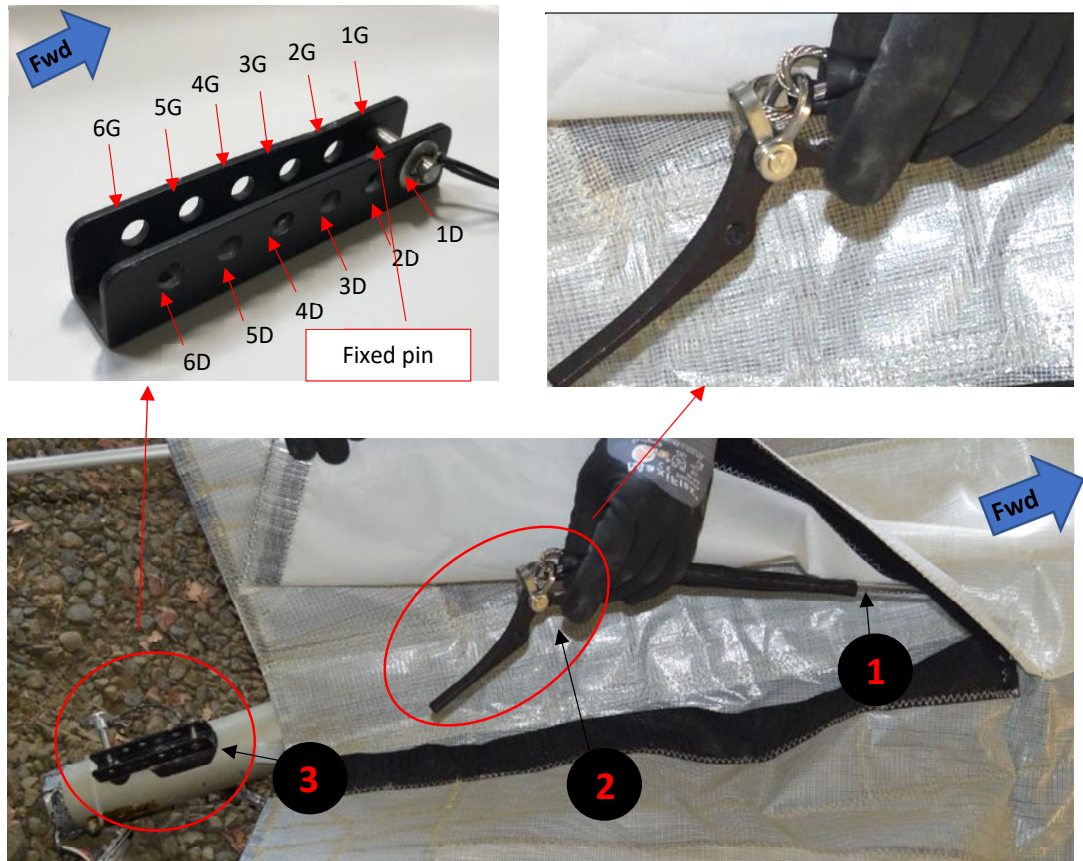
Figure 2: Tautening system

The tautening system is composed of a metal cable ①, which is attached to the Xbar and is equipped with a metal hook ② at its other end. The cable is attached to the hook with a shackle (see Figure 2). A hanger ③ made of a U-shaped metal part is attached to the rear of the keel tube (see Figure 2). This hanger has a series of drill-holes equally spaced along its length.

The Xbar was not taut. The hook was not in place in the rear hanger. The tautening system components were not damaged. The ball pin securing the hook in the hanger was partially inserted in drill-hole 6R (see [Figure 2](#)). This position does not hold the tautening system in place.

A few days before the accident, the pilot performed a maintenance operation to replace a batten on the right wing. To do this, he handled the rear tautening system of the wing. It is likely that he did not remove the wing from the trike. After replacing the batten, when he tautened the wing, he did not put the hook and the ball pin back into position.

During the first flight following this operation, with the rear tautening system device not in position, the pilot took off in 31RS and rose to a height of 45 m. The force of the air on the leading edges of the wing caused it to partially fold. The trike swung then the microlight descended rapidly. The pilot tried to push on the control bar but was unable to control the descent. The microlight struck the ground.
