**Unavailability of transponder, unavailability of ACAS,  
difficulties with, or loss of radiocommunication and  
datalink, degraded approach and landing capabilities,  
dangerous loss of separation**

SERIOUS INCIDENT	INCIDENT	SERIOUS INCIDENT
AIRBUS A320-251N registered EI-NSF	AIRBUS A321-252NX registered PH-YHA	AIRBUS A321-252NX registered PH-YHC
Aer Lingus Teoranta	Transavia Airlines C.V.	Transavia Airlines C.V.
Passenger commercial air transport		
20 September 2024 around 07:30 <sup>1</sup>	13 January 2025 around 21:20	29 April 2025 around 10:30
en route

*Note: this interim report is solely based on information known to the BEA at this stage of the investigations. It does not prejudge the conclusions that the BEA may draw in the final reports relating to these three investigations.*

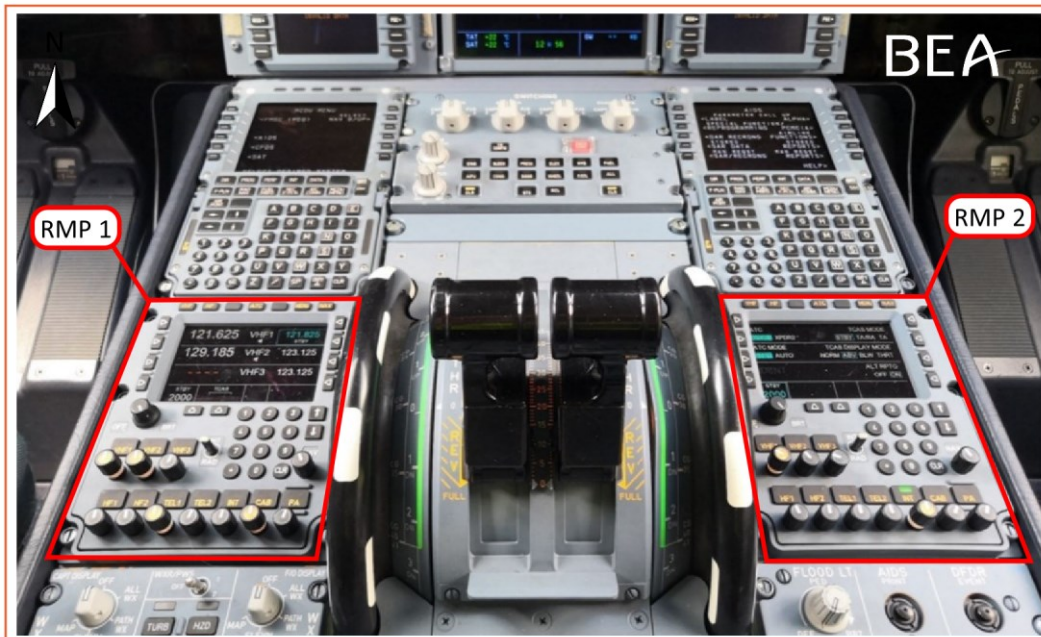
Figure 4: DRAIMS RMP (source: Airbus, annotations BEA)

Due to a lack of robustness in one of the AMU components to Ethernet micro-cuts, the AMU may switch to degraded mode, leading to erratic processing of the Ethernet data flow between the RMPs and the AMU.

The erratic nature of the failure makes it impossible to predict, with certainty, its operational consequences on the functions controlled by the DRAIMS. Nevertheless, the following consequences have been observed during the incidents and during simulator or test bench tests carried out during the investigation at the manufacturer's:

- On operation of RMP 1 and 2:
  - o different information displayed on the two RMPs (for example, radio frequencies, ACAS mode, transponder code);
  - o alternating different displays (normal display, blank screen, **VHF PAGE NOT AVAILABLE** or **RMP NOT AVAILABLE** messages).
- On communications and aural alerts:
  - o degraded audio quality of the crew microphone (robotic voice, crackling);
  - o impossible to change VHF frequency;
  - o display of a selected VHF frequency that is different from the active VHF frequency;
  - o loss of the radiocommunication capability, intercom and aural warnings via RMP 1

A modification to the AMU software has been developed by the manufacturer (Thales) for the A320neo family and certified by EASA. This modification prevents the failure described above from having consequences on the DRAIMS and its peripheral systems. This new version of the software includes:

- internal monitoring of the component that causes the failure;
- an automatic restart mechanism for this component as soon as the failure is detected;
- additional checks performed by the AMU to prevent corrupted messages from being sent to interfaced systems.
