**Accident** to the PILATUS PC-6/B2-H4  
registered **D-FIPS**  
on Sunday 28 June 2026  
at Tomblaine

| This is a courtesy translation by the BEA of the preliminary report on the safety investigation. As accurate as the translation may be, the original text in French is the work of reference. | |

**Loss of control just after take-off, collision with ground,  
during a parachute dropping flight**

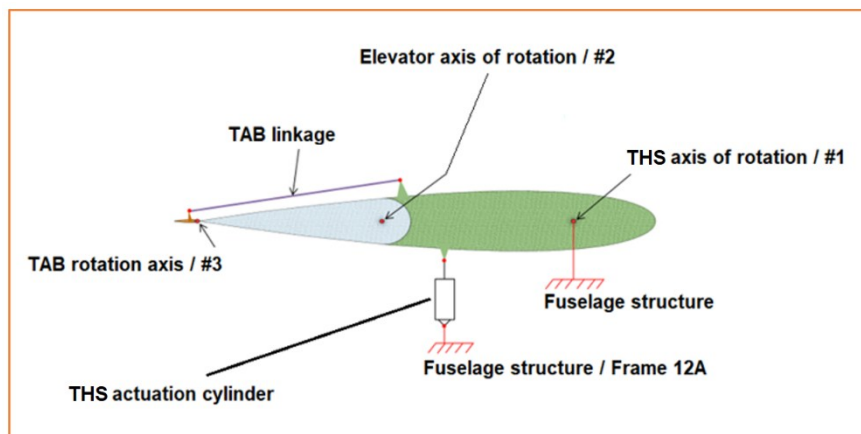
Figure 5: diagram of elevator control system (source: BEA)

The electrical actuator controlling the THS was nominally installed on the aeroplane structure (lower attachment of actuator) and on the THS (upper attachment of actuator). No anomaly was observed during its disassembly. An X-ray radioscopic examination was also carried out which did not reveal any particularity. The actuator is operated by an irreversible screw-nut system. The position in which the actuator was found on the wreckage is therefore representative of its position during the collision with the ground. The measurement of this position indicates that the THS was in a position consistent with the manufacturer's recommendations for take-off.
