Accident to the CESSNA TR182 (RG)
registered **D-ELXC**
on Friday 19 July 2024
close to Vichy - Charmeil aerodrome

**Collision with vegetation during an off-field
emergency landing**

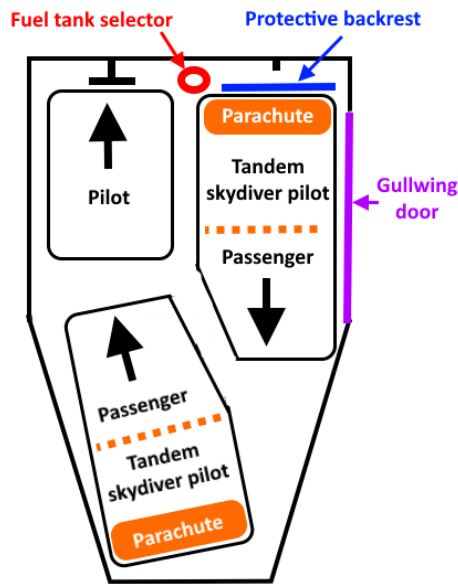
Figure 3: position of tandem skydivers in the aeroplane (source: BEA)

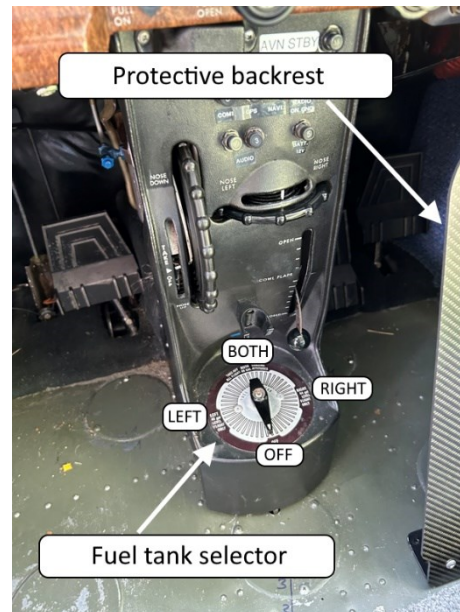
The aeroplane had been modified for skydiving with a gullwing door on the right-hand side. It can carry up to four passengers in addition to the pilot. The seat to the right-hand side of the pilot had been removed, as well as the control wheel; a guard had been added to the end of the control wheel shaft. A rigid protective backrest had been added for a skydiver to lean against, and which also ensured sufficient space with respect to the line of operation of the flight controls and their full stroke.

Figure 4: layout inside the airframe (source: BEA)
