Serious incident

to the Boeing 737- 809
registered **EC-NGC** operated by Albastar
and to the Embraer 190
registered **F-HBLD** operated by HOP!
on 21 July 2023
in cruise close to Limoges VOR/DME

Undetected in-flight transponder failure, following of a conflicting flight path in RVSM airspace without radar contact

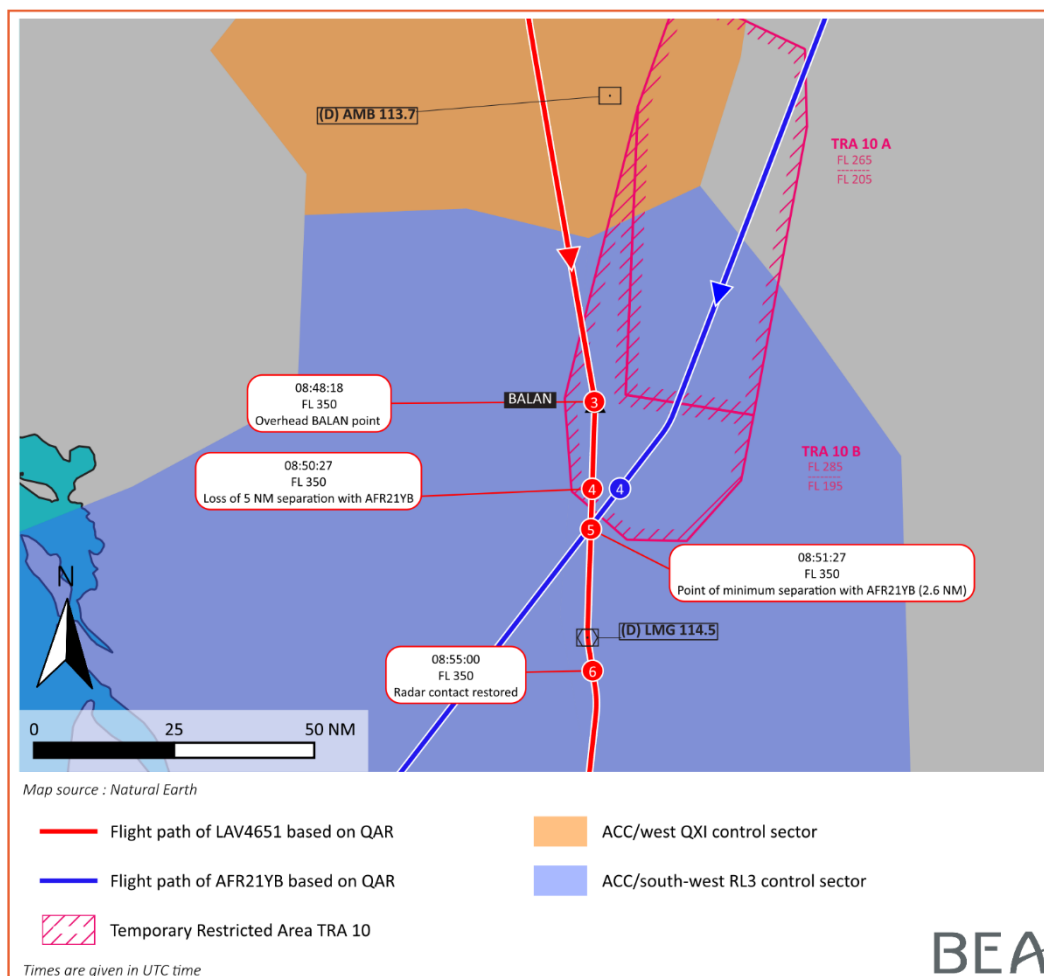
Figure 6: flight paths of LAV4651 and AFR21YB

At 08:48:18, the crew of flight LAV4651 passed overhead the BALAN point (see **Figure 6**, point **3**) and, in accordance with their flight plan, continued their route to LMG located 42 NM to the south. The crew did not contact the PCR of the QXI sector over the radio to report that they had passed BALAN.

A few seconds later, and for around 45 s, the QXI sector and RL3 sector controllers along with the Cinq-Mars-La-Pile CDC controllers coordinated together to determine the precise position of flight LAV4651. From 08:52:21 onwards, the QXI sector controller in ACC/west tried to contact the crew of flight LAV4651 on the sector frequency. At 08:52:23, the crew of flight AFR21YB contacted the RL3 sector PCR in ACC/south-west and informed him that there was an aeroplane at around 3 NM on their right-hand side, at the same flight level, and that it was not displayed on their ACAS system.

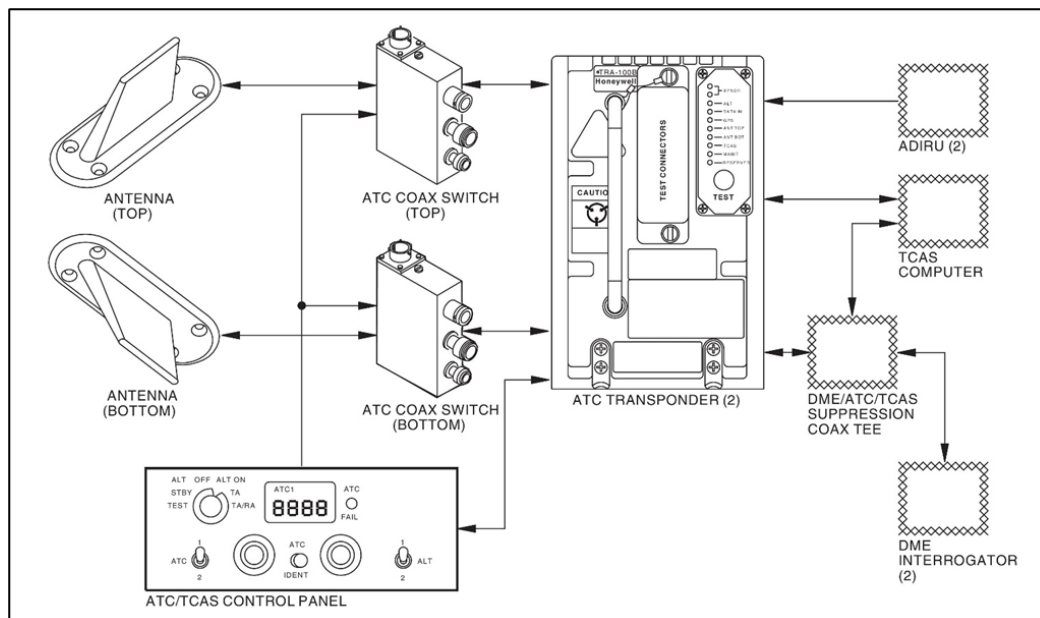
Figure 8: schematic diagram of ATC system (Source: Boeing)

An amber **ATC FAIL** light lights up if there is a failure on the selected transponder. The antennas situated on the top and bottom of the fuselage are used for transmitting and receiving messages exchanged with the transponder selected by the crew, via coaxial selectors (see Figure 8).

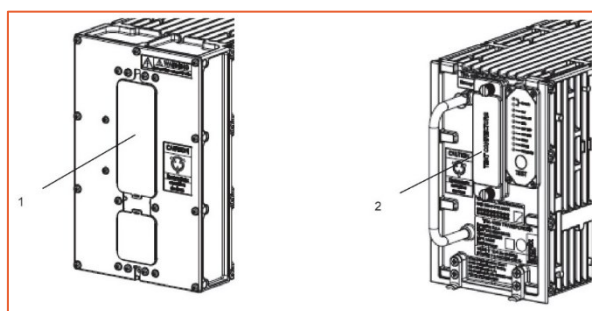
Figure 10: TRA-100B transponder connectors (Source: Honeywell)

An ARINC 429 bus¹² enables the transponder to exchange information via its main connector with the TCAS in particular. Two main connector pins each transmit a discrete parameter indicating a failure of the transponder to the ATC control panel, to illuminate the **ATC FAIL** light.

In 2022, Honeywell was informed of TRA-100B transponder malfunctions, with respect to the +50 VDC power supply circuit, with the same failure messages as those identified during the examinations of EC-NGC transponder 2. At the end of June 2023, 44% of transponders sent back to Honeywell were returned due to a transistor problem, while 34% were due to other causes and 22% had no identified fault.

Honeywell's analysis concluded that these malfunctions were due to an operating fault on a transistor in the conditions of use of the transponder. The analysis also revealed that the design margins relating to transistor heat dissipation requirements were insufficient.

Based on this analysis, Honeywell developed a technical solution that was the subject of a Service Bulletin¹⁴ issued on 23 August 2023. One of the main modifications was the replacement of some components on the DC power supply sub-assembly. Since this date, Honeywell has not received any new reports of malfunctions with respect to the power supply of transponders.

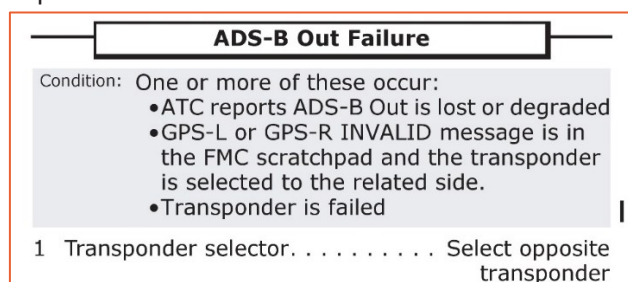
Figure 12: ADS-B Out Failure – Boeing 737 FCOM QRH procedure (Source: Boeing)

The failure of a transponder is only mentioned in the “**ADS-B Out Failure**” abnormal procedure (see **Figure 12**) in the FCOM, in the event of an ADS-B malfunction. The procedure asks the crew to select the second transponder.

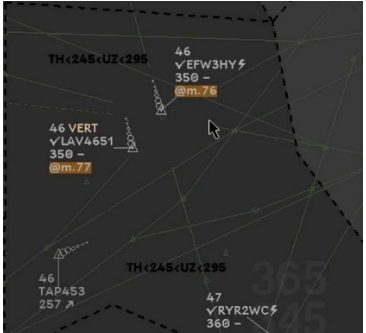
<p>This window and the symbol remained displayed for 4 min and 20 s before disappearing with no inputs from the PCR or the PCO.</p>
08:30:47	PCR and PCO QXI	<p>VERT message appeared on the LAV4651 label.</p>

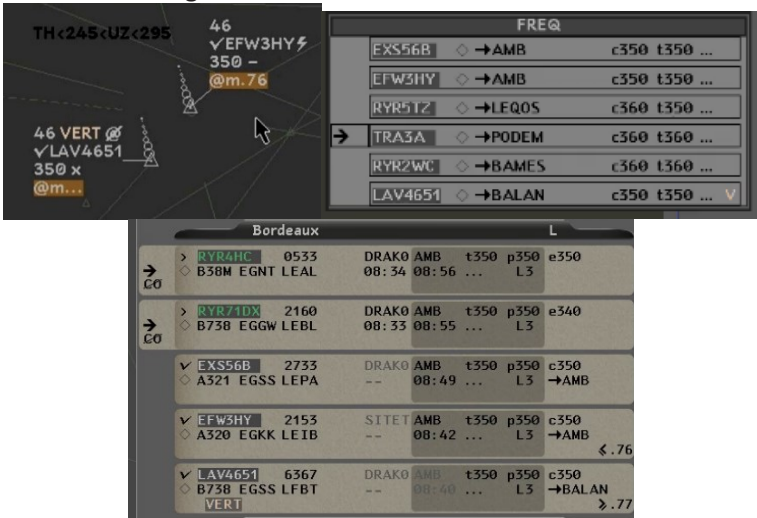
08:30:48	PCR and PCO QXI	<p>Loss of downlink parameters and the trend bar on the LAV4651 label.</p> <ul style="list-style-type: none"> ▪ VERT message displayed on the label ▪ @ symbol crossed out on the label ▪ V message in the FREQ box ▪ VERT message on the DYP

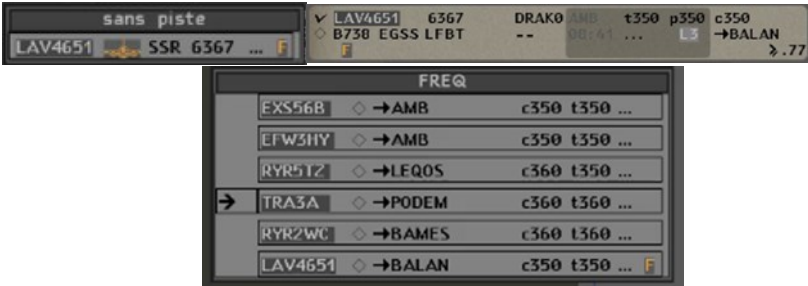
08:30:59	PCR and PCO QXI	<p>The F message replaced V in the FREQ and “Flights with no track” windows as well as on the DYP for flight LAV4651.</p>

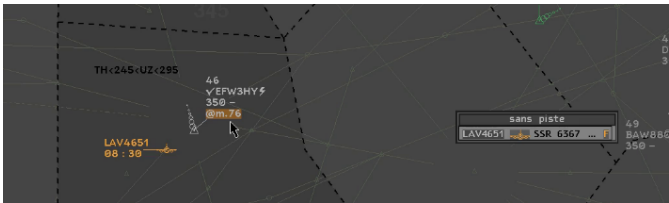
08:31:21	PCR QXI	<p>Input on the mouse that had not been moved since 08:27:04.</p>

<p><i>Position of the mouse in relation to the label for LAV4651 at the time of the PCR's input</i></p>
08:33:19	PCR QXI	Movement to the right of the "Flights with no track" window screen.
08:33:48	PCR QXI	<p>Track marker deleted by right-clicking on the mouse.</p> <p>Flight LAV4651 remained displayed in the FREQ window and the F alert was associated with it.</p>

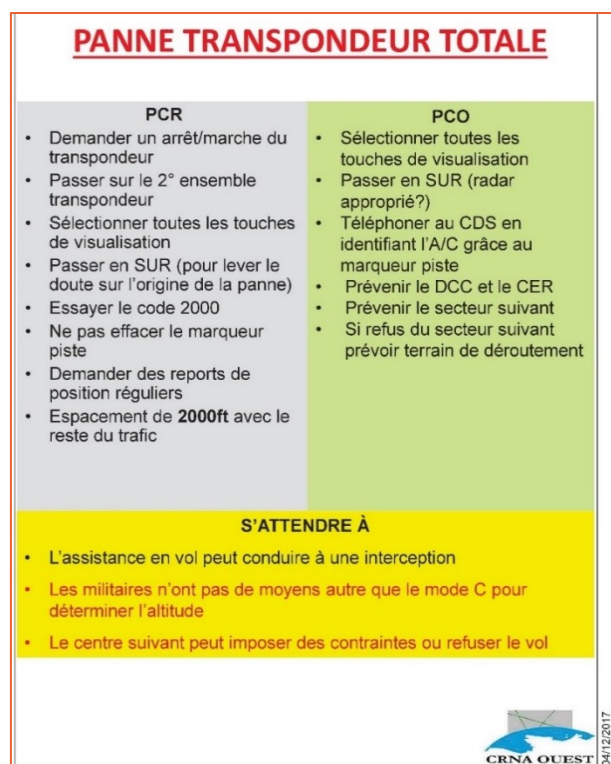
Figure 26: ACC/west checklist for complete transponder failure (Source: ACC/west)

In the event of transponder failure, the document specifies referring to the associated procedure, which states not to delete the track marker (see **Figure 26**).

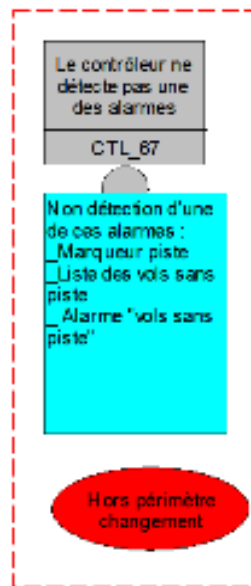
It is specified (see **Figure 30**) that the causes of the lack of detection of track markers and of the list of flights with no track were not impacted by the changes resulting from the implementation of the ERATO electronic environment, insofar as these track markers already existed with the previous functional system, in a paper environment.

Figure 30: non-detection of warnings outside of the scope of change
(Source: DSNA)

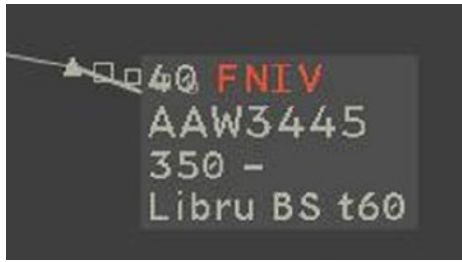
- a. Static display of a word in an orange-red colour in the label associated with the aircraft, generally used to signify low-urgency alerts (see **Figure 34**). This display corresponds to that of alerts characteristic of radar track ageing.

Figure 34: static display

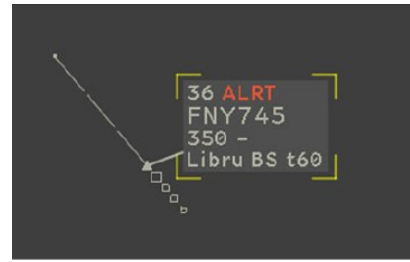
- b. Blinking display of a word in an orange-red colour in the label associated with the aircraft, used to signify higher urgency alerts.
- c. Animated display with four yellow chevrons placed around the label of the aircraft and static display of a word in an orange-red colour in the label (see **Figure 35**).

Figure 35: chevrons and static display

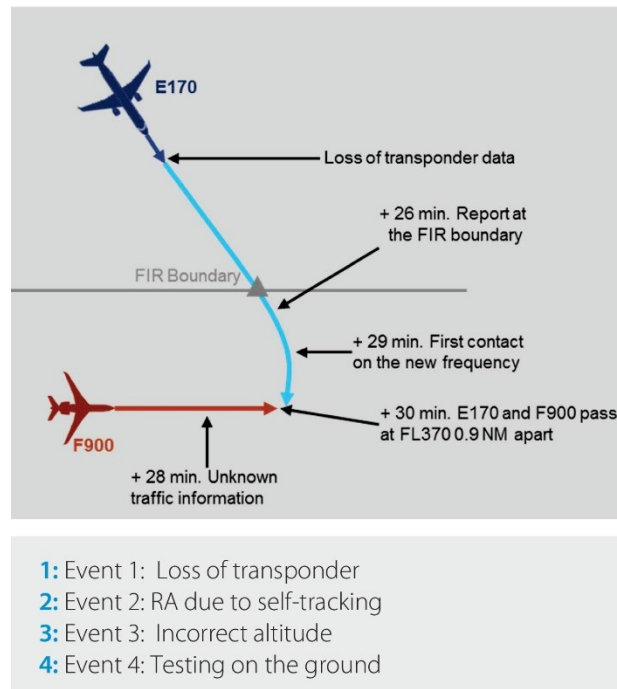
Figure 36: loss of separation in June 2015
