**Accident** to the MORANE SAULNIER MS733  
registered **F-AZXU**  
on Friday 6 June 2025  
near Rochefort - Charente-Maritime airport

**Unintentional start of spin, collision with ground,  
during an airshow**

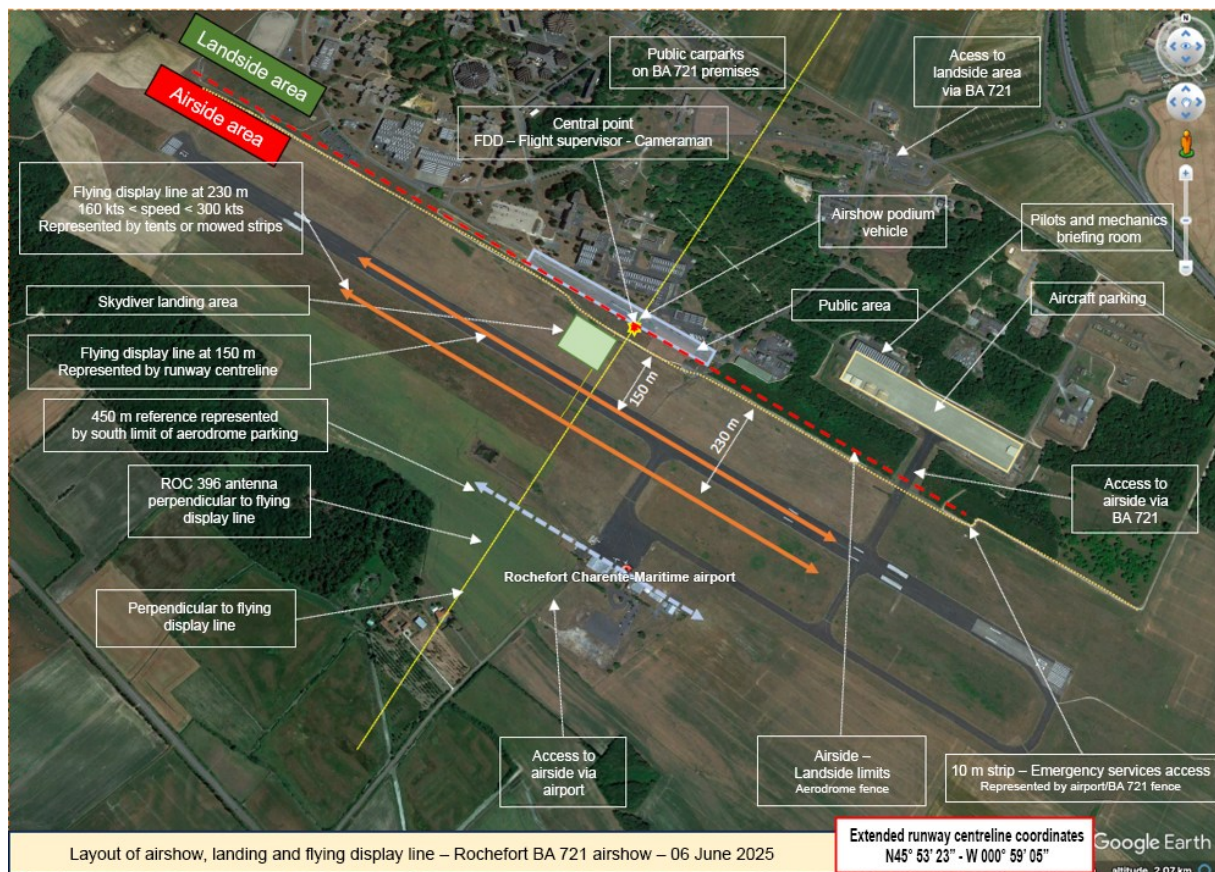
Figure 5: layout of airshow (source: air safety coordinator)

During the airshow, the ASC was situated at the central point (see **Figure 5**), level with the public and was in contact with the aircraft on a dedicated frequency with the call sign "DV". He used the AFIS as a relay for masked positions. Following the accident, he contacted the AFIS and the gendarmerie and had the airshow cancelled.
