Accident to the BELL 47G-2
registered **F-BIFN**
on Wednesday 12 July 2023
at Arles

Time	Around 10:05 ¹
Operator	GIRAGRI 17
Type of flight	Spraying
Persons on board	Pilot
Consequences and damage	Pilot severely injured, aircraft substantially damaged
This is a courtesy translation by the BEA of the Final Report on the Safety Investigation. As accurate as the translation may be, the original text in French is the work of reference.

Loss of yaw control during a spraying flight

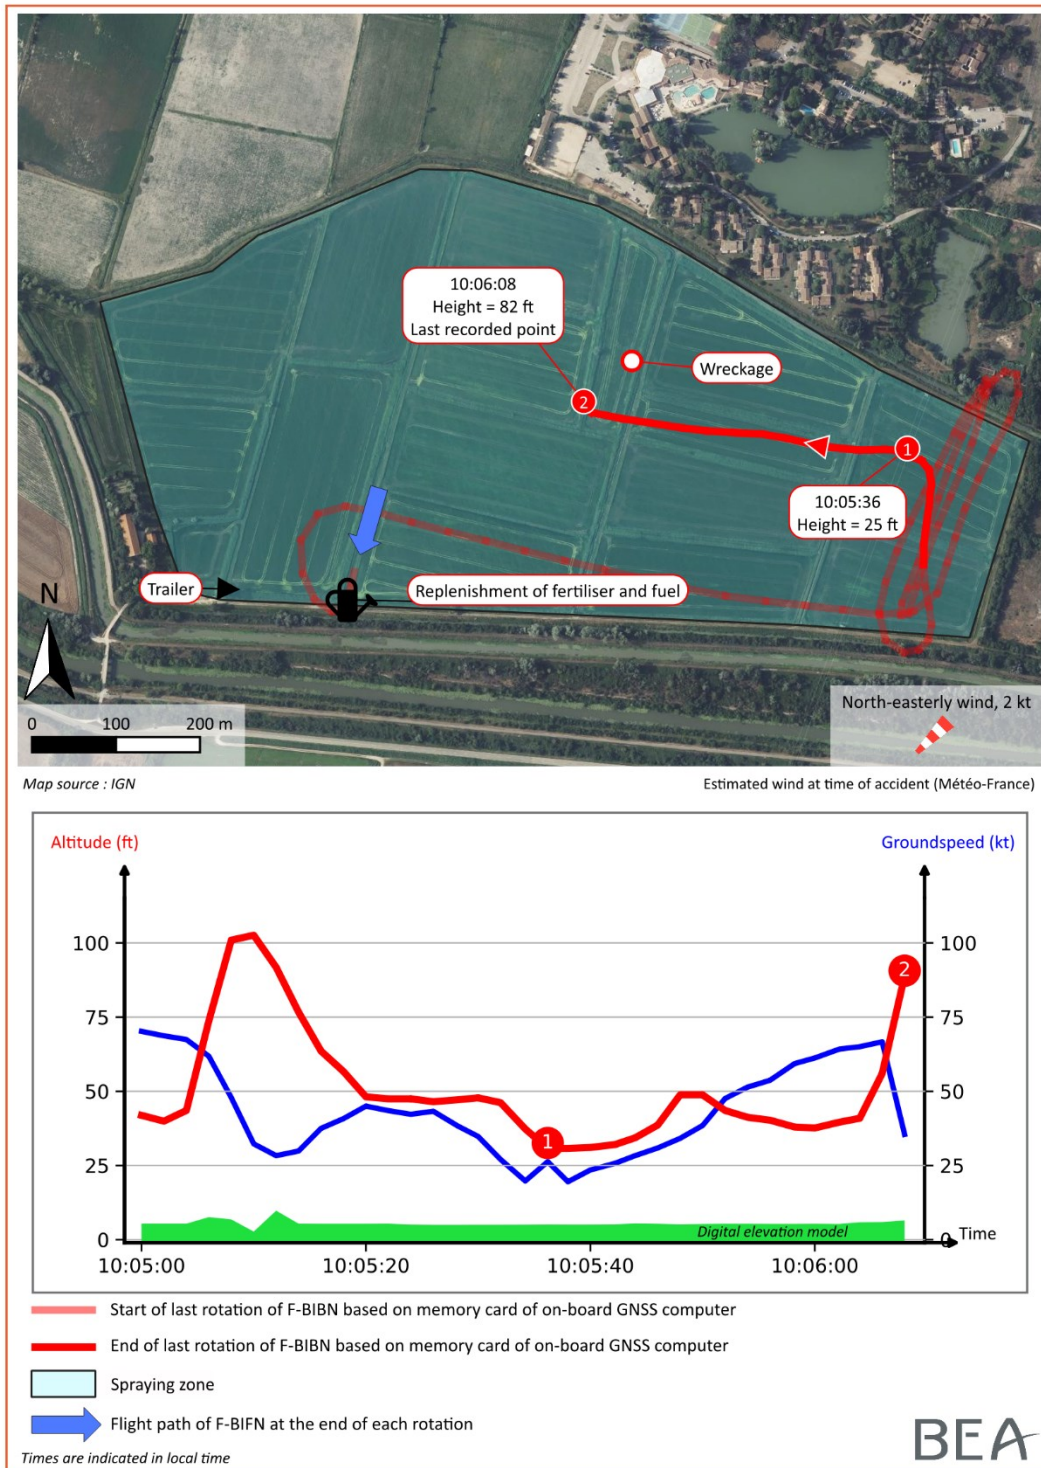
Figure 1: paths before the accident

At around 07:40, the pilot took off from the trailer to start fertiliser spraying operations by helicopter over an area of rice fields to the south of the town of Arles (see **Figure 1**). He was assisted by a staff member responsible for ground operations.

Between 08:00 and 09:40, he carried out 33 spraying rotations. At 09:53, after refuelling for 12 min, the pilot resumed the spraying operation, at the end of which he initiated a return leg to the fertiliser supply area. During this phase, the pilot lost yaw control of the helicopter, which started yawing to the left, fell some 20 m and ended up in the submerged part of a rice field.

Note: the end of the flight was not recorded in the memory card of the computer. This lack of data is probably linked to the setting of the GNSS computer, which recorded a point every two seconds, and to a recording failure of the computer at the time of the collision with the ground.

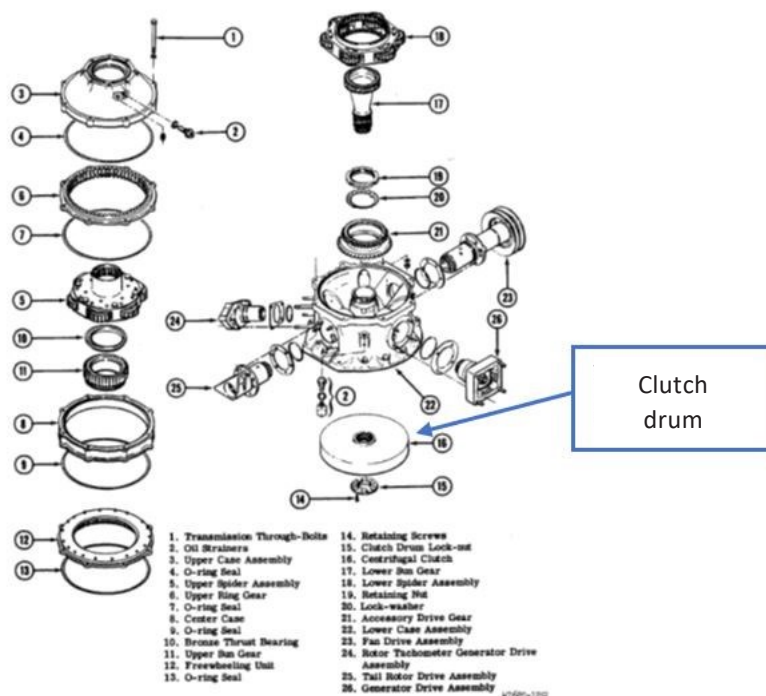
Figure 2: MGB and junction with the engine (main rotor drive)
(Source: manufacturer, Bell 47 Maintenance Manual)

A detailed examination of the main gearbox (MGB) did not find any particular anomaly. The free wheel had no damage. It was operational.

The clutch was visually examined. The thickness of the linings was greater than the minimum required². Significant discolouration, consistent with local heating, was observed at the bottom of the drum. It was not possible to determine whether this discolouration was normal. On the day of the accident, the clutch had logged 1,555 flight hours. The manufacturer prescribes an intermediate visual inspection of the clutch every 600 hours and an overhaul every 1,200 hours. The last overhaul was carried out on 15 December 2021. Since then, the helicopter had logged 306 flight hours.
