**Accident** to the Jodel DR1050 Ambassadeur  
registered **F-BJOZ**  
on Saturday 5 July 2025  
close to Châteauroux – Villers aerodrome

**In-flight engine failure, return to departure aerodrome,  
loss of control during go-around<sup>2</sup>**

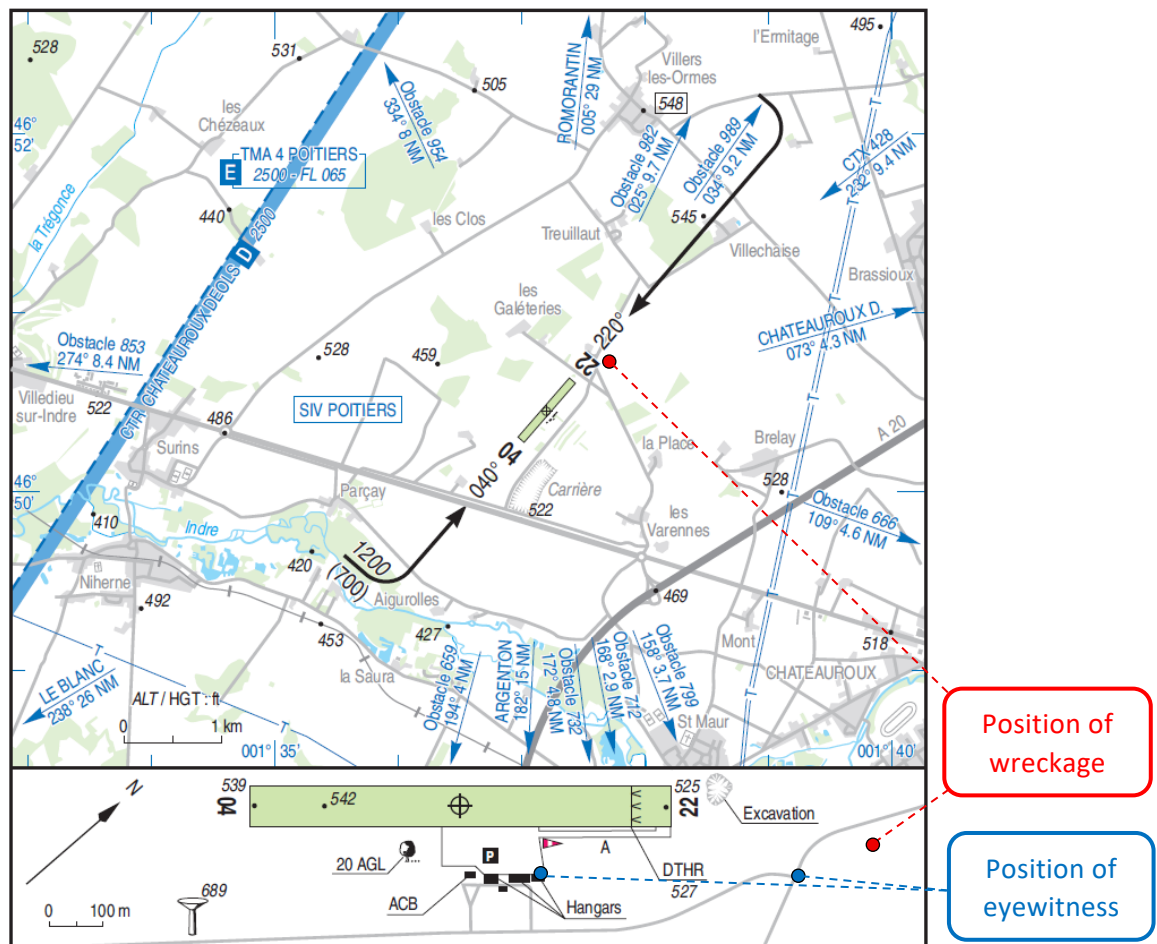
Figure 2: excerpt from Châteauroux - Villers aerodrome VAC chart  
(source: SIA, annotations BEA)

The pilot flew over the aerodrome, carried out a U-turn in the south (point ⑦) and then joined the final for runway 04. According to two eyewitnesses on the ground (see **Figure 2**), the aeroplane was travelling fast when it flew over the runway. At a height of a few metres, the pilot initiated a go-around and passed in front of the first of the two eyewitnesses situated close to the hangars. The latter estimated that full power was not reached. At the end of the runway, the pilot opened up to the left, passed close to the second eyewitness situated on the road and then turned right in the direction of the runway.
