Accident to the Piper PA30
registered **F-BPIR**
on Monday 4 December 2023
at Villejuif

**Unpriming of fuel system, uncontrolled engine shutdown,
forced landing in urban area at night**

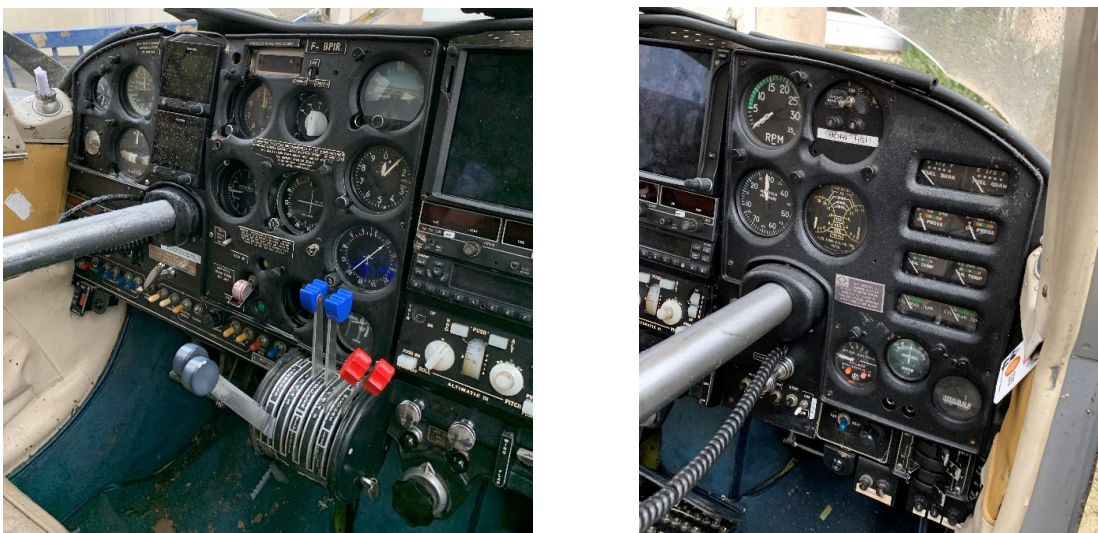
Figure 3: photos of instrument panel (source: BEA)

F-BPIR was equipped with EADI and EHSI systems with a digital display, conventional instruments with needles and an on-board GNSS system, a Garmin GTN 750 equipped with a fuel monitoring function¹⁰.

It can be seen that certain MAIN, AUX, TIP, OFF indications are missing. They were not damaged during the accident or during the examinations. It was found that this was also the case on the other two PA 30s in the ATO fleet.

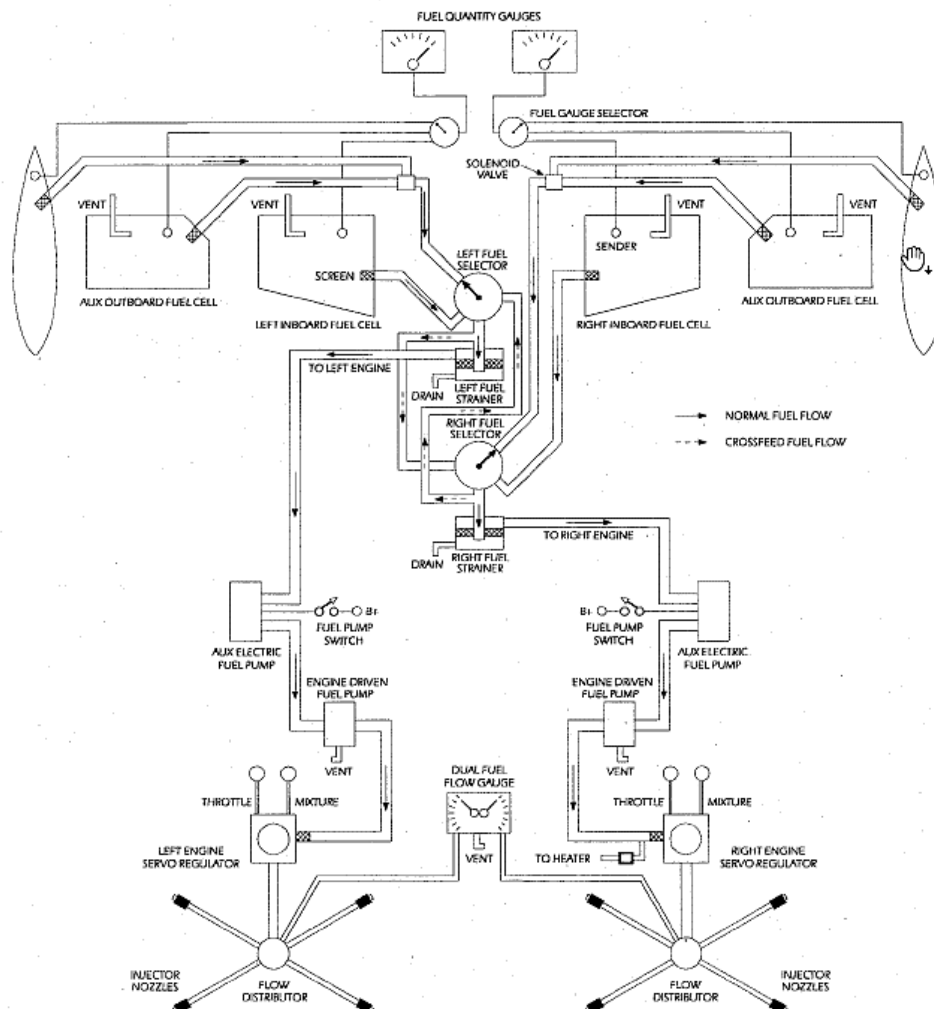
Figure 4: fuel system of PA30 (source: Piper Aircraft)

F-BPIR had six fuel tanks situated in the wings:

- two MAIN inboard fuel tanks each holding 30 US gallons¹¹ (27 US gal being usable);
- two AUX outboard fuel tanks each holding 15 US gal (15 US gal being usable);
- two TIP fuel tanks each holding 15 US gal (15 US gal being usable).

The examinations carried out on the fuel system found that all of the system was functional on the aeroplane. The fuel quantities found in each fuel tank and the statements from the first responders who had safetied the aeroplane were consistent with the fuel tank selectors being set to the AUX position before the accident.
