**Accident** to the Centair ASW 20 F  
registered **F-CFFF**  
on Saturday 3 June 2023  
at Bailleau-Armenonville

**Loss of pitch control during take-off, collision with ground,  
during a competition flight**

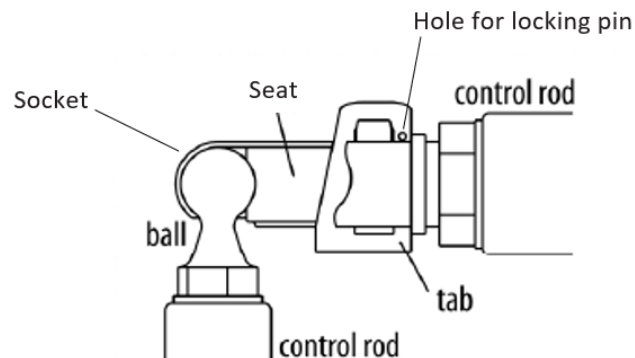
*Figure 3: schematic diagram of ball and socket connector  
(source: BEA, based on [EASA SIB 2019-07](#))*

To disconnect the elevator, the pilot must press the spring-loaded tab (downwards on **Figure 3**) and then remove the ball from the socket (by moving the socket upwards on **Figure 3**). The unlocking and disconnecting are therefore carried out in opposite directions. When the ball is in place, a locking pin can be positioned in the hole provided in the tab, preventing any untimely disconnection. The use of this pin is not required by the glider manufacturer. However, the civil aviation authorities in several countries have made it compulsory (see paragraph 2.5).

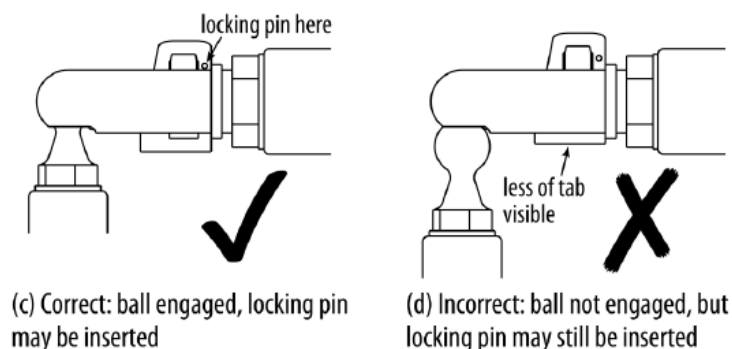
At least two people are needed to check the rigging of the elevator: one person must block the control surface, while the other person moves the stick in both directions. Without someone blocking the control surface, the incomplete rigging might not be detected by simply moving the stick (see paragraph 2.3.1). This method can also be used to detect if the socket and the ball are not connected whereas a simple visual check can be misleading, as the hole on the tab is visible in both the locked and unlocked positions.

Figure 6: possible positions of tab (locked position on LH side, unlocked position on RH side)
