**Accident** to the BELL 47G-2  
registered **F-GANY**  
on Tuesday 2 May 2023  
at Thouars-sur-Garonne

## **Fuel supply failure, forced landing**

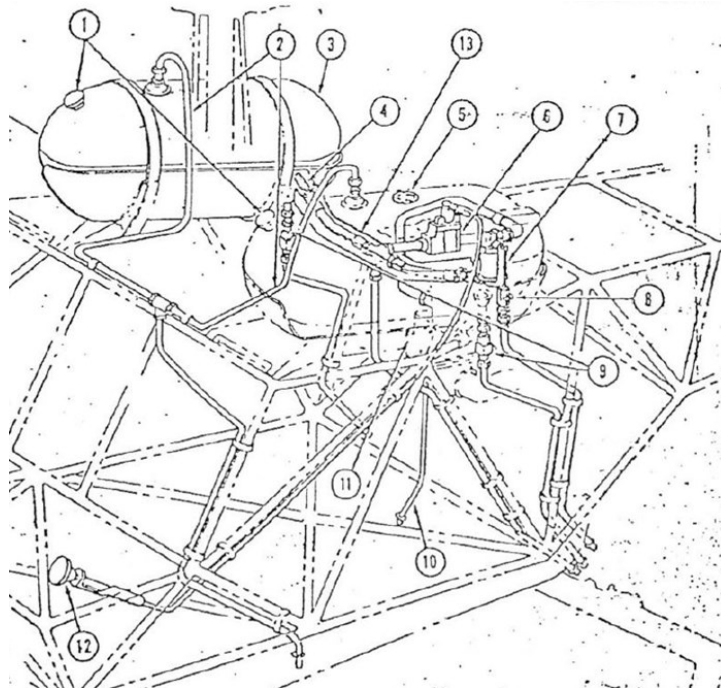
Figure 2: fuel system of Bell 47 (source: Bell 47G-2 flight manual, translation BEA)

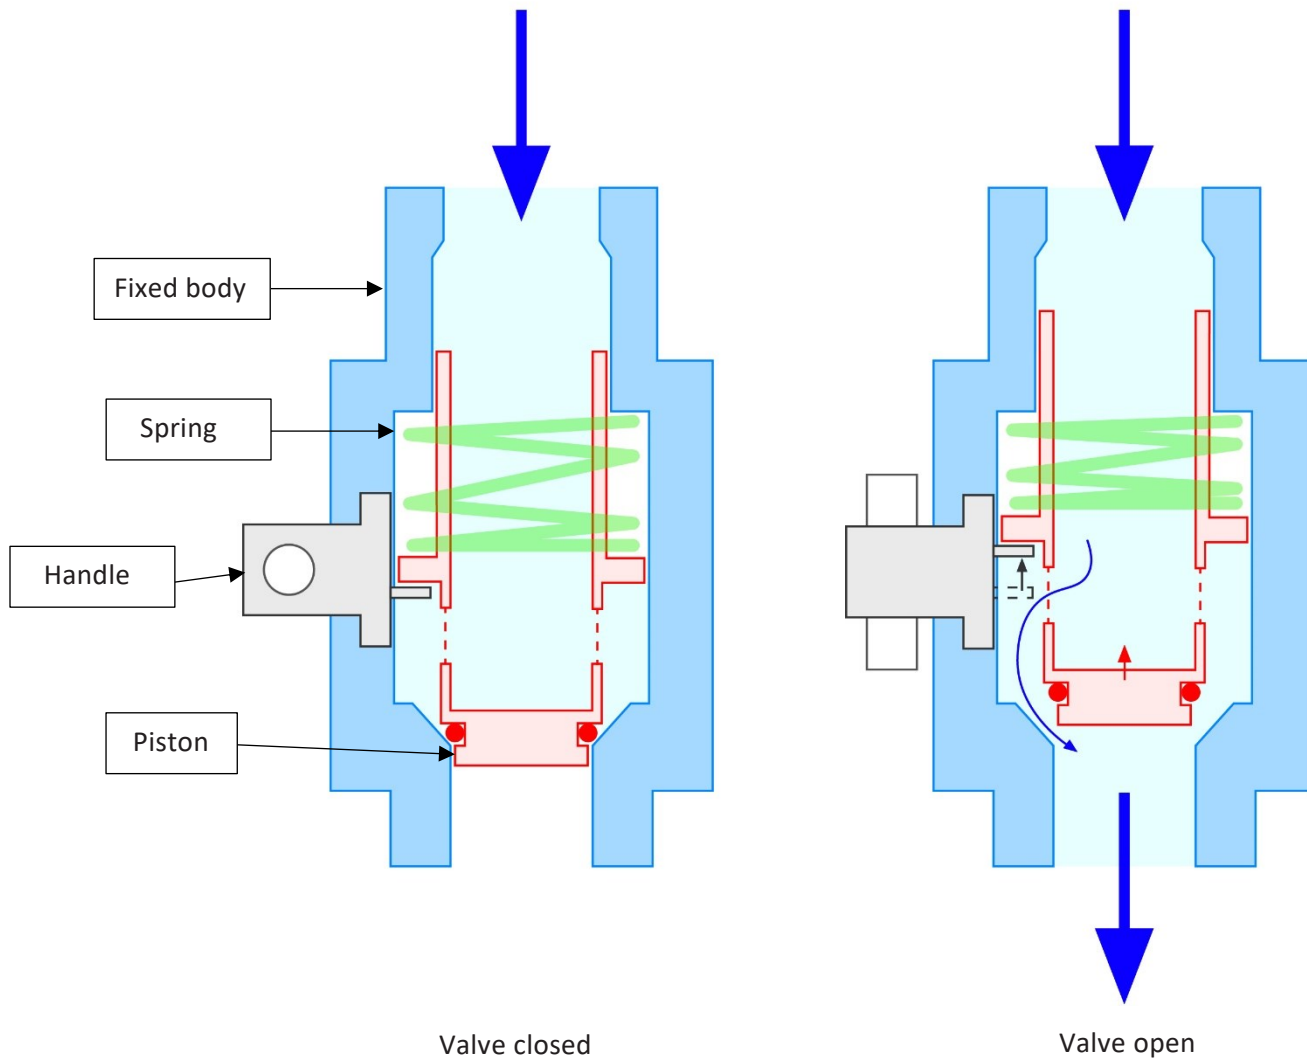
Figure 3: diagram showing operation of right-hand bleed valve (source: BEA)

In the closed position, the force applied by the spring combined with the weight of the fuel naturally holds the piston in contact with the fixed body, preventing any fuel flow.
