Accident to the ROBIN - DR400 - 120
registered **F-GBUY**
on 18 November 2022
at Couhé-Vérac

Collision with vegetation on final approach

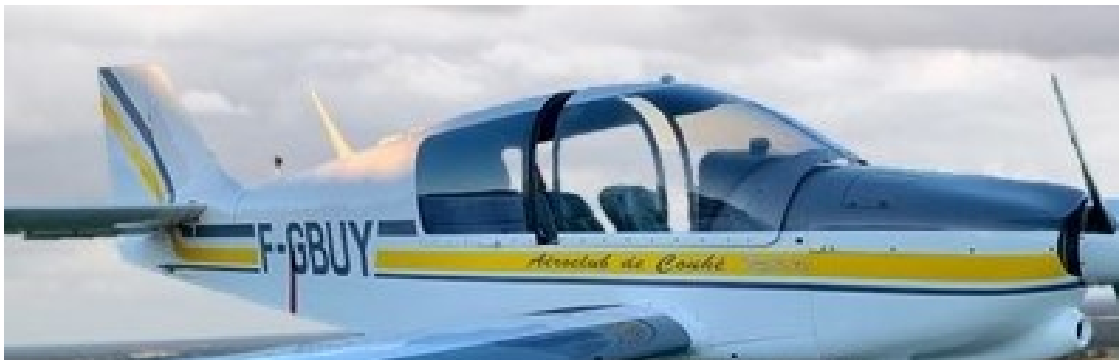
F-GBUY was a DR400-120, a four-seater aeroplane equipped with a Lycoming O-235-L2A engine delivering 118 hp. DR400s have a forward-sliding canopy and, like most light aircraft, do not have a windshield wiper system.

Figure 3: view of the canopy of F-GBUY (source: flying club)

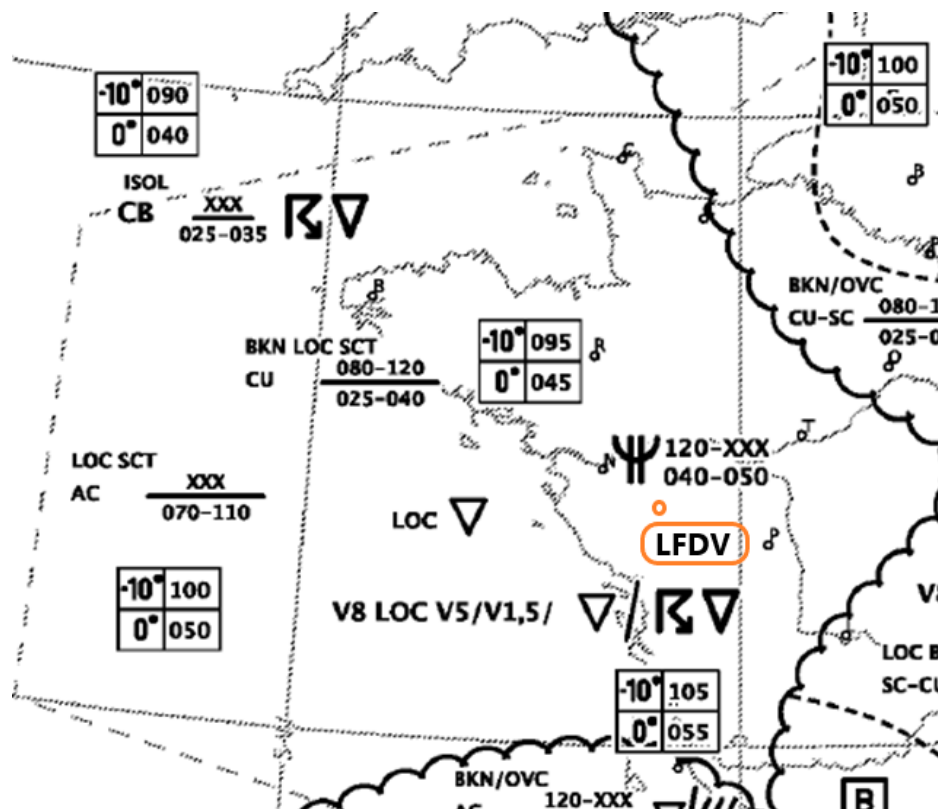
Figure 7: excerpt from the SIGWX chart for 18 November 2022 at 16:00
(source: Météo-France)
