Accident to the SOCATA - TB20
registered **F-GDNU**
on 22 May 2023
at Langogne-Lespéron

Time	Around 12:20 ¹
Operator	Private
Type of flight	Cross-country
Persons on board	Pilot and four passengers
Consequences and damage	Aeroplane substantially damaged

**Insufficient acceleration during take-off,
attempted take-off, runway overrun**

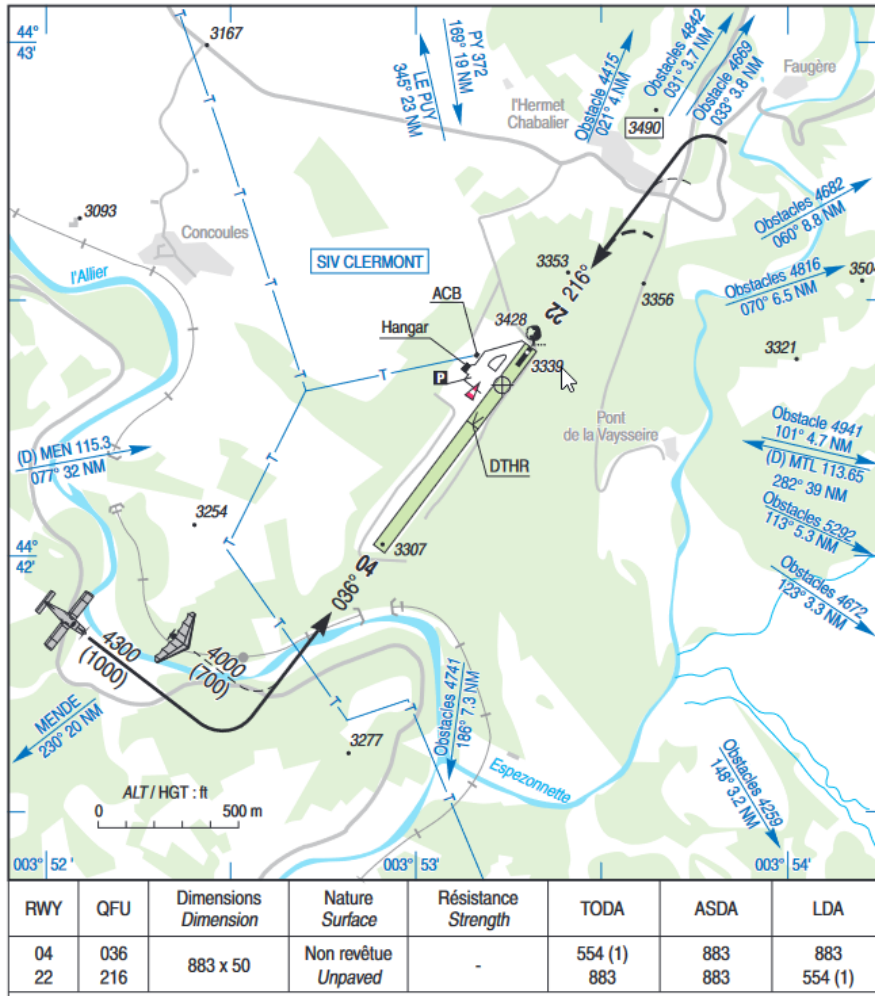
Figure 2: excerpt from Langogne-Lespéron aerodrome VAC chart (Source: AIS)

Langogne-Lespéron aerodrome is used on the A/A frequency. It is located at an altitude of 3,339 ft. The runway to be used by aeroplanes on take-off is unpaved runway 22. It has an average downward slope of 1.1 %, and the runway take-off distance available is 883 m. The last third of the runway has mainly a downward slope. The president of the aerodrome's flying club indicated that the runway is covered with sparse grass, which is more present and thicker on the second half of the runway.

The VAC chart indicates that Langogne-Lespéron aerodrome is restricted to based aeroplanes, pilots who hold a mountain flying rating or pilots who already carried out a reconnaissance of the strip with an instructor and used the aerodrome as pilot-in-command in the last 12 months.
