Accident to the ROBIN DR400-160
registered **F-GLKL**
on Tuesday 30 July 2024
at Buigny-Saint-Maclou

Time	Around 17:50 ¹
Operator	Aéroclub d'Abbeville - Buigny - Baie de Somme
Type of flight	Introductory flight
Persons on board	Pilot and three passengers
Consequences and damage	Aeroplane destroyed

**Staying on the backside of the power curve during
take-off, collision with ground, post-impact fire,
during an introductory flight**

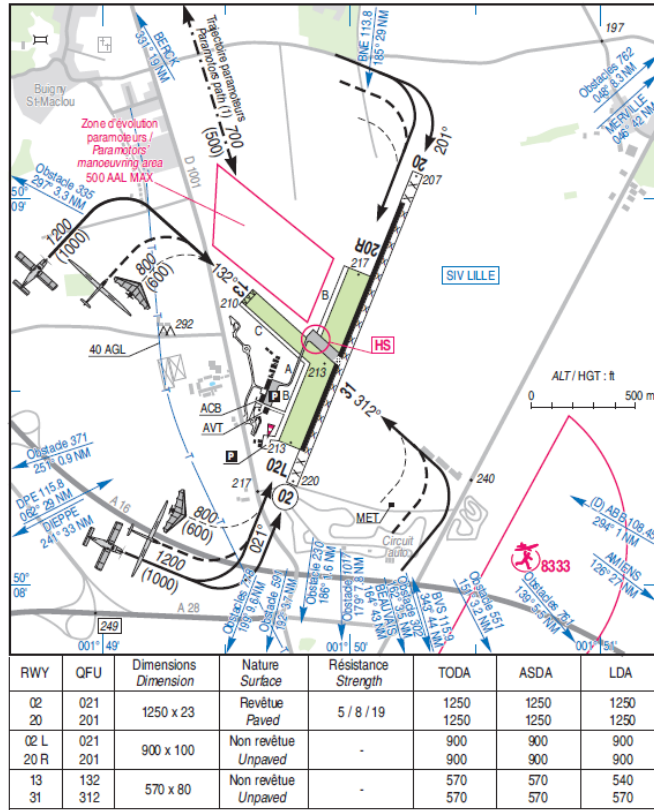
Figure 2: excerpt from Abbeville VAC in force the day of the accident (source: SIA)

Abbeville aerodrome situated at an altitude of 220 ft⁴ has three runways, two main runways 02/20 and a third runway 13/31.

Paved runway 02/20 was closed in 2022 after an area had sunk and then the unpaved runway 02/20 was also closed in December 2023. Furthermore, in order to repair the latter, runway 13/31 had been shortened by 20 m level with threshold 31, reducing the distance available to 550 m. The day of the accident, only runway 13/31 could be used and subject to the authorization of the operator⁵. The grass of the runway was short.
