Accident to the ROBIN - DR400 - 140B
registered **F-GMXY**
on Tuesday 15 August 2023
at Lavau-sur-Loire

Time	Around 11:45 ¹
Operator	Aéroclub Loudunais
Type of flight	Cross country
Persons on board	Pilot, two passengers
Consequences and damage	Pilot and passengers fatally injured, aeroplane destroyed
This is a courtesy translation by the BEA of the Final Report on the Safety Investigation. As accurate as the translation may be, the original text in French is the work of reference.

**Loss of external visual references, loss of control,
collision with surface of water**

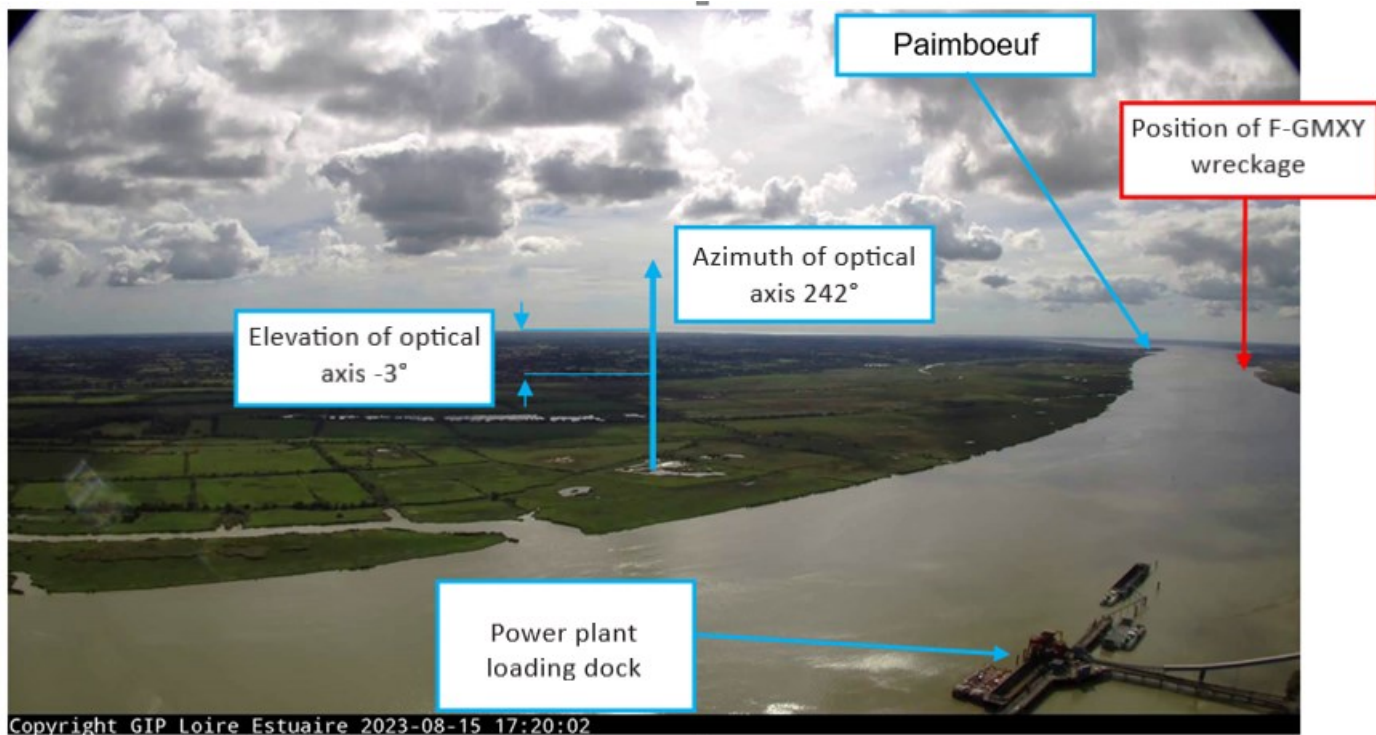
The camera was attached to the top of a chimney and was at an altitude of 735 ft. Its horizontal angle of view was around 90°. It was slightly tilted to the LH side by around 0.5°. Its optical axis was oriented 242° in azimuth and -3° in elevation, slightly below the horizon.

Figure 4: image from Cordemais power station taken around five hours after the occurrence
(Source: GIP Loire Estuaire, annotations BEA)

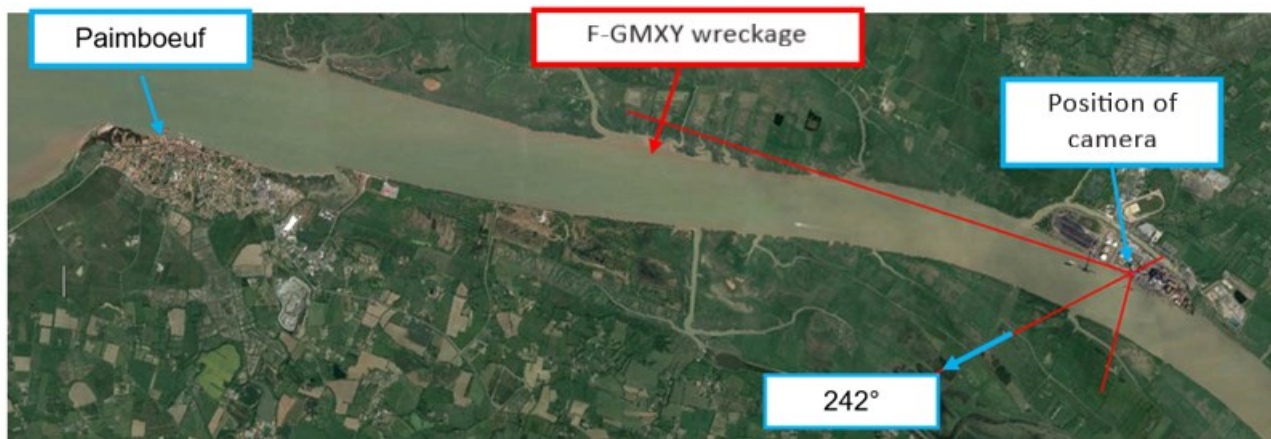
The camera was on the westernmost chimney of Cordemais power station, around six kilometres from where the wreckage was found.

Figure 5: position of camera in relation to accident site (Source: IGN, annotations BEA)
