Accident to the Issoire Aviation APM20 “Lionceau”
registered **F-GRPN**
on Wednesday 17 May 2023
at La Chapelle-la-Reine

Time	Around 18:30 ¹
Operator	Aéroclub Brocard
Type of flight	Cross country
Persons on board	Pilot
Consequences and damage	Pilot fatally injured, aeroplane destroyed
This is a courtesy translation by the BEA of the Final Report on the Safety Investigation. As accurate as the translation may be, the original text in French is the work of reference.

Collision with ground

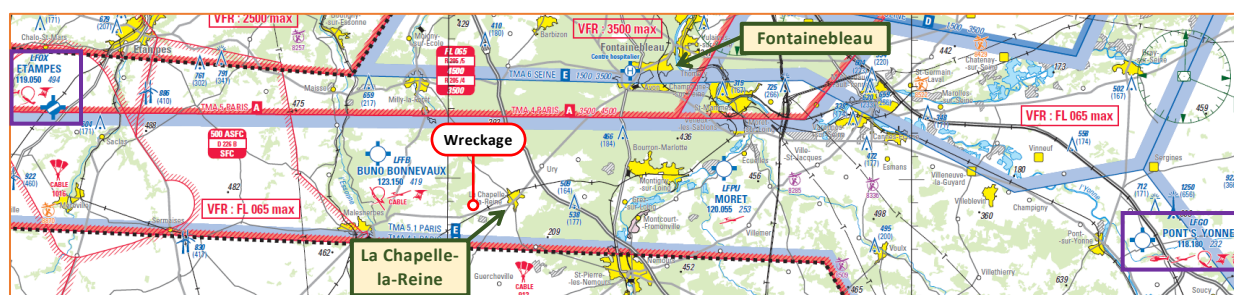
Figure 1: position of wreckage (annotated excerpt of Paris region SIA chart 1/250,000)

The aeroplane wreckage was found during the night, at around 02:40, by the search services, in a quarry west of La Chapelle-la-Reine.
