**Accident** to the BOEING - 737- 800  
registered **F-GZHA**  
on 1 October 2022  
on Nantes - Atlantique airport

This is a courtesy translation by the BEA of the Final Report on the Safety Investigation. As accurate as the translation may be, the original text in French is the work of reference.

**Late flare, hard bounced landing, in instruction**

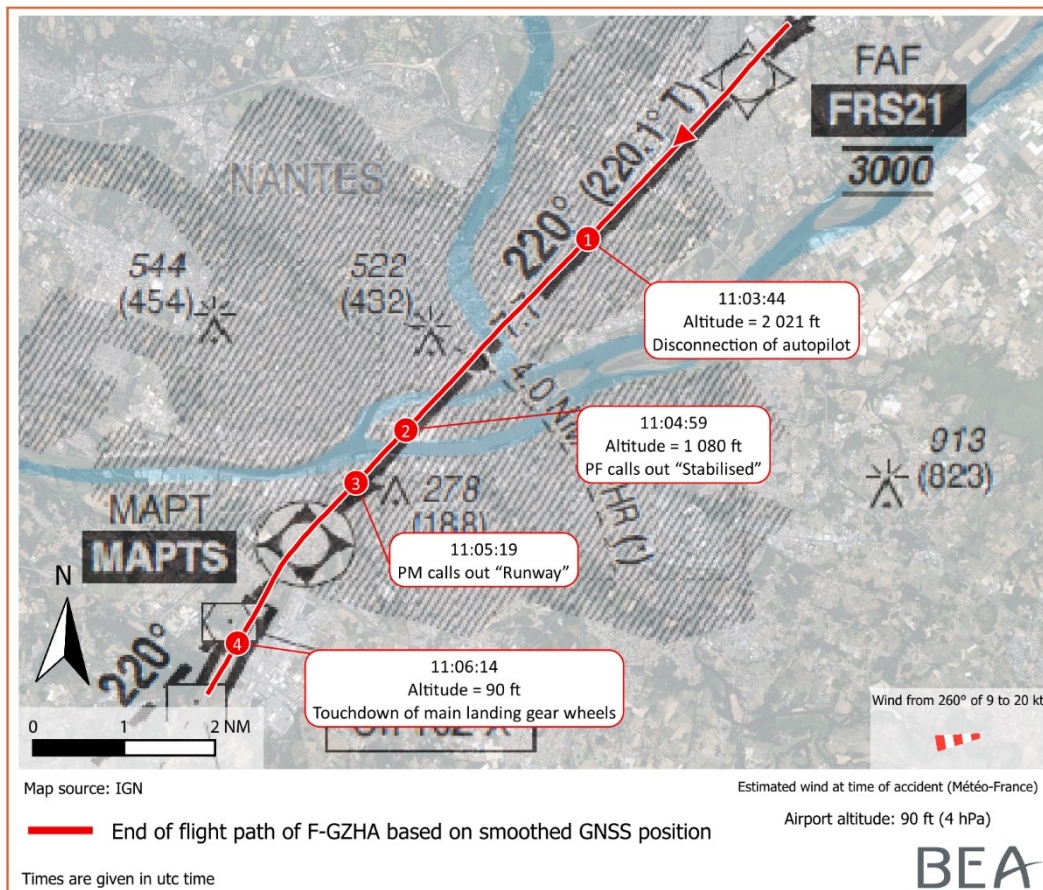
At 11:03:21, thirteen seconds after the radio altimeter 2,500 ft callout, the co-pilot informed the instructor that he would be flying the aeroplane manually from 2,000 ft, as on the previous day's flight, "for training purposes" following the period he had spent without flying. Approximately twenty-five seconds later, the co-pilot disconnected the autopilot and then the autothrottle and continued the flight in manual mode, in descent along a 220 heading as specified in the approach procedure (see Figure 1).

Figure 1: path of F-GZHA during the approach (source: BEA)

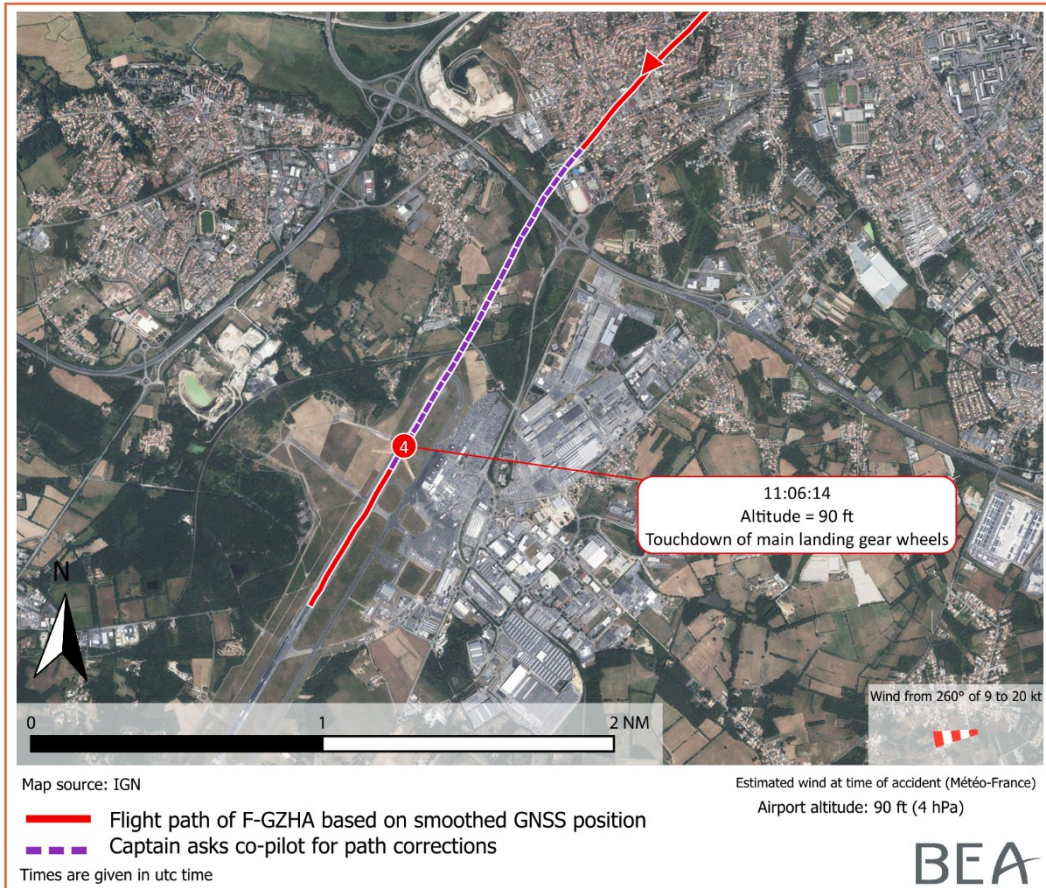
The co-pilot held the runway axis with a drift correction of less than five degrees. He indicated that he was monitoring the approach slope using the PAPI. The approach was stabilised, with a  $V_{app}$  close to that calculated by the crew. On final for runway 21, between 500 ft and 100 ft, i.e. for about 30 s, the instructor asked the co-pilot to apply corrections to hold the runway axis several times. During this period, the aeroplane’s path remained aligned with the runway axis and the slope. The speed deviations remained small.

Figure 2: final flight path of F-GZHA (source: BEA)

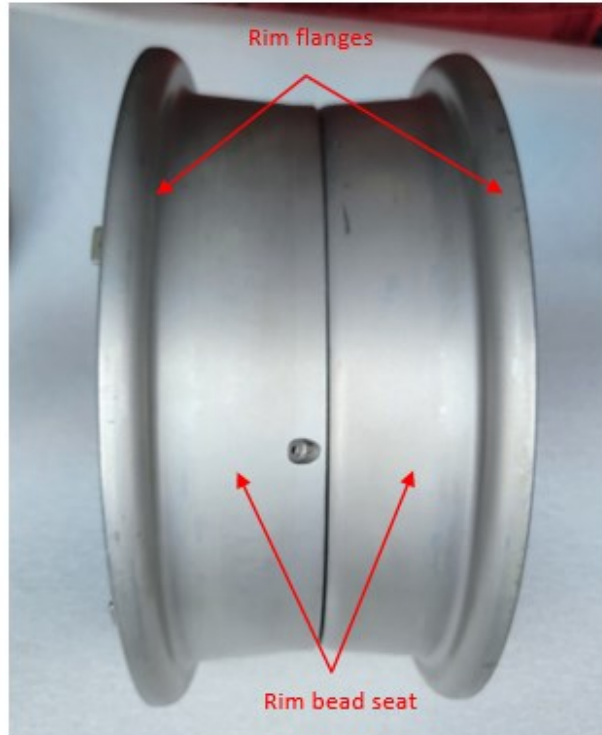
The nose landing gear rims failed between the bead seating area and the rim flanges (see Figures 8 and 9). These were also ejected between the point of contact with the ground and the moment when the aeroplane came to a stop.

Figure 8: new rim (source: BEA)

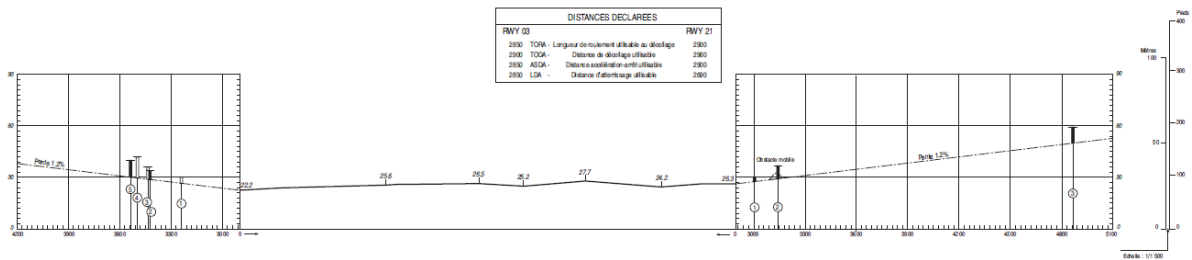
Runway 03/21 at Nantes - Atlantique airport has a runway profile with various successive slopes.

Figure 12: [profile of runway 03/21](#) (source: AIS)

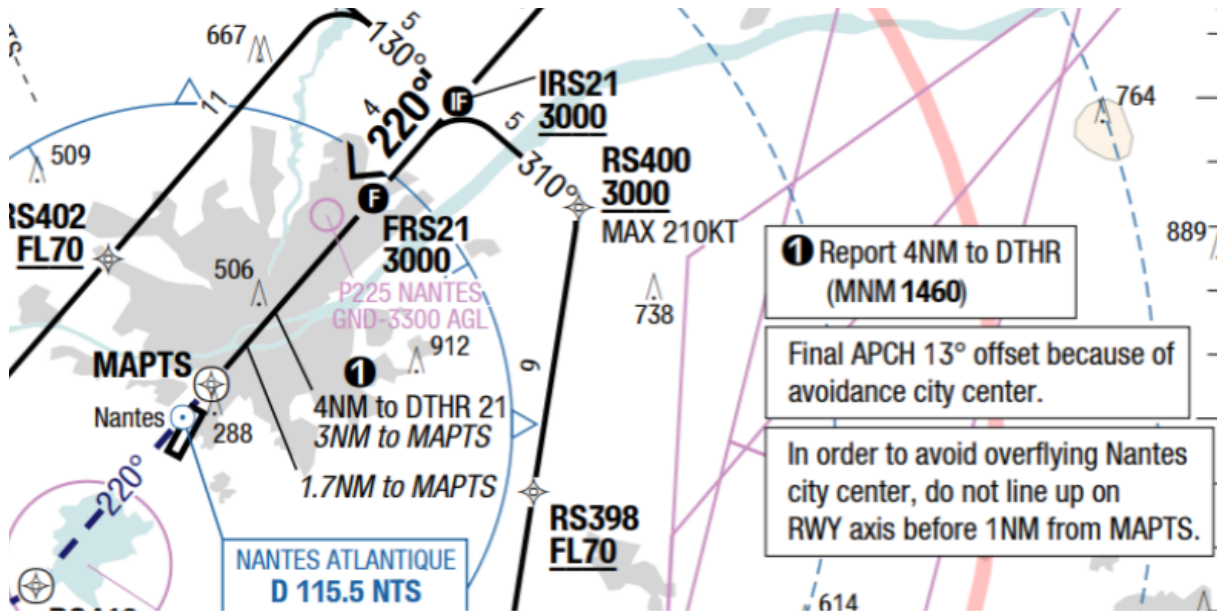
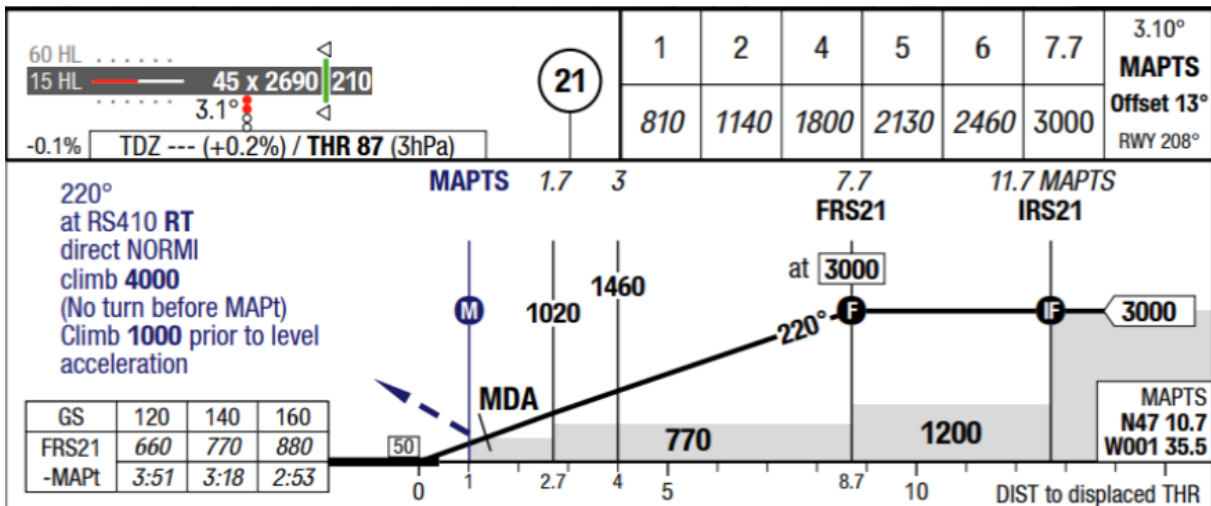
Figure 14: extracts from the approach chart used by the crew (source: LIDO<sup>16</sup>)
