Accident to the KUBICEK - BB26 - E
registered **F-HBBQ**
on 23 September 2021
at Chambley aerodrome

Time	07:38 ¹
Operator	Private
Type of flight	Instruction
Persons on board	Student pilot
Consequences and damage	Instructor seriously injured

Tethered flight take-off, in solo instruction, fall of instructor hanging from the guide rope

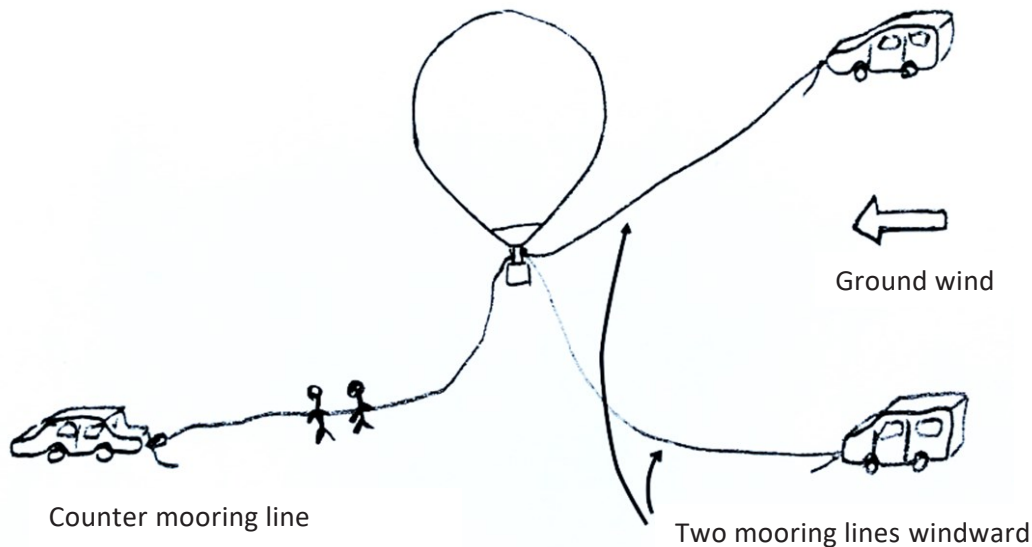
**Figure 2: configuration of mooring lines and anchoring points: two mooring lines situated at around 30° or 40° to the wind's path plus a third line.
(source: Manuel du pilote de montgolfière, annotated by the BEA)**
