**Accident** to the Airbus A320-214  
registered **F-HBNJ**  
on Wednesday 20 August 2025  
in descent to Ajaccio (Corsica)

**Flight through an area of severe convective turbulence,  
during descent**

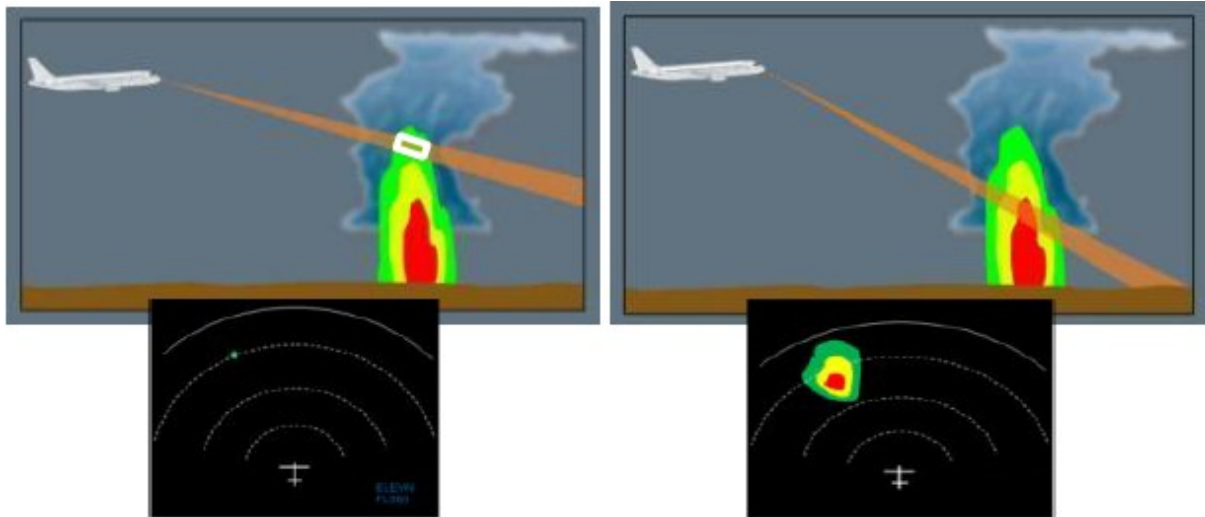
Figure 4: detectability according to tilt (source: Airbus)

The radar on F-HBNJ was tested at the manufacturer's, Collins Aerospace. No failure that might have contributed to the accident sequence was brought to light.

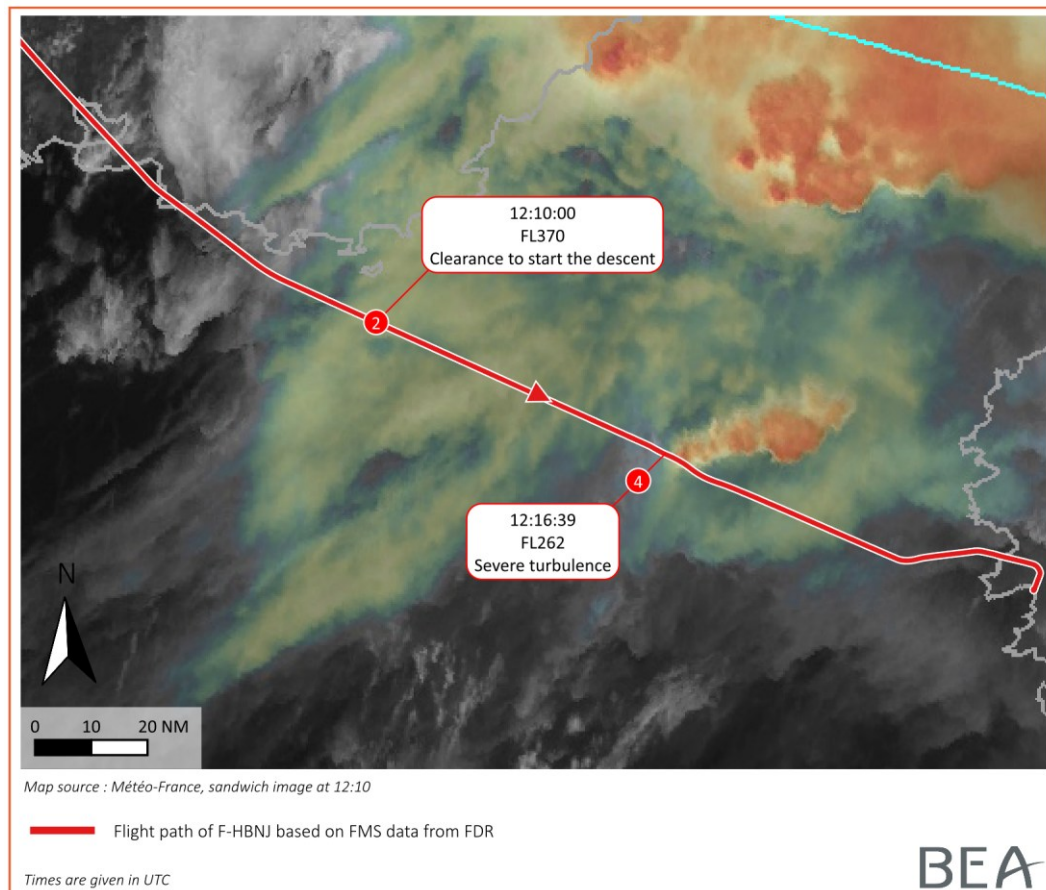
Figure 5: sandwich image at 12:10

The analysis of the data from the Météo-France ground precipitation radar concerning the convective cell which the aeroplane flew through at FL 262 showed:

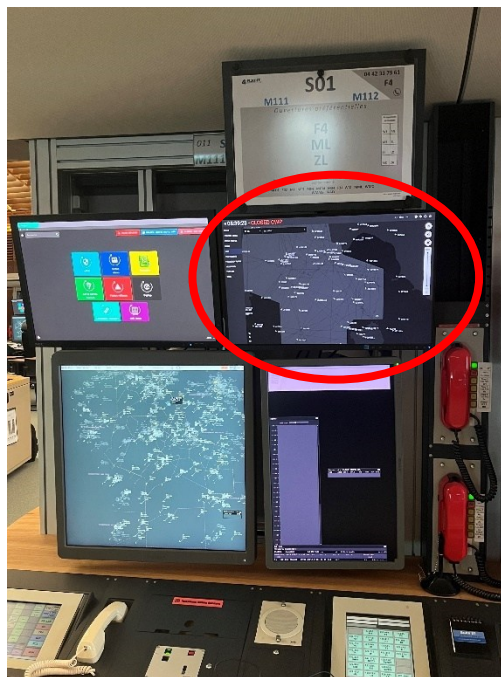
*Figure 10: position of 4Me multifunction screen in control position  
(source: DSNA/south-east ACC)*

The south-east ACC controllers have a multi-service secondary screen called the 4Me at their disposal, close to their main radar screen used for the traffic control function (See **Figure 10**). The MAP function of the 4Me screen includes the simultaneous display of the ASPOC<sup>29</sup> weather situation and the ARTAS<sup>30</sup> air picture in the control area (see **Figure 11** and **Figure 12**) to reinforce the controller’s situational awareness with the aim of defining traffic management strategies. It should be noted that the ASPOC data can have a lag of up to 15 min.

The DSNA specified, however, that the 4Me secondary screen is multi-service and that the MAP function is not always displayed on the screen. It can be replaced, for example, by another window (amount of traffic, flight plans, etc.). The DSNA added that it is expected of a controller to give this type of flight information if he has the time to do so.

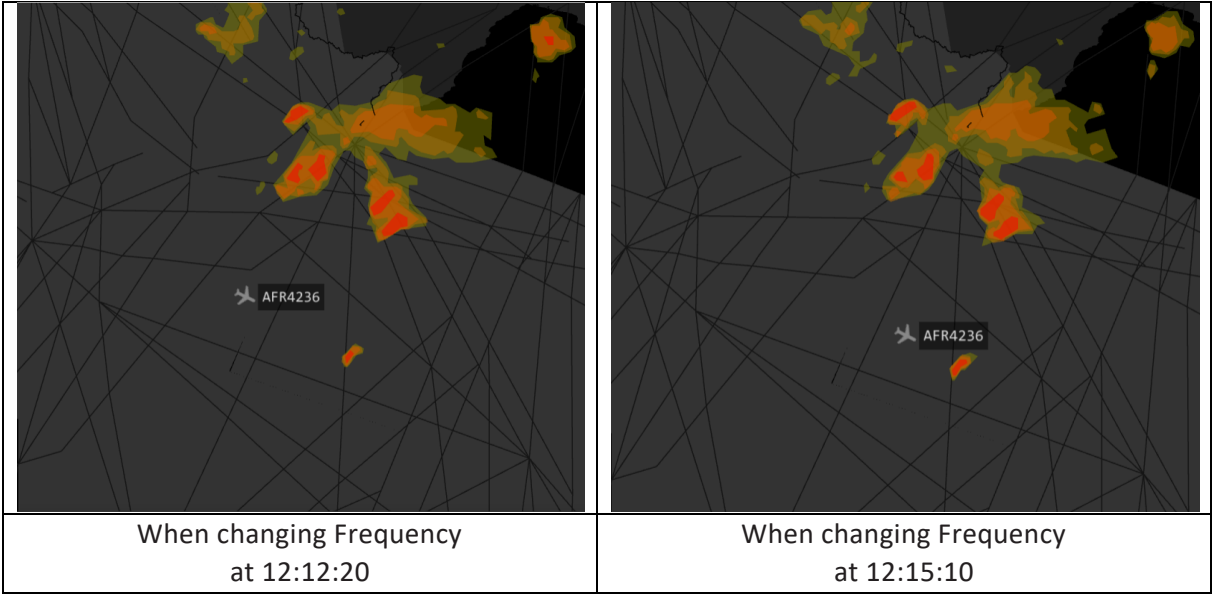
Figure 11 and Figure 12: recreation of 4Me image<sup>31</sup> and position of F-HBNJ based on ASPOC data (source: DSNA/DTI)

The analysis of the radio communications shows that more than fifty avoidance manoeuvres were requested by the pilots in the sectors mentioned. No avoidance manoeuvre was carried out in the vicinity of the convective cell before it was flown through by F-HBNJ.

The investigation brought to light that in the conditions of the occurrence, the flight crew had an on-board display of the adverse weather phenomenon that was less precise than that provided by the sensors used by the air traffic services.
