Incident to the Embraer ERJ170
registered **F-HBXI**
operated by HOP!
on Saturday 11 May 2024
on Toulouse – Blagnac airport

Landing with left landing gear not locked indication

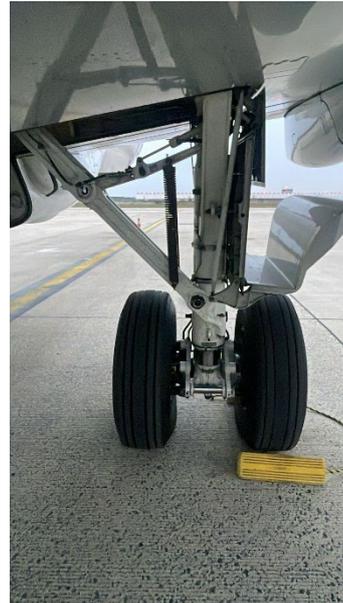
- the torque link actuating the left main landing gear was not aligned (see **Figure 2** and **Figure 3**)
- the locking-stay had separated from the landing gear shock strut (see **Figure 4** and **Figure 5**).

Figure 3: left main landing gear in normal position, view looking aftwards (source: BEA)

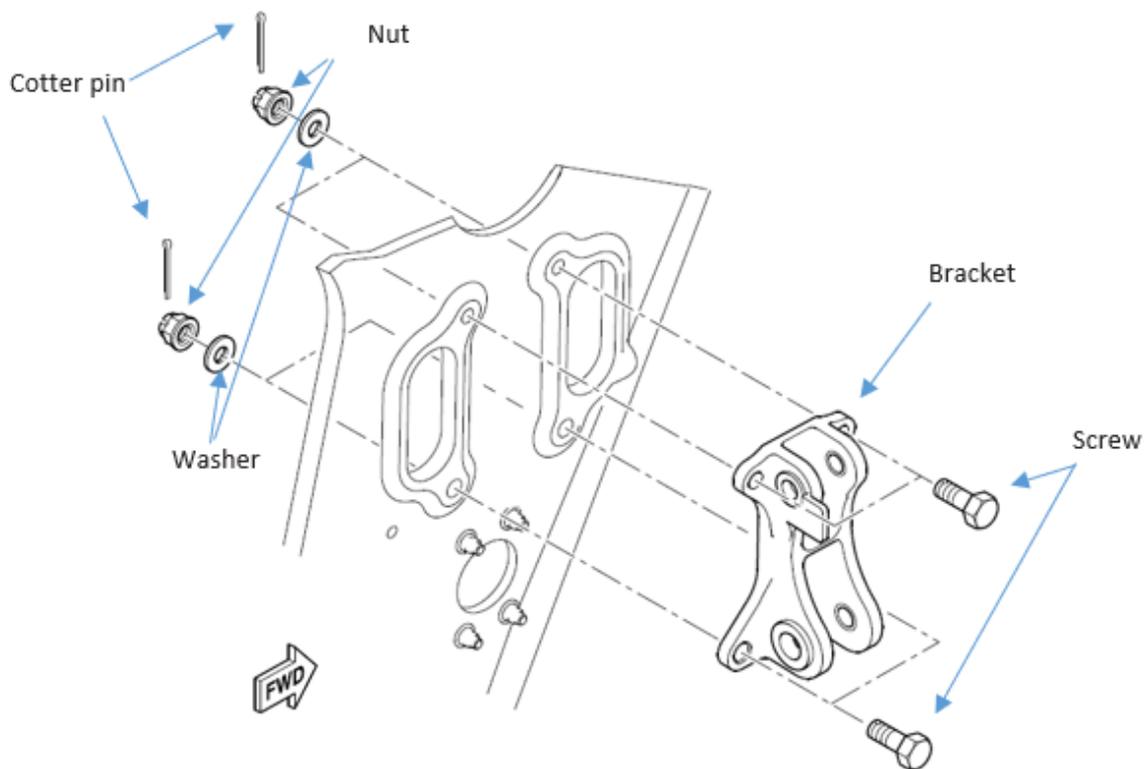
The landing gear system is designed and manufactured by Liebherr. The locking-stay bracket is normally attached to the landing gear shock strut by four bolt assemblies consisting of the screw itself, a nut, a washer and a cotter pin (see **Figure 7**).

Figure 7: assembly of locking-stay bracket (source: Embraer, annotations BEA)

After the incident, the bracket was found separated from the landing gear shock strut. The four attaching bolts were found in the following condition:

- rear top position (see **Figure 8**): the screw was broken without deformation; all the components were recovered;
- forward top position (see **Figure 9**): the screw was broken and bent, the washer was missing;
- rear bottom position (see **Figure 10** and **Figure 11**): the screw was in good condition, the washer and nut were missing, a fragment of the cotter pin was still in place in the screw. Some metal debris was caught in the screw threads;
- forward bottom position: the screw was in good condition, the washer and nut were missing, a fragment of the cotter pin was still in place in the screw. Some metal debris was caught in the screw threads.

It is very likely that the nuts of the two bottom bolts, being incorrectly sized, were damaged when torqued during their installation and subsequently tore off⁷. The forward bolt located in the top position then gradually cracked due to fatigue, until eventually breaking. As the bracket was then only held by the rear bolt, the latter suddenly broke due to overloading.
