**Accident** to the ELIXIR  
registered **F-HCDN**  
on Friday 2 May 2025  
at Amboise-Dierre aerodrome

**Runway veer-off during an emergency landing, rupture of  
nose gear fork, overturn**

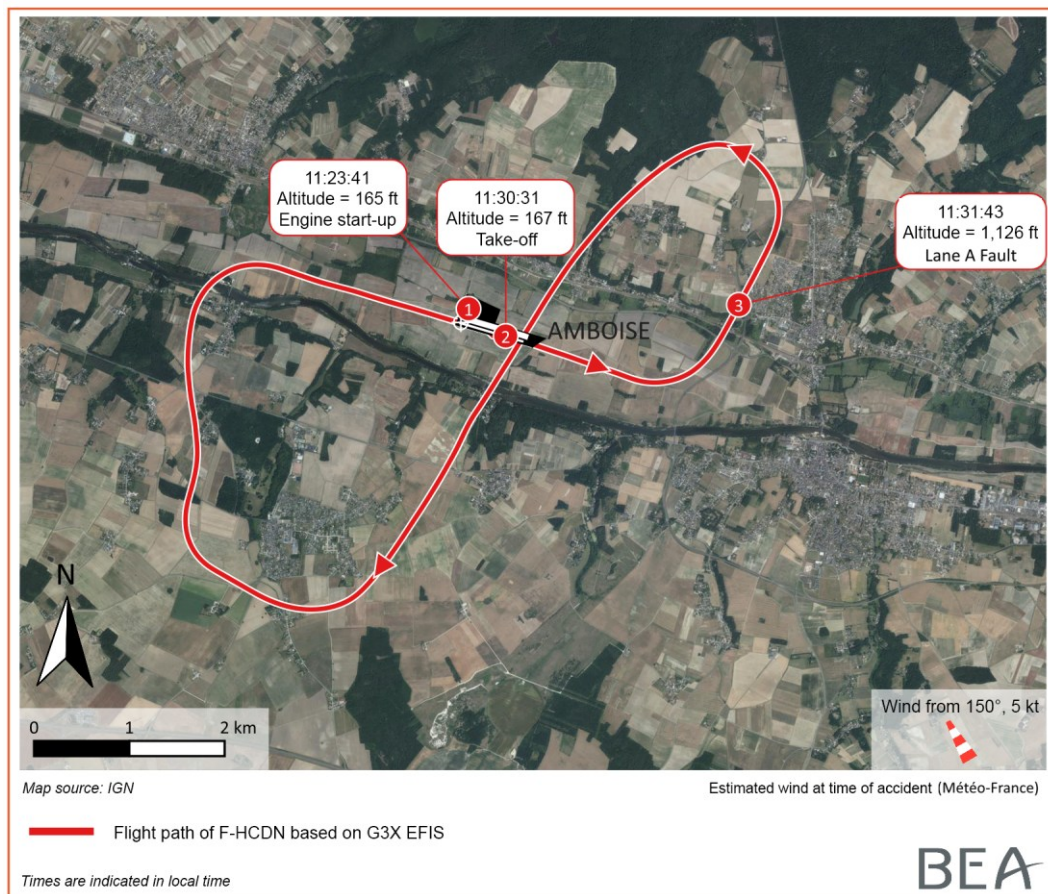
Figure 1: flight path

The pilot took off from runway 10<sup>3</sup>. Around one minute after take-off (see **Figure 1**, point ③), the “LANE A” caution light came on and remained steadily illuminated. The pilot decided to carry out a U-turn and an emergency landing. He joined the end of the right-hand downwind leg for runway 10. On final, the aeroplane’s speed (IAS) was between 64 kt and 70 kt (see **Figure 2**, point ④) and the descent slope was around 4° (see **Figure 3**). The elevator trim was set to nose down (-39%).

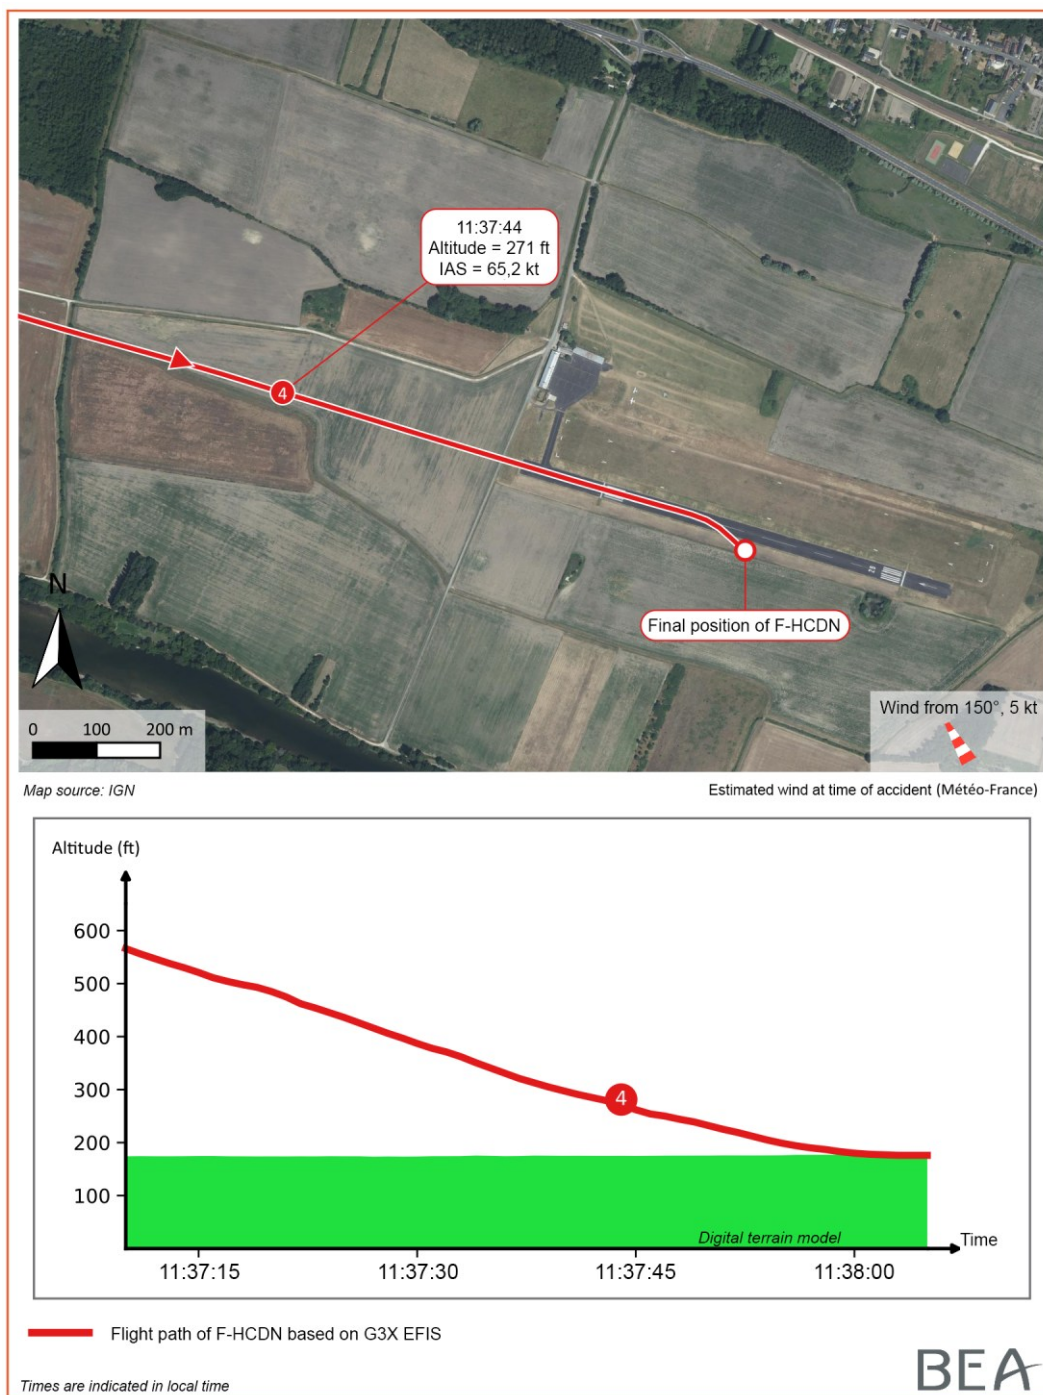
At the beginning of runway 10, i.e. 130 m from the threshold, the speed decreased to 60 kt. After the flare, the speed decreased to 55 kt. On touchdown, the aeroplane bounced, swerved to the right-hand side and then veered off the runway. The nose gear fork ruptured on running over a rut in the grass. The aeroplane nosed over onto its back and came to a stop on the grass strip on the right-hand side of the runway. The occupants were unable to evacuate the aeroplane. Witnesses present at the aerodrome managed to break the canopy of F-HCDN using a canopy breaker tool taken from one of their aeroplanes and helped the occupants evacuate.

Figure 2: final of approach to runway 10
