Accident to the DIAMOND - DA42 - NG
registered **F-HIMY**
on 16 June 2022
at Courchevel

**Runway overrun, collision with a bank, in mountain flight,
in instruction**

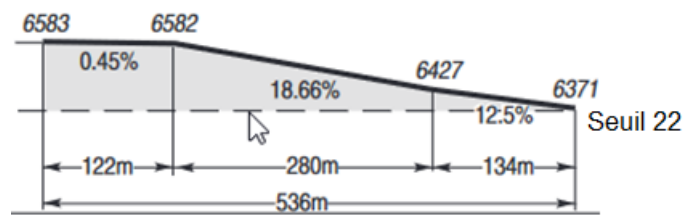
Courchevel mountain airfield is a restricted-use aerodrome. It has one runway oriented 22/04 measuring 536 m long; the threshold of runway 22 is situated at 6,371 ft. The profile of the runway is shown below:

Figure 1: lengthwise profile of runway 04/22 at Courchevel taken from VAC
