Accident to the AIRBUS - EC135- T1
registered **F-HJAF** operated by SAF HELICOPTERES
on 8 December 2020 at Bonvillard (Savoie)

Time	Around 17:15 ¹
Operator	SAF HELICOPTERES (France)
Type of flight	Instruction flight
Persons on board	2 pilots, 2 hoist operators, 2 rescuers
Consequences and damage	5 persons fatally injured, 1 person severely injured, helicopter destroyed

**Collision with vegetation during an instruction flight in
helicopter hoist operations, at night**

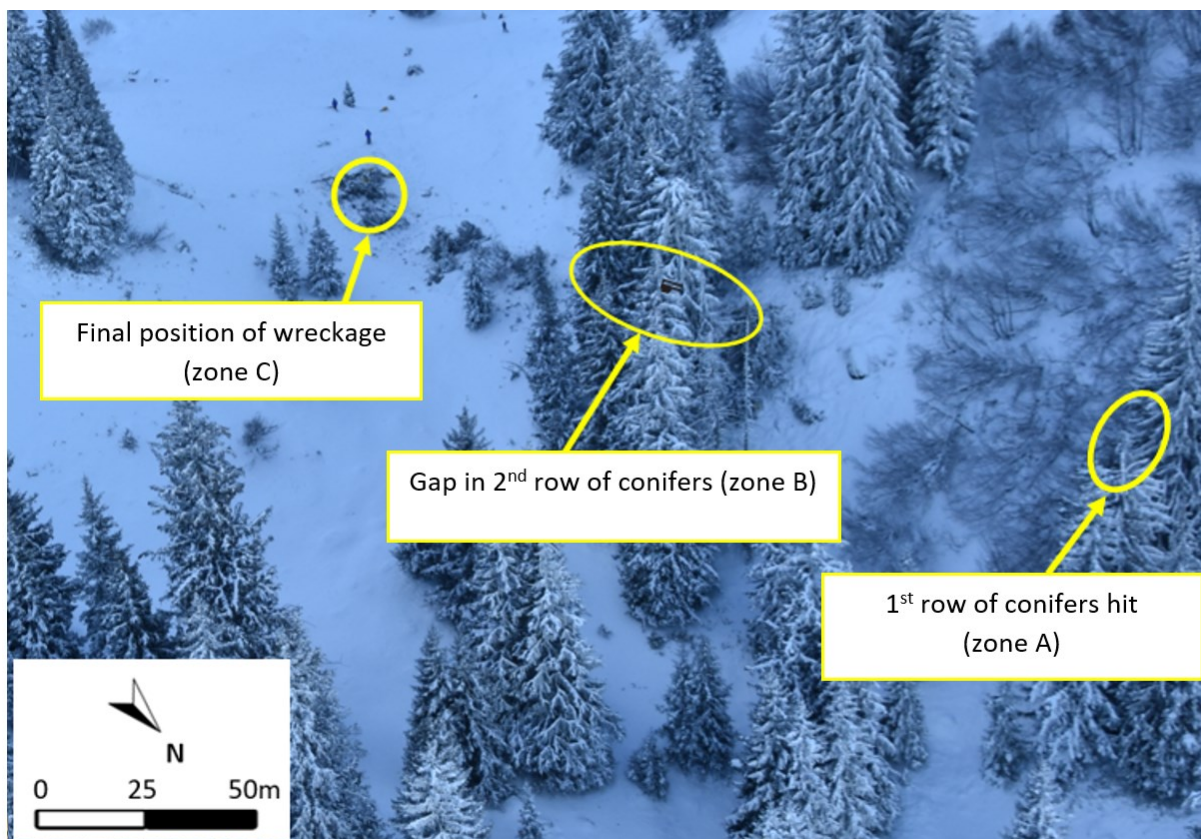
Figure 6: aerial view of site by day on 10 December 2020 (source: GTA)

Three areas of impact could be observed between the helicopter and the vegetation/ground:

The wreckage was located in an area of low vegetation, surrounded by several groups of conifers standing at a height of up to around 30 m. To the north-west of the position of the main wreckage and about 50 m from the latter in the direction of the valley, a row of trees was damaged at mid-height. This gap was recent. A large number of branches as well as a lot of debris from the helicopter were found in the gap and on the ground, between this group of trees and the main wreckage.

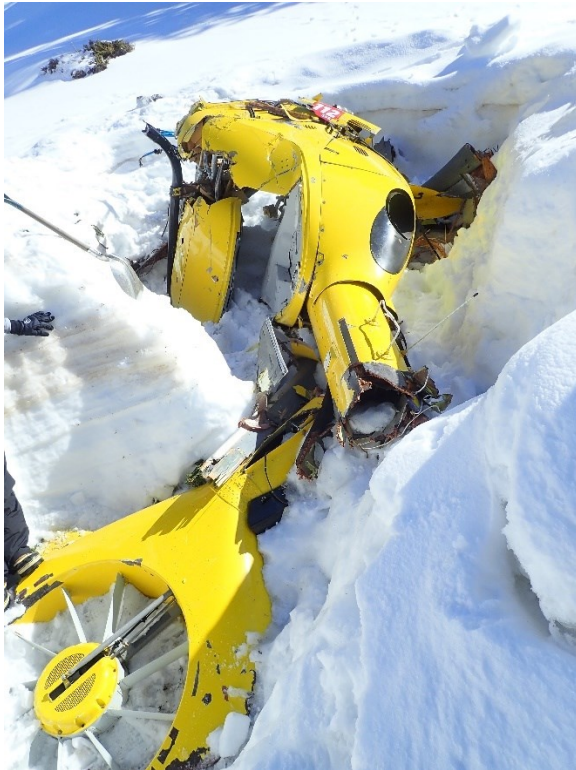
Figure 11: wreckage cleared of snow before being raised (source: BEA)

The meteorological conditions were such that the recovery of the large assemblies was only possible in April 2021 and the smaller elements in June 2021.

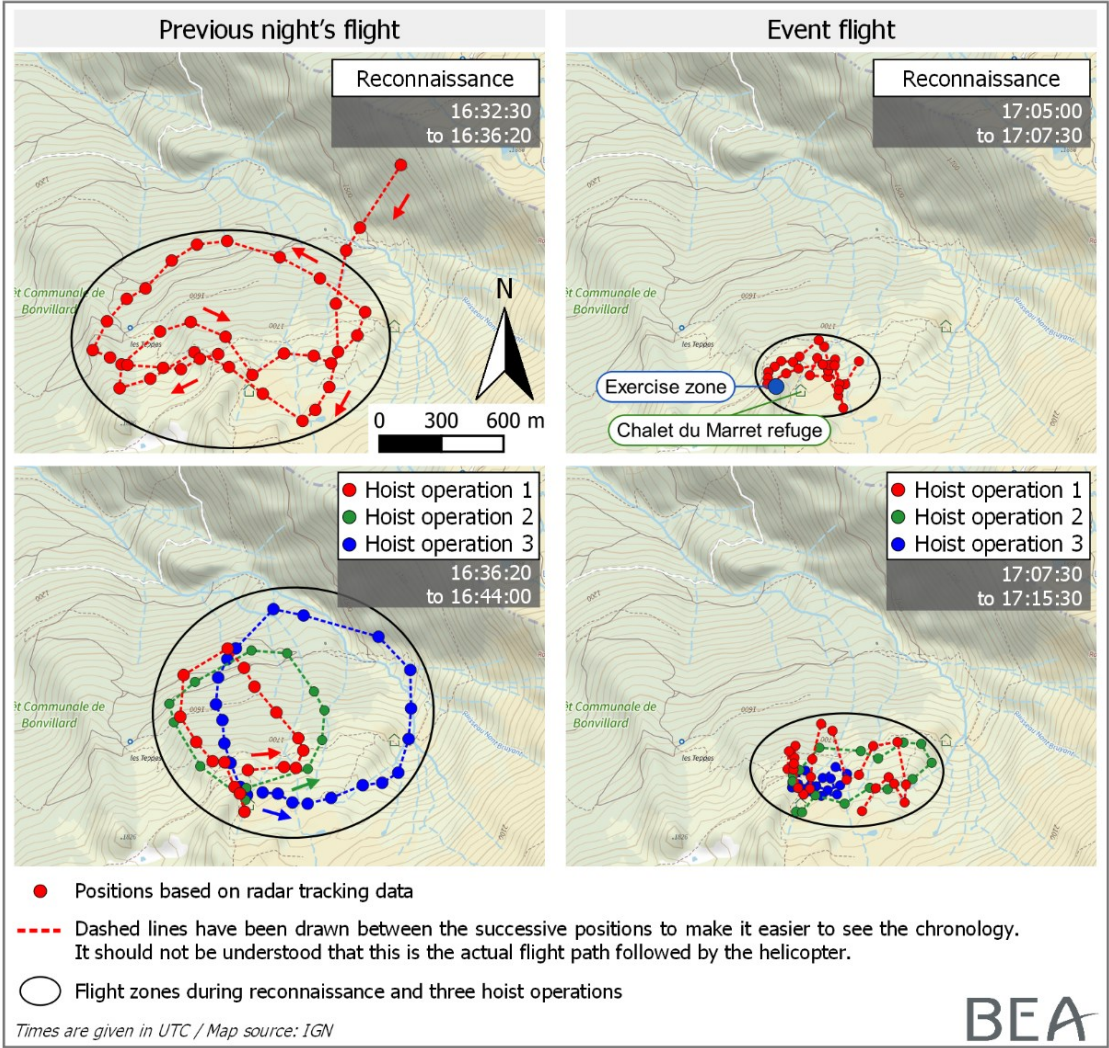
Figure 18: flight paths followed for site reconnaissance and hoist operations

Despite the inaccuracies of the radar positions, it can be seen that during the event flight, a left-hand racetrack pattern was performed before each hoist operation No 1 and No 2.

For hoist operation No 3, two circuits can be seen, the first probably being a left-hand circuit. It was not possible to determine the final approach path for the last hoist operation using the path data.

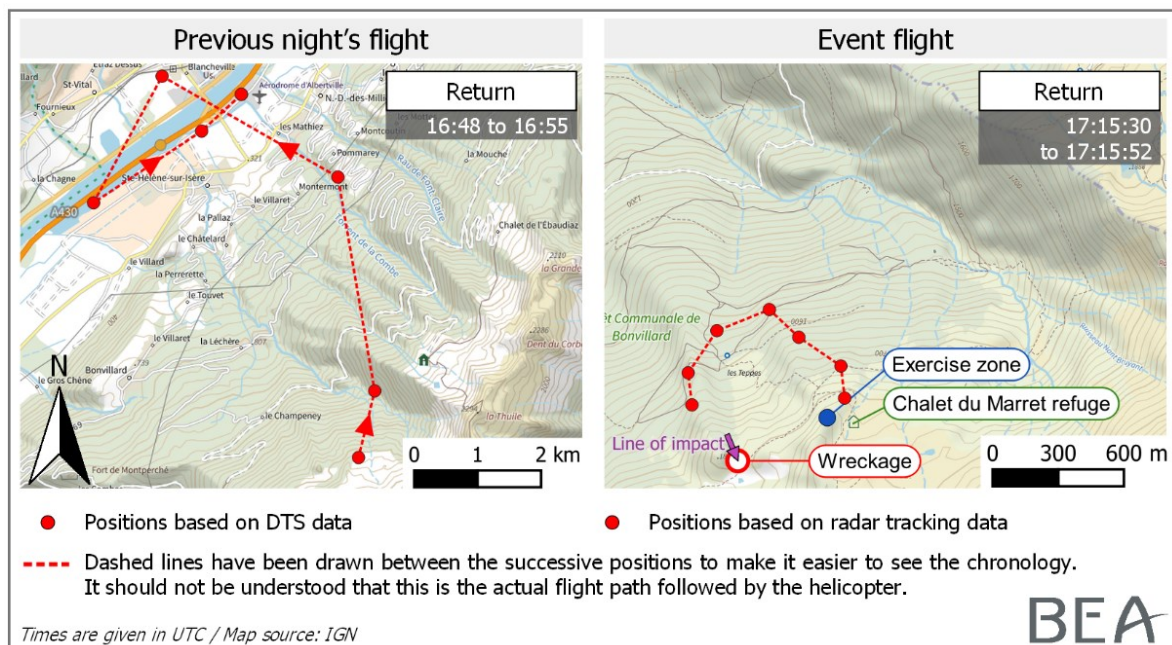
Figure 20: path followed at end of hoist operations

The radar tracking information made it possible to detect a north-westerly flight path when leaving the exercise site²⁴, with an increase in the helicopter's speed and a left-hand turn at a constant altitude. The estimated end of the flight path was consistent with observations made at the accident site and the position of the wreckage. It is not possible to be precise about the true positions of the helicopter.

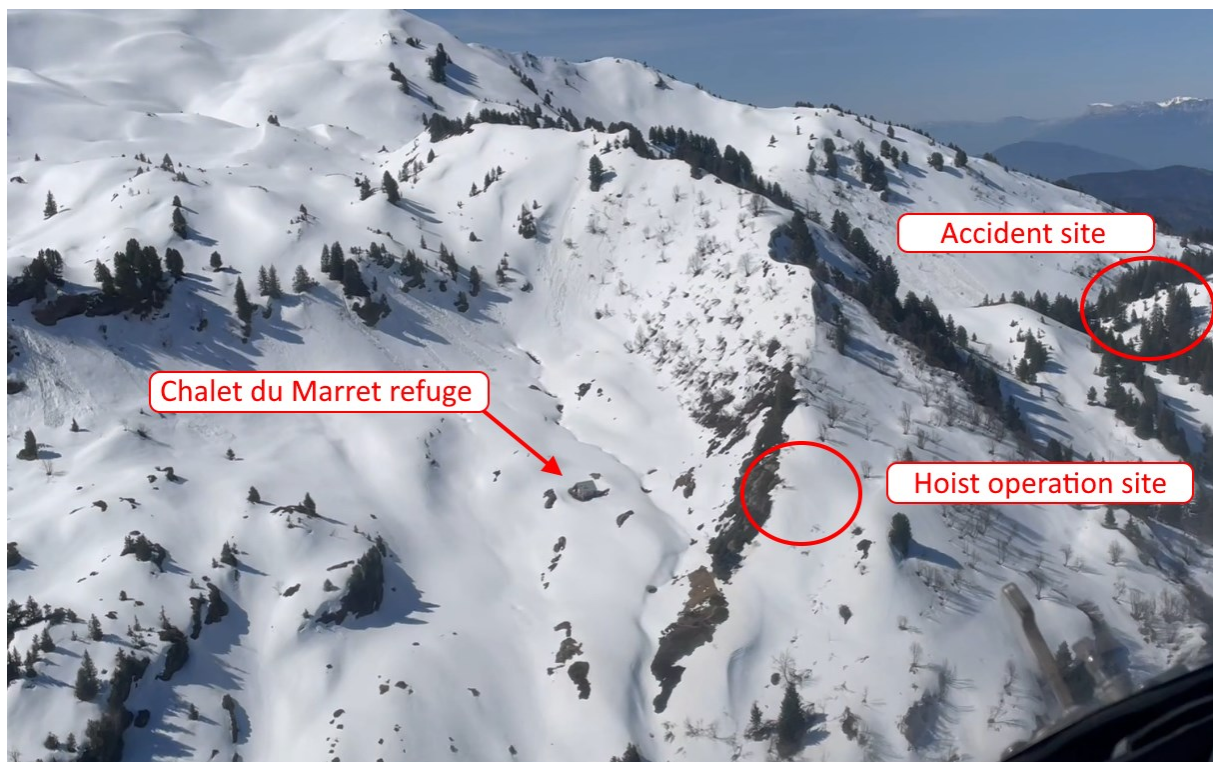
Figure 22: general view of the hoist operation site (facing south-west) (source: BEA)

The hoist operation site was located on a spur overhanging Marret refuge, about 50 m to the north-west of the latter. The chalet is a visual reference for pilots to position themselves at the hoist operation site with a helicopter oriented in an easterly to southerly direction.

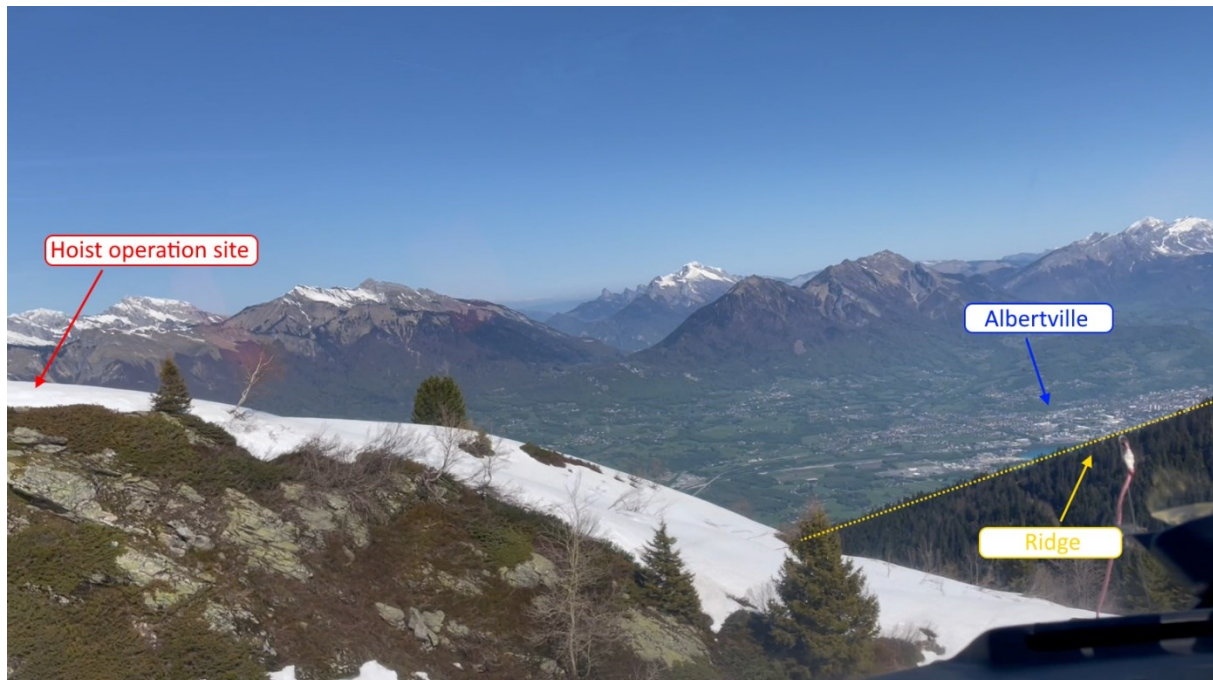
Figure 23: view towards Albertville at altitude of hoist operation site (source: BEA)

In order to assess the visibility of Albertville, the helicopter was positioned between the hoist operation site and Marret refuge, pointing towards the town, at an altitude corresponding to that of the hoist operation site, then it gradually rose by 100 m. From the initial position up to 100 m, Albertville was visible; the first (most penalising) ridge line between the hoist operation site and Albertville only masked the south end of the town.

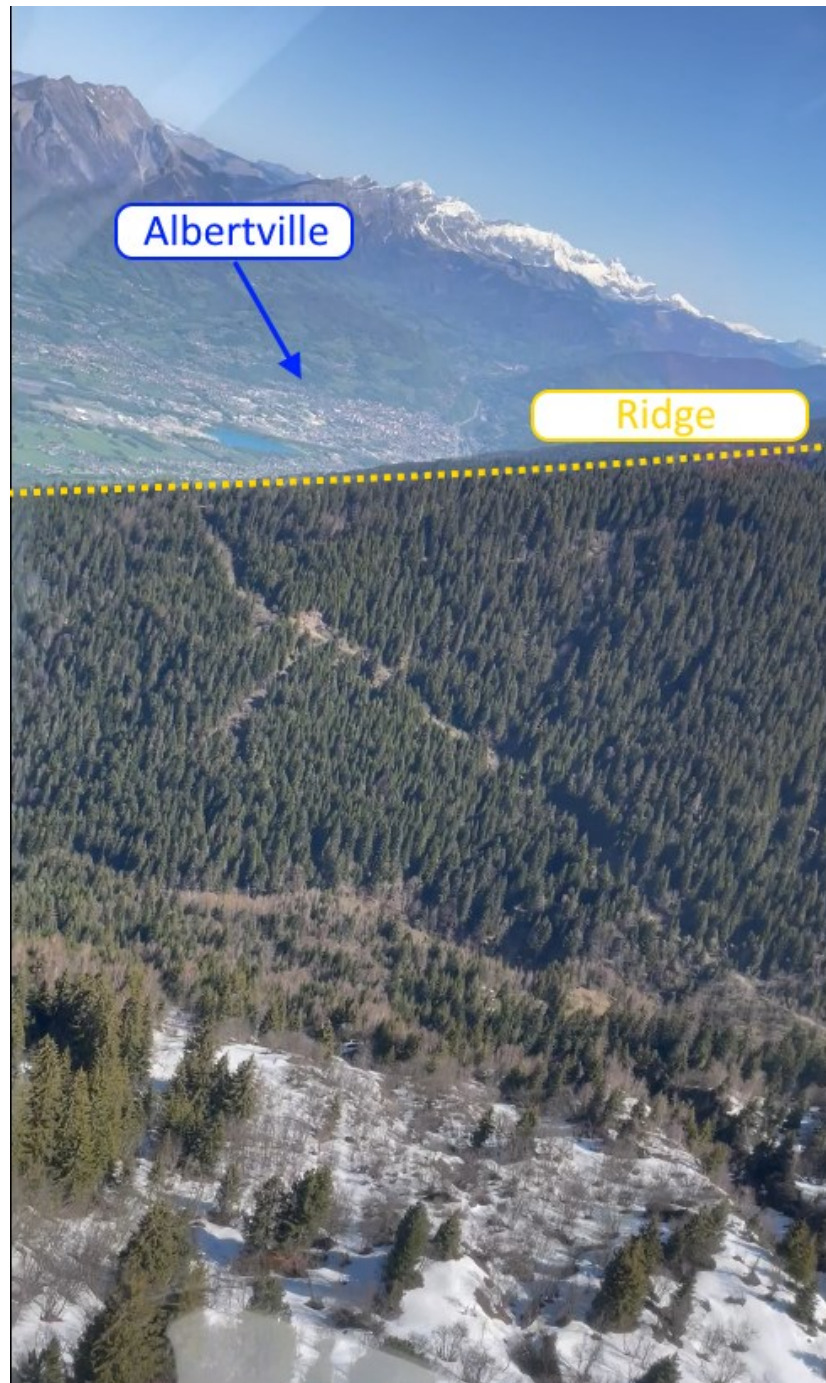
Figure 24: view from hoist operation site (height 20 m) towards Albertville during left turn
(source: BEA)

On following the accident flight path, from the departure from the hoist operation site at a height of 20 m agl with the helicopter turned towards Marret refuge (south-east), and on turning left to head north-west, it was possible to confirm that:

- Overhead the hoist operation site, Albertville was visible and located on the pilot's left.
- During the turn, the pilot successively had in front of him (direction 12 o'clock): Albertville, Gilly-sur-Isère, Frontenex, and finally Grésy-sur-Isère.
- All the villages in the valley between Albertville and Grésy-sur-Isère were visible.

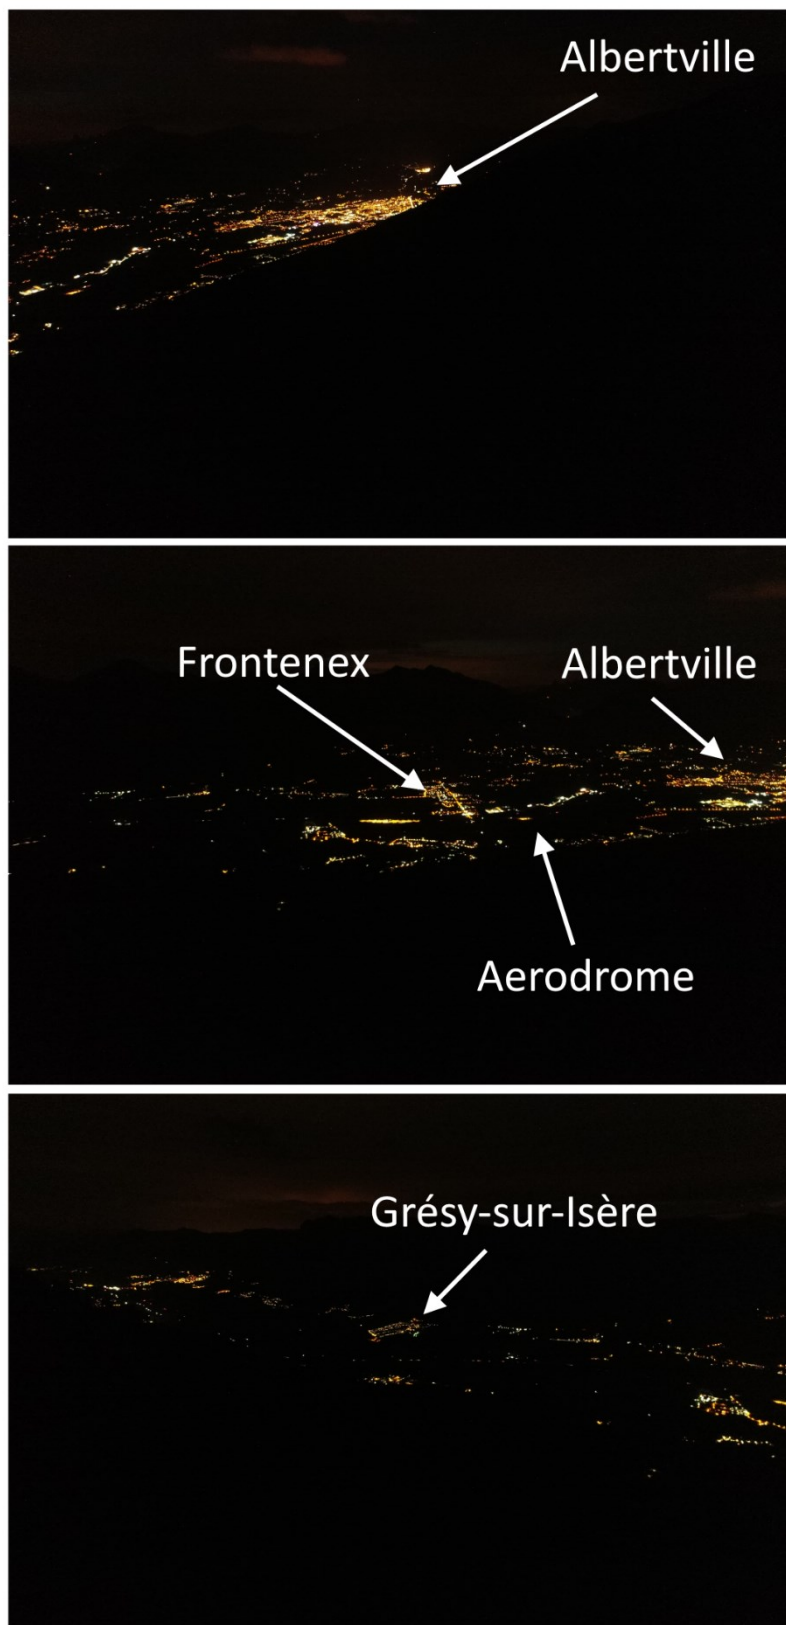
Figure 25: night photos (source: BEA)

The following three photos taken in the direction of Albertville, the aerodrome and Grésy-sur-Isère, two hours after sunset, show the town lights situated in the valley and visible overhead the exercise site at a height of 50 m.

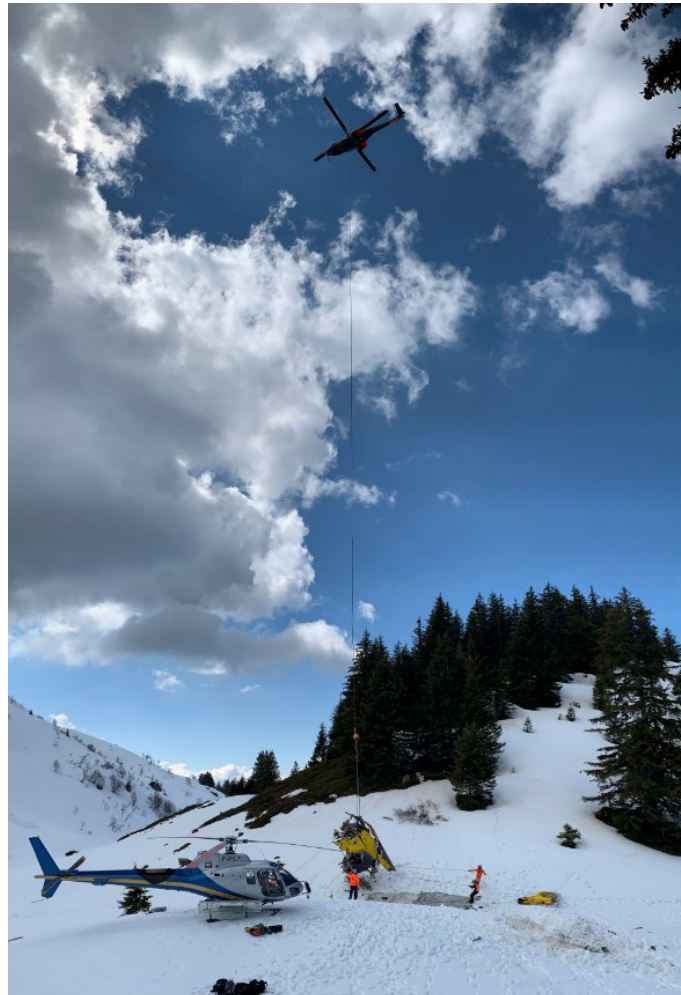
Figure 27: photo of recovery operation (source: BEA)

operation: all the available power had to be used due to the presence of a large layer of ice under the wreckage which was holding it back.
